John M. Daly & Associates Pty Ltd  
P.O. Box 25  
CAMPBELTOWN NSW 2560Project 92297.00  
17 July 2018  
R.001.Rev1  
CKM

**Preliminary Site Investigation (Contamination) - Addendum  
Proposed Residential Development  
Reeves Creek, Picton (East), NSW****1. Introduction**

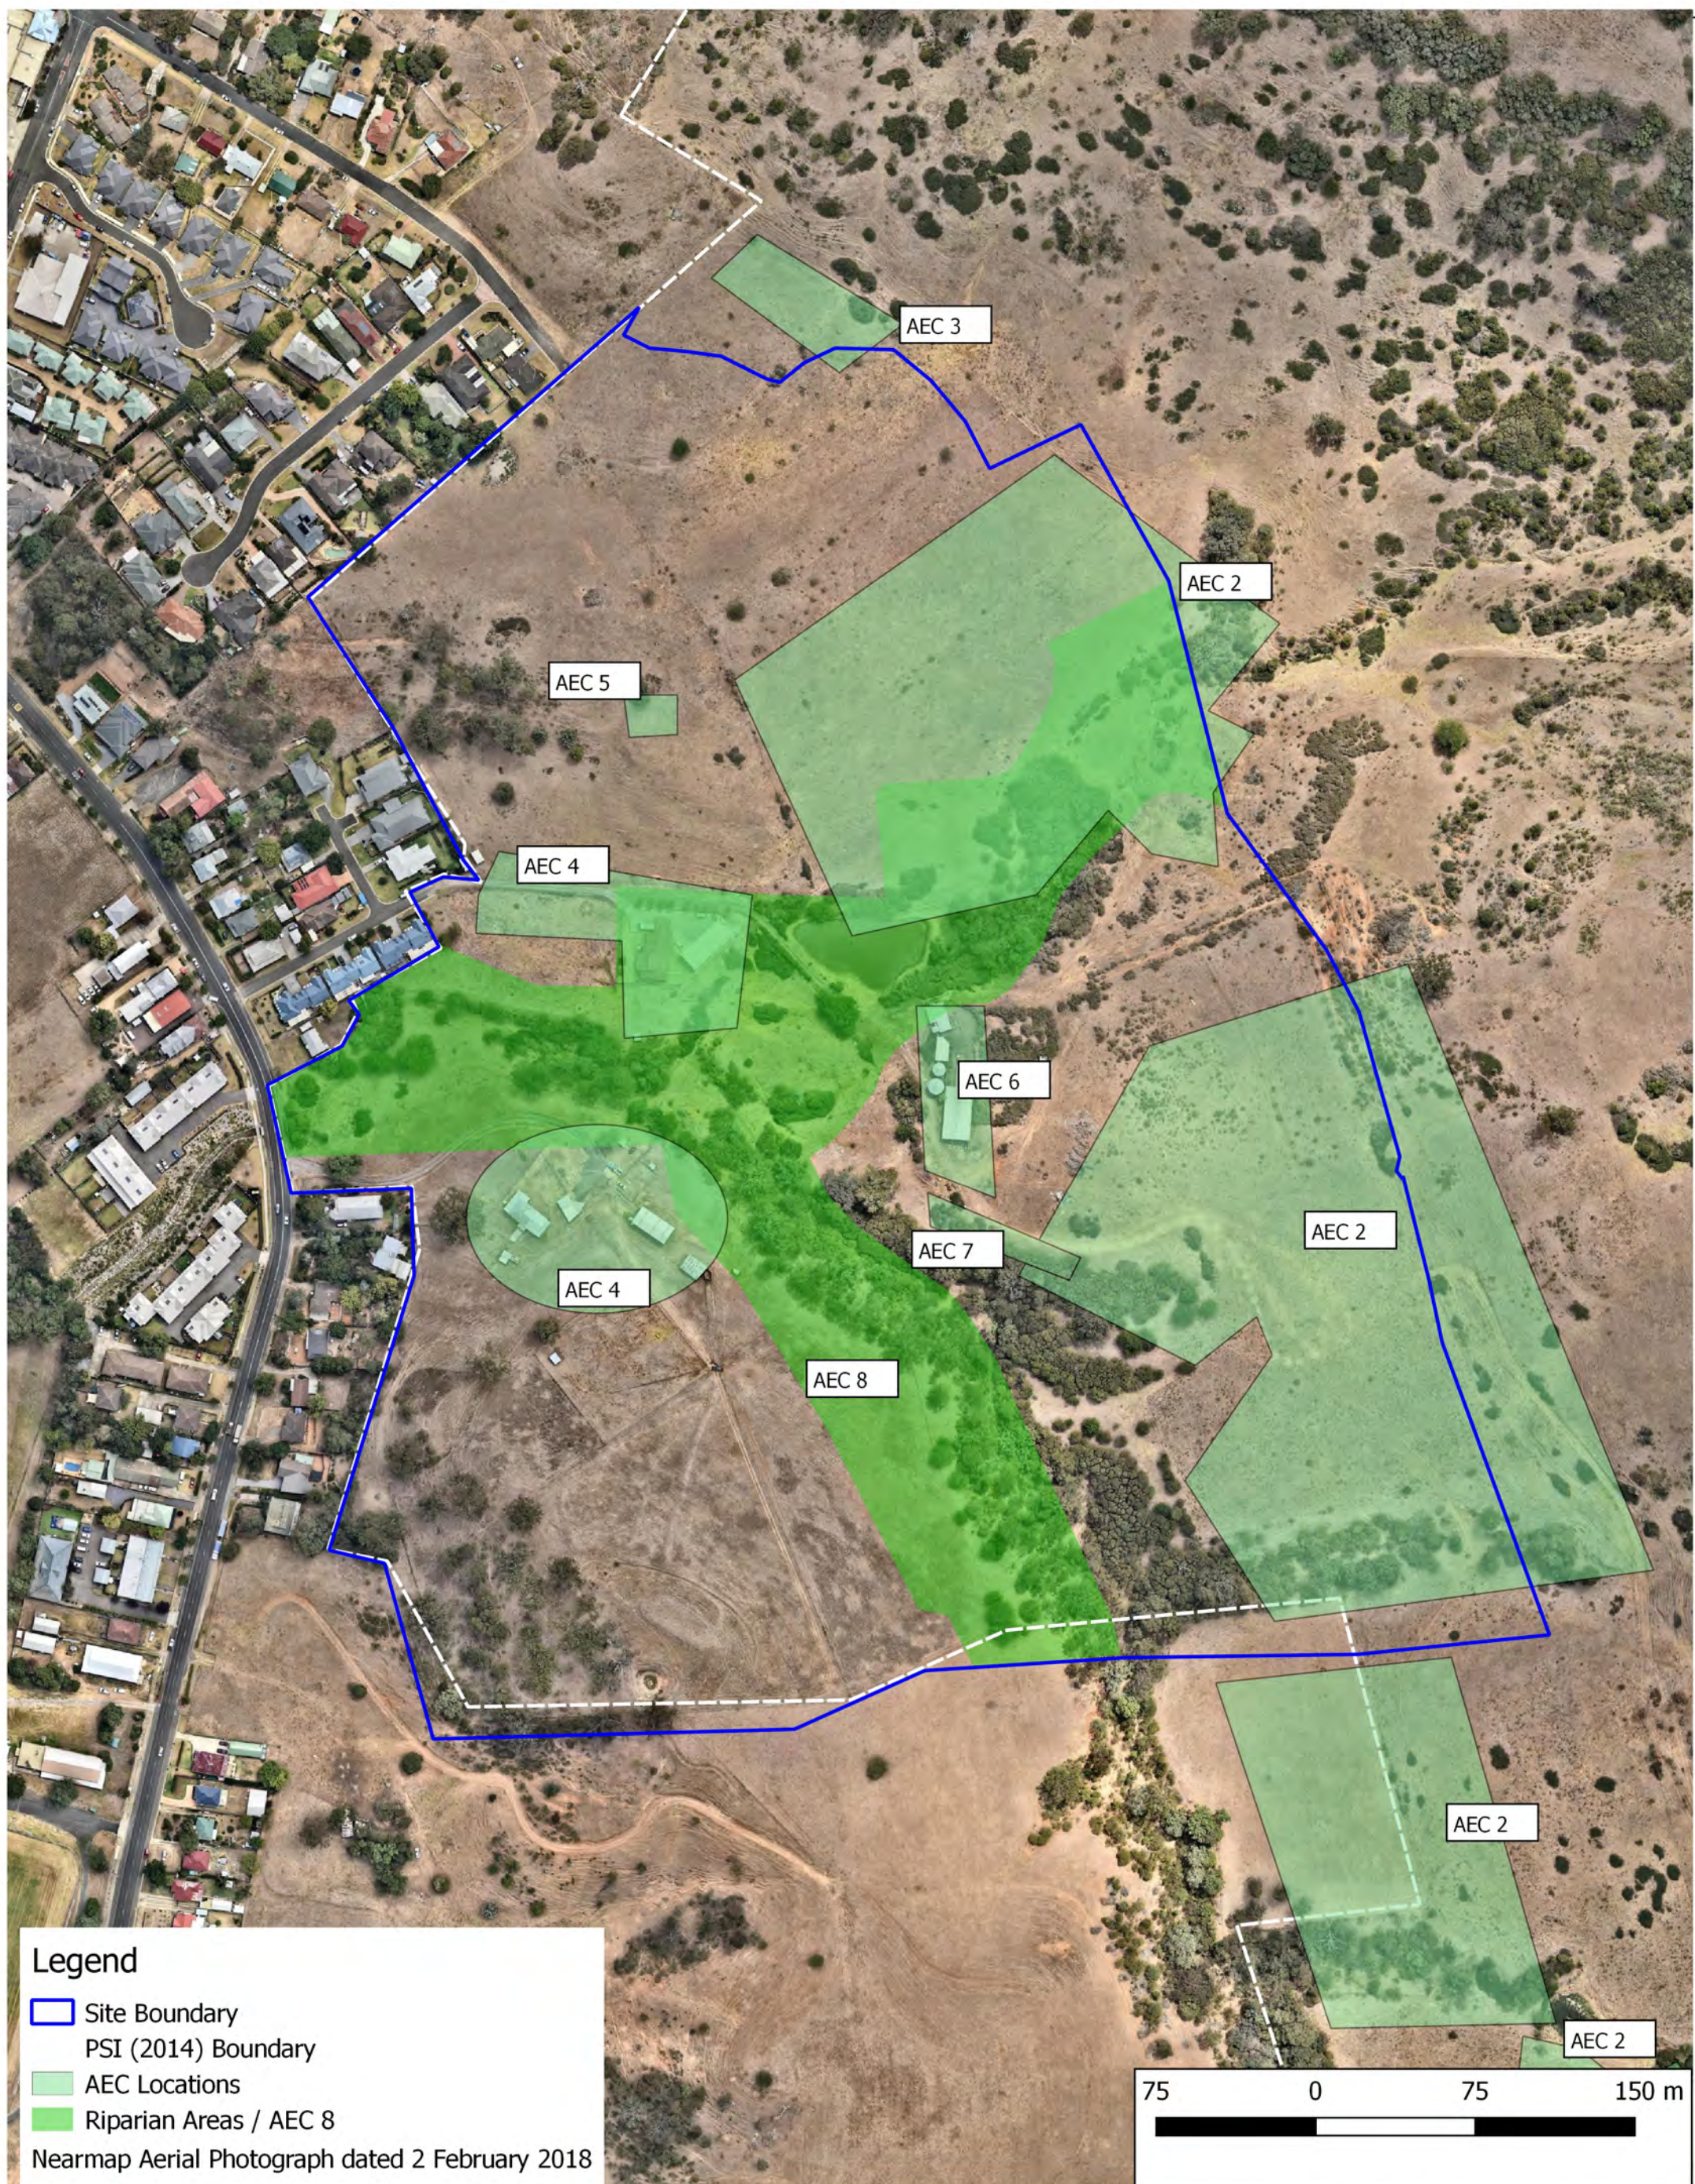
TITLE: **Updated AECs  
Contamination Addendum  
Reeves Creek, Picton East, NSW**

The stockpile footprints and adjacent surficial ACM area has been assigned as AEC 7;

For the purposes of future investigations, the riparian corridor has been assigned as AEC 8;

- There were no changes to the AECs identified in the PSI report with the exception of the inclusion of suspected ACM and stockpiles in AEC 6 (the dairy); and
- Further investigation of the AECs is still required prior to development. Refer Drawing 4 for a map of updated AECs.

- The area of surficial suspected ACM and pre-existing stockpiles adjacent to the dairy (assigned under AEC 6);
- The footprints of the former stockpiles (suspect ACM and chemical contaminants) (AEC 7); and
- The riparian corridors.(AEC 8).

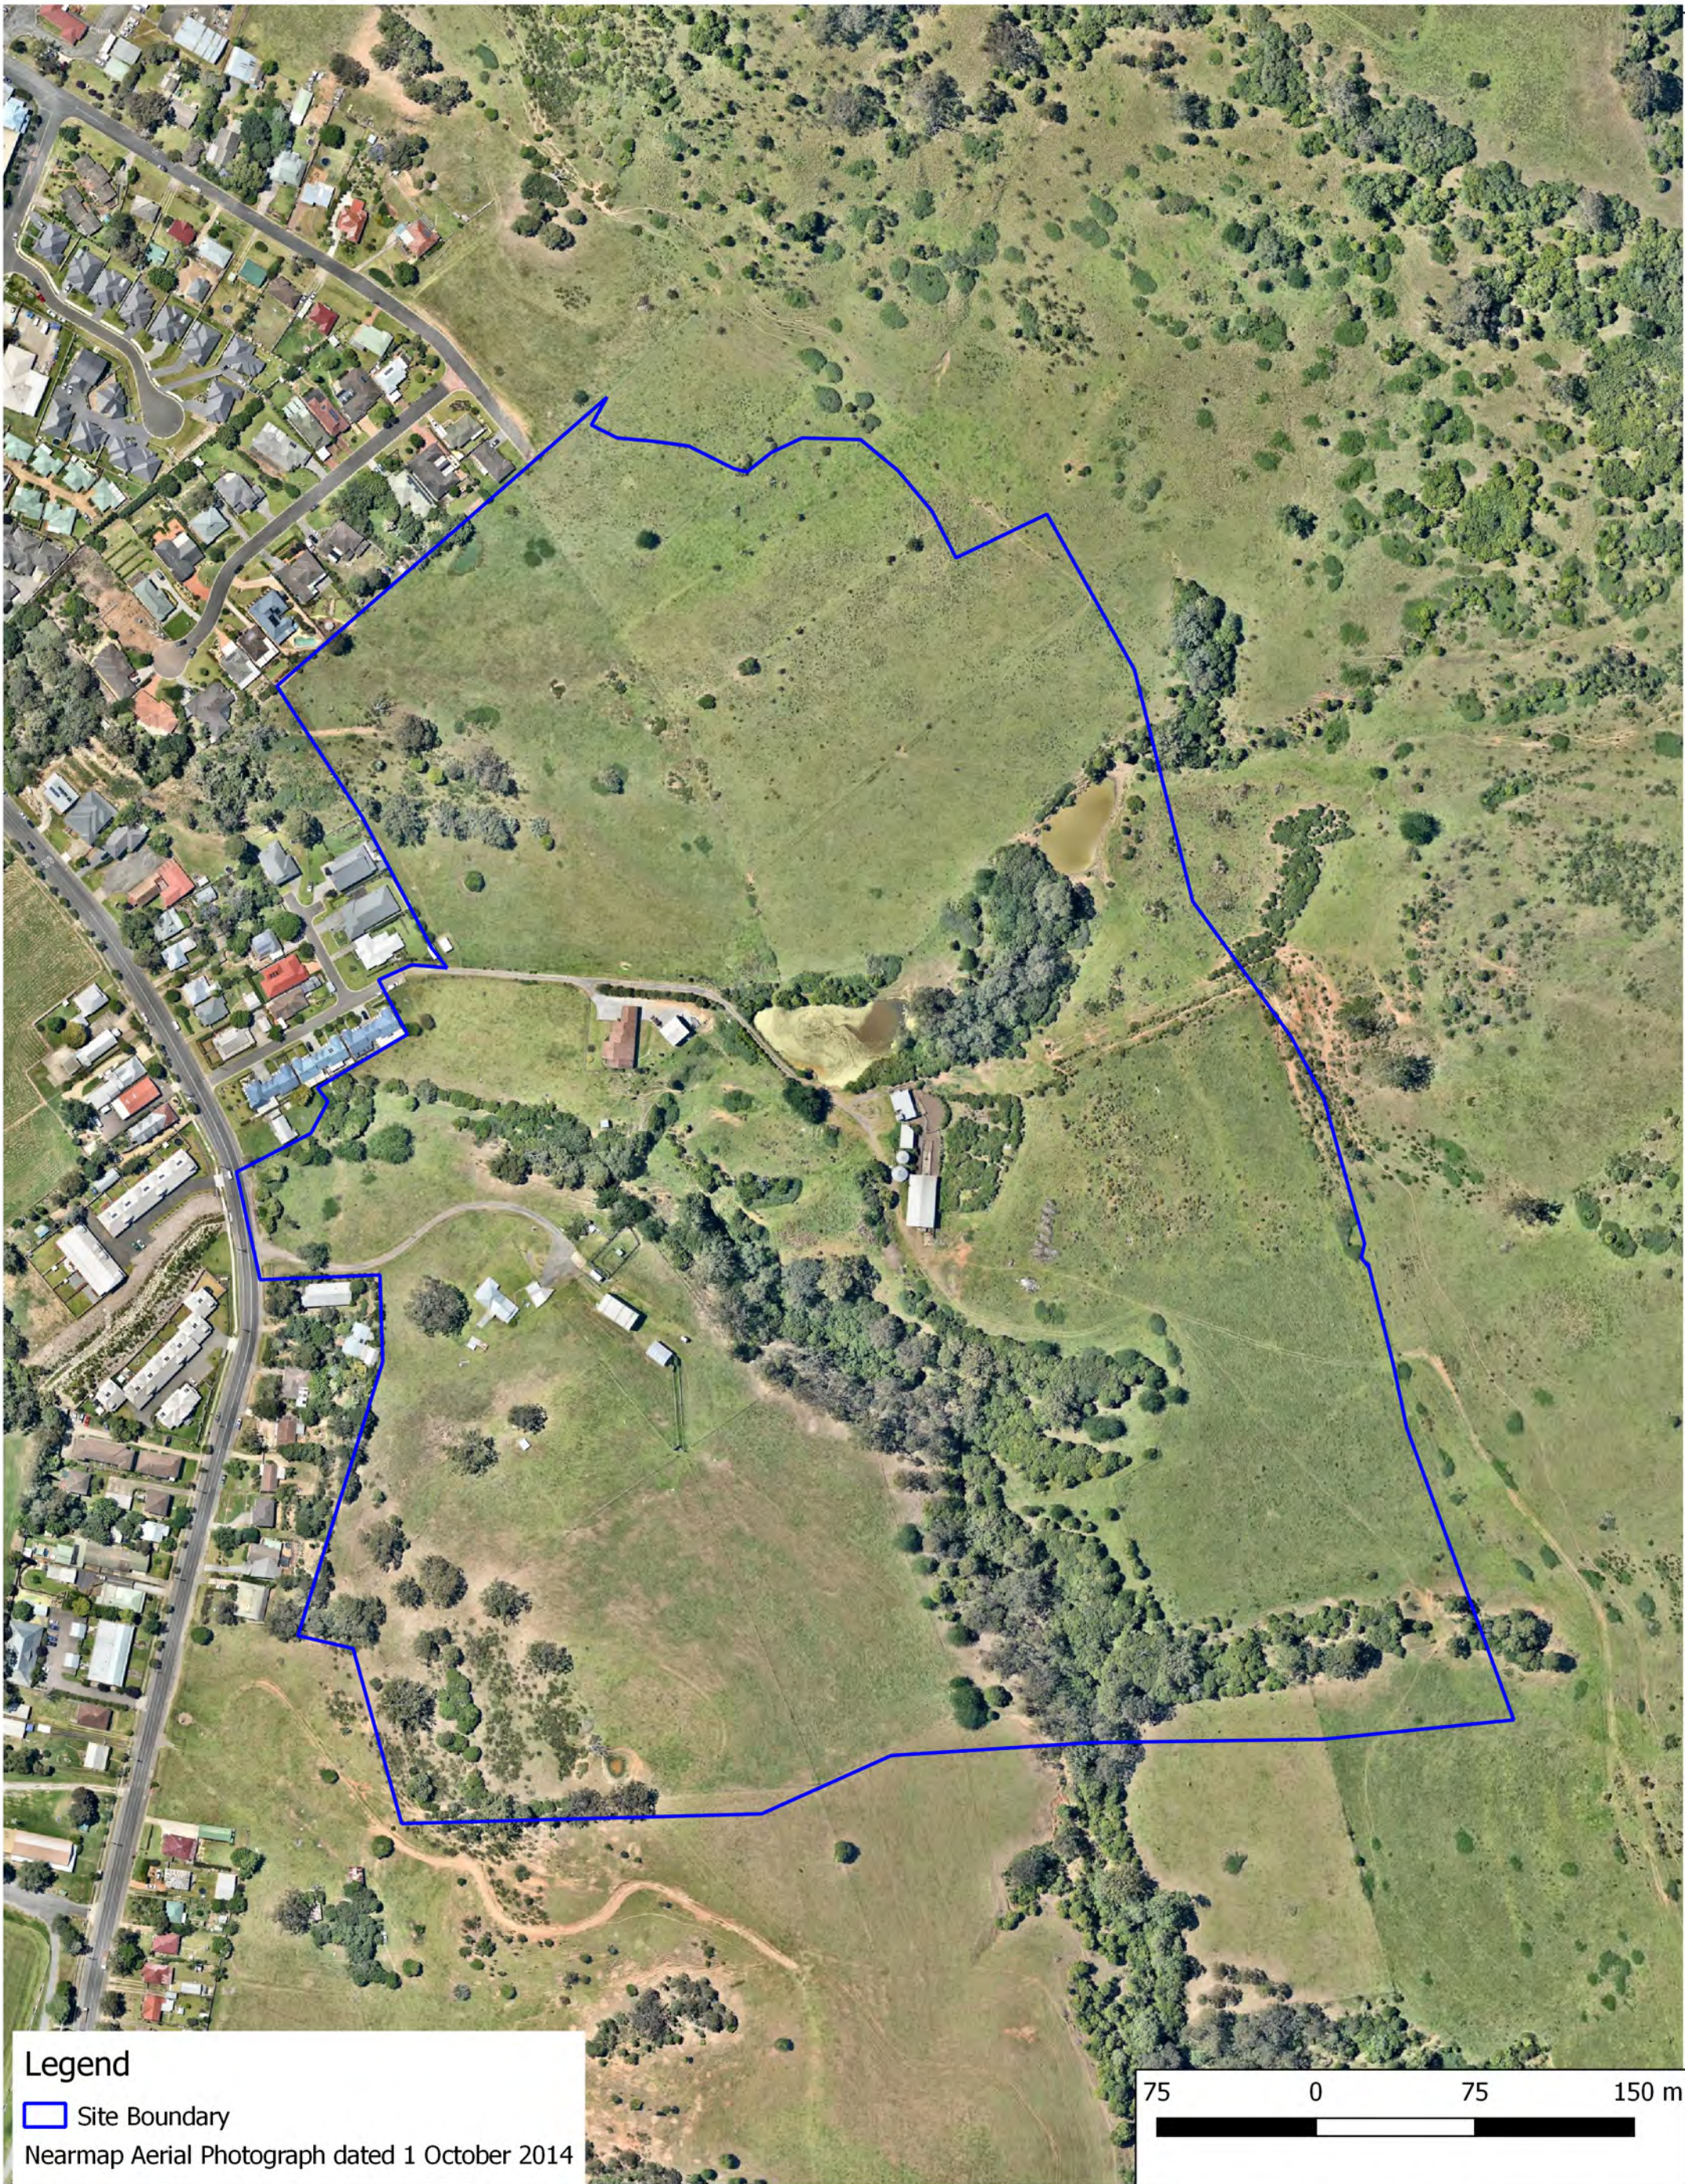
Aerial Photograph No: 1

**1 October 2014 (Aerial 1):** The site and surrounding area appear relatively unchanged from the 2012 aerial used in the PSI report with the exception of the placement of multiple stockpiles of wood and one stockpile of what is assumed to be corrugated tin sheeting approximately 50 m east of the dairy. Some surficial waste surrounding the dairy has been removed.

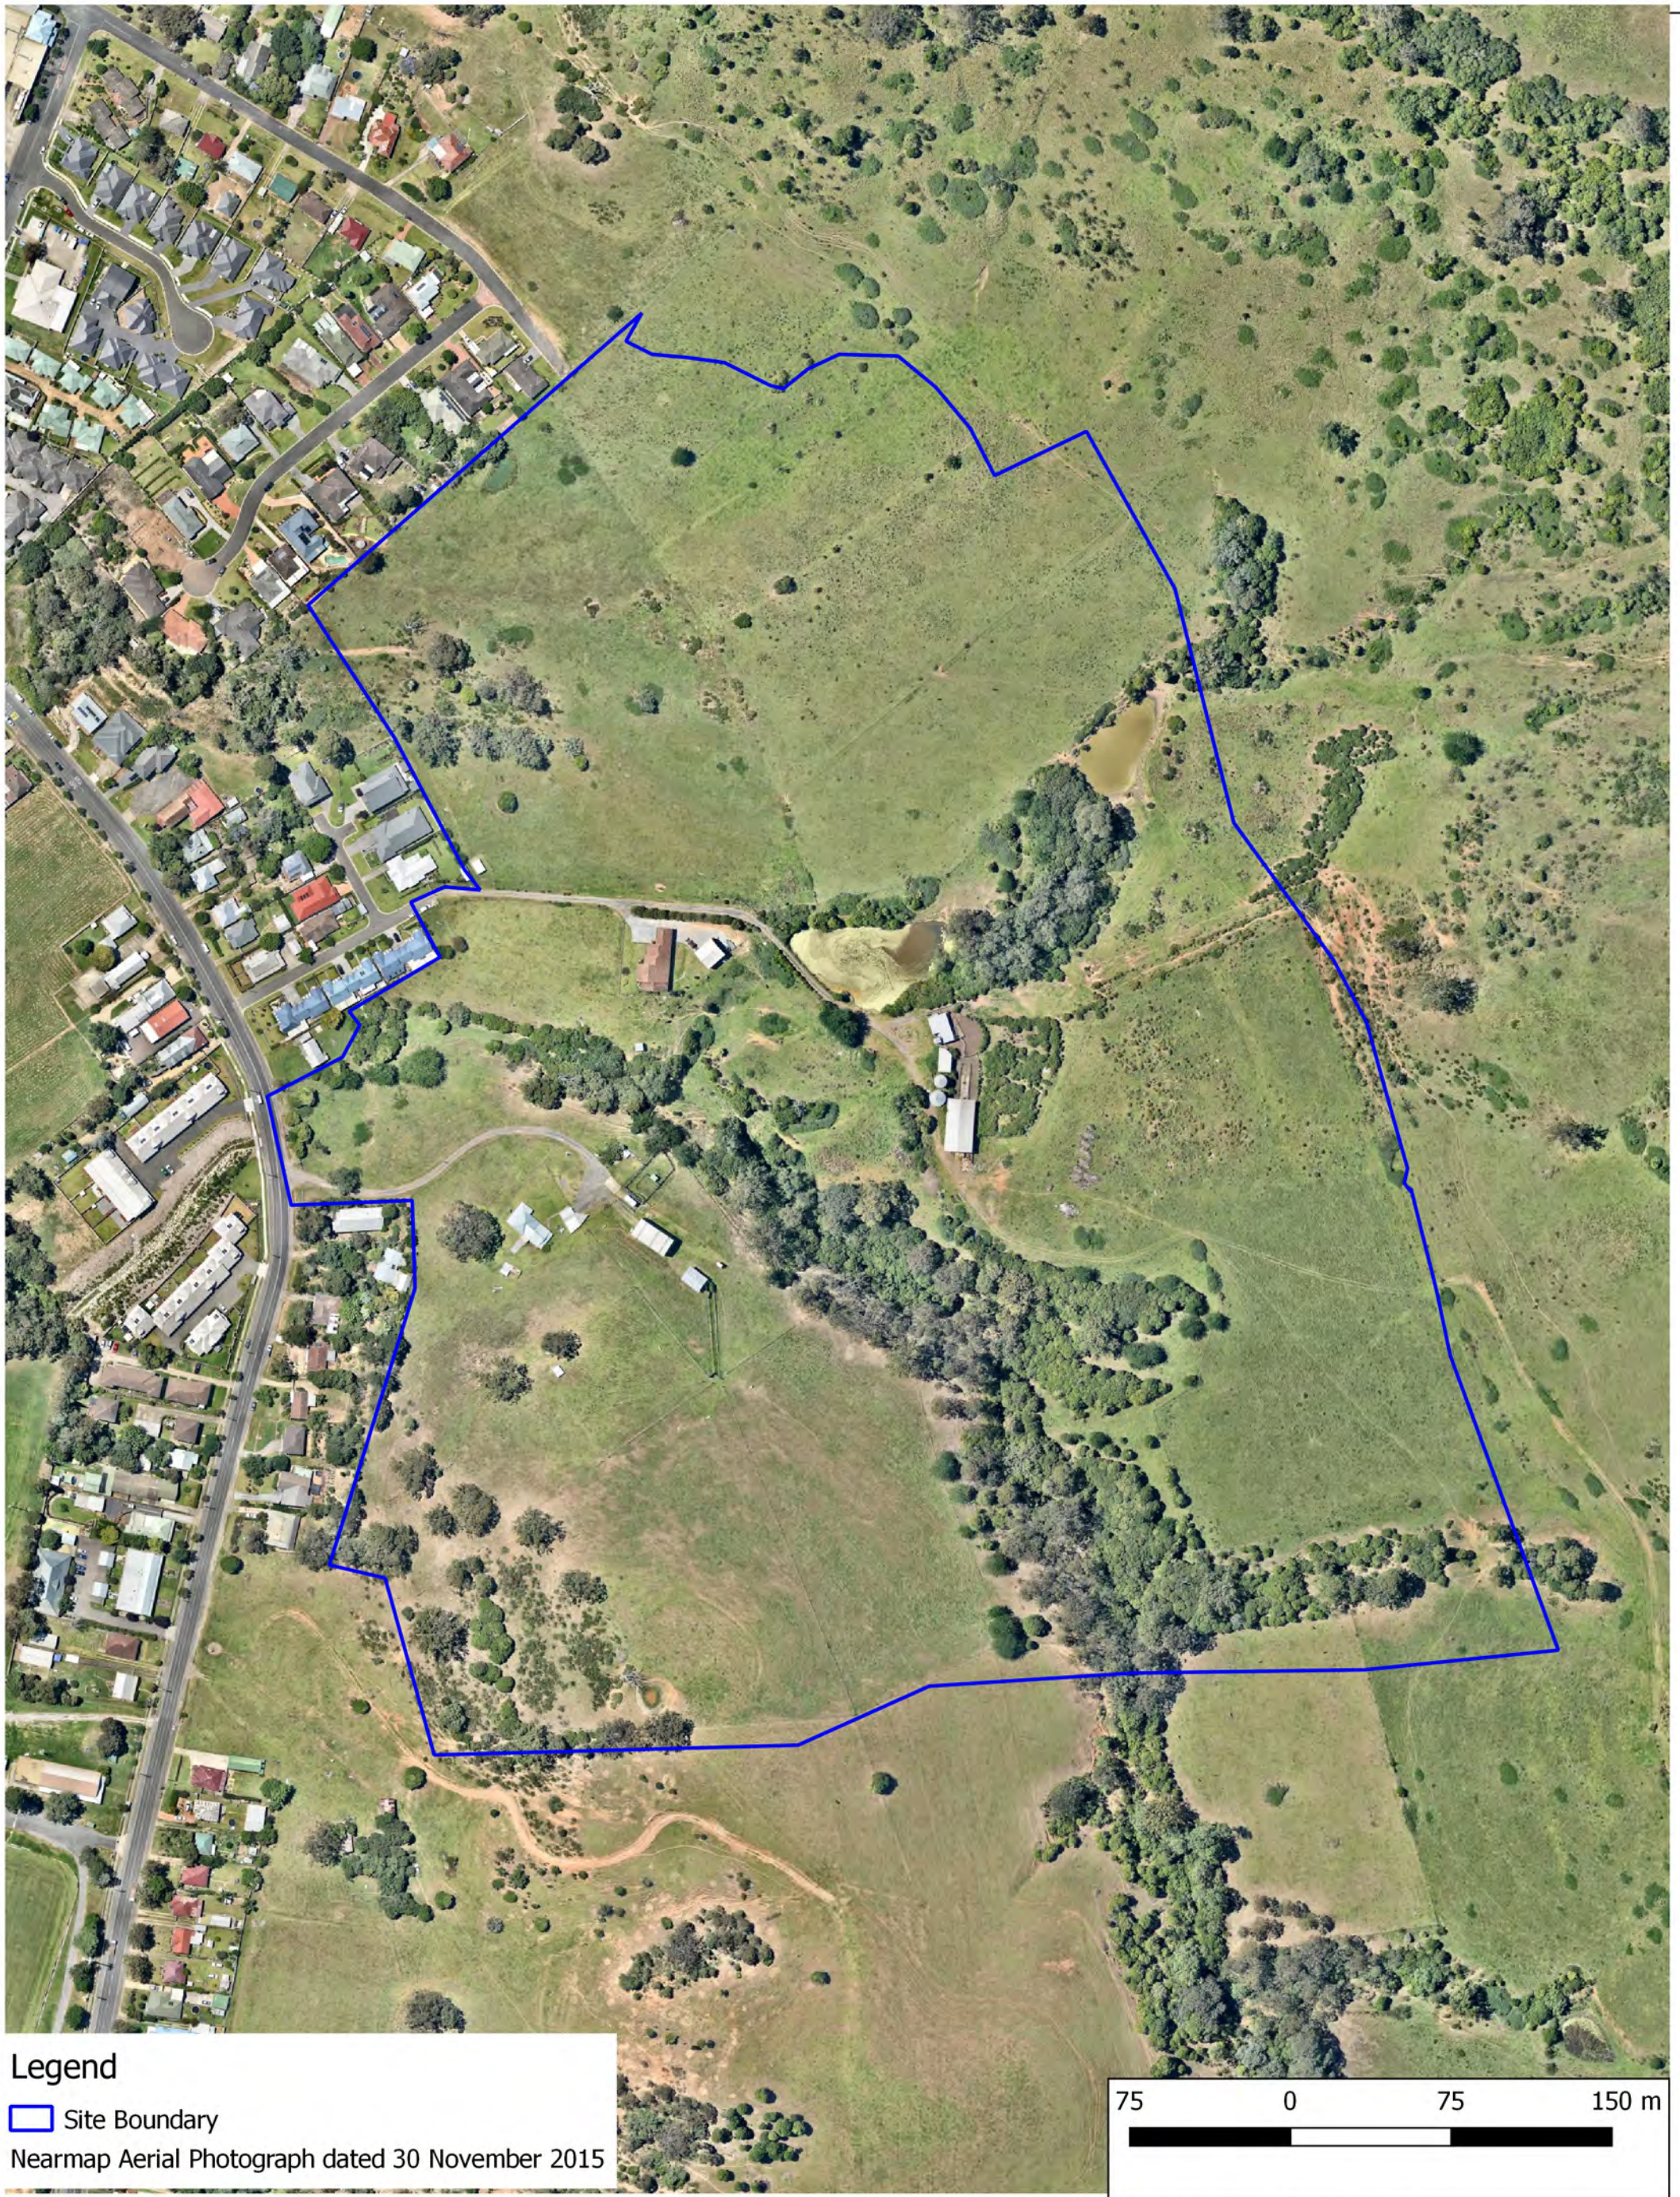
Aerial Photograph No: 2

**30 November 2015 (Aerial 2):** The site appears relatively unchanged from the October 2014 aerial image.

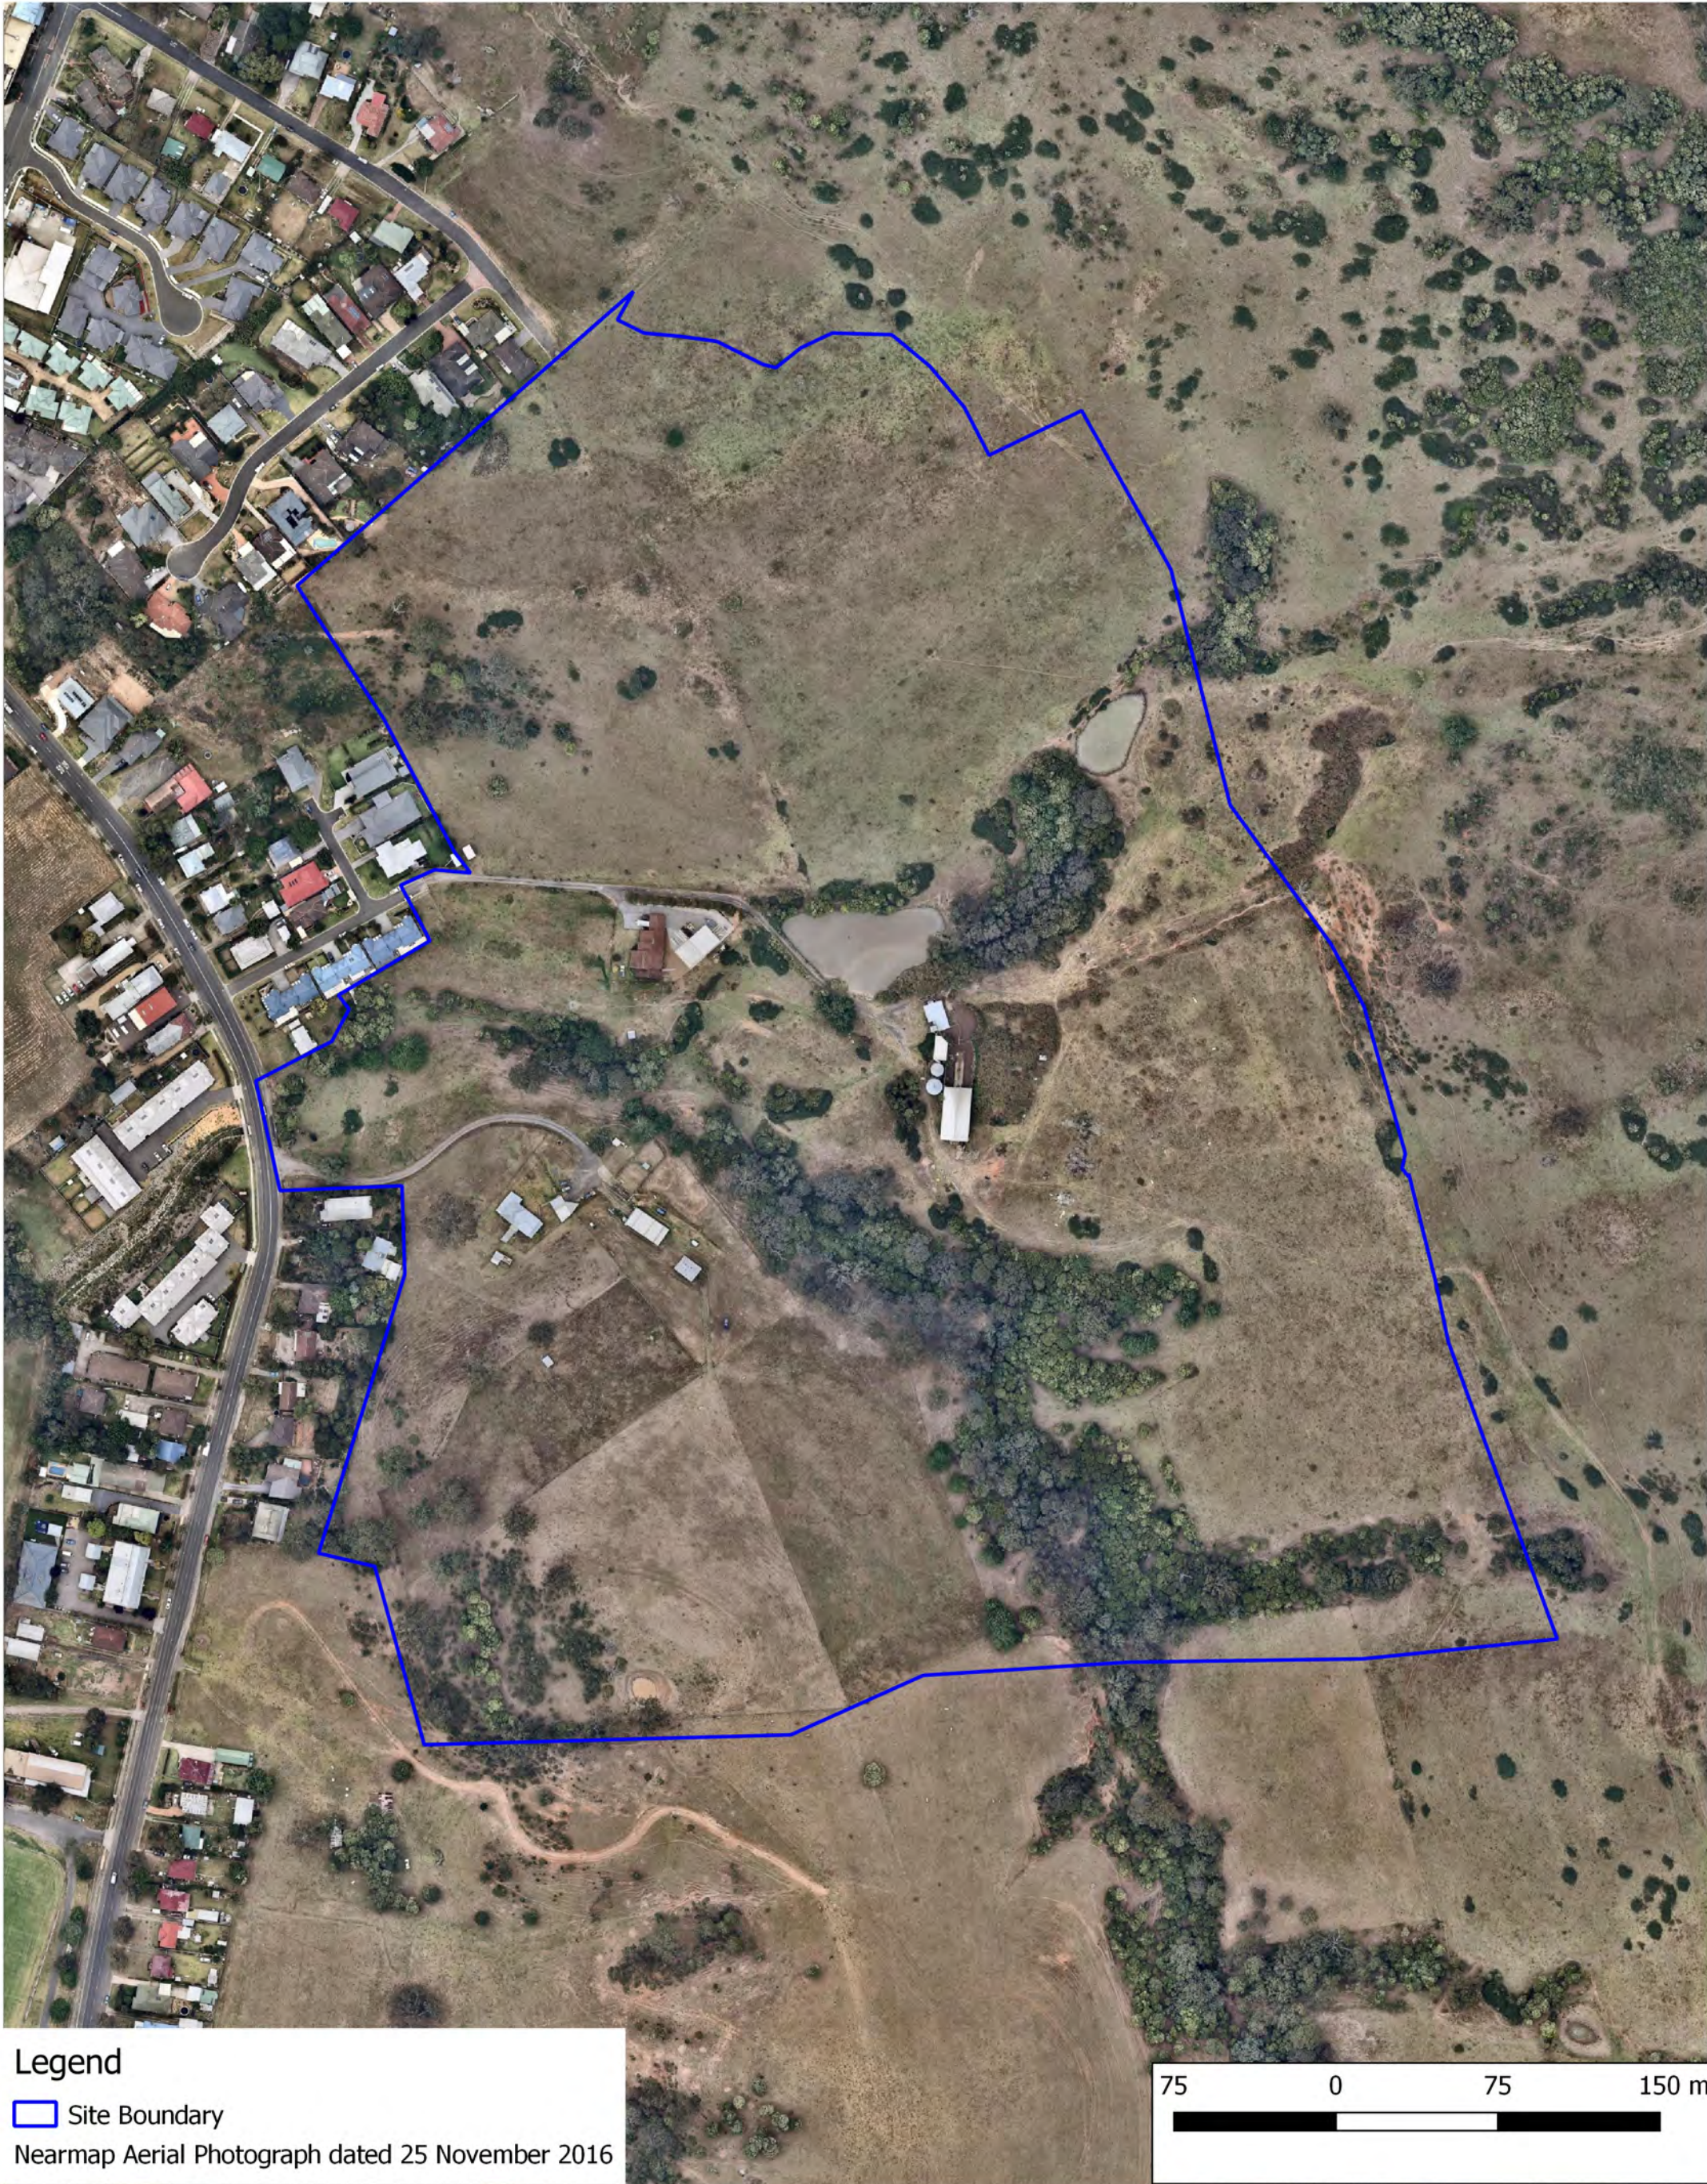
**25 November 2016 (Aerial 3):** The site appears relatively unchanged from the November 2015 aerial image with the exception of the reduced volume of wood in the stockpiles east of the dairy.

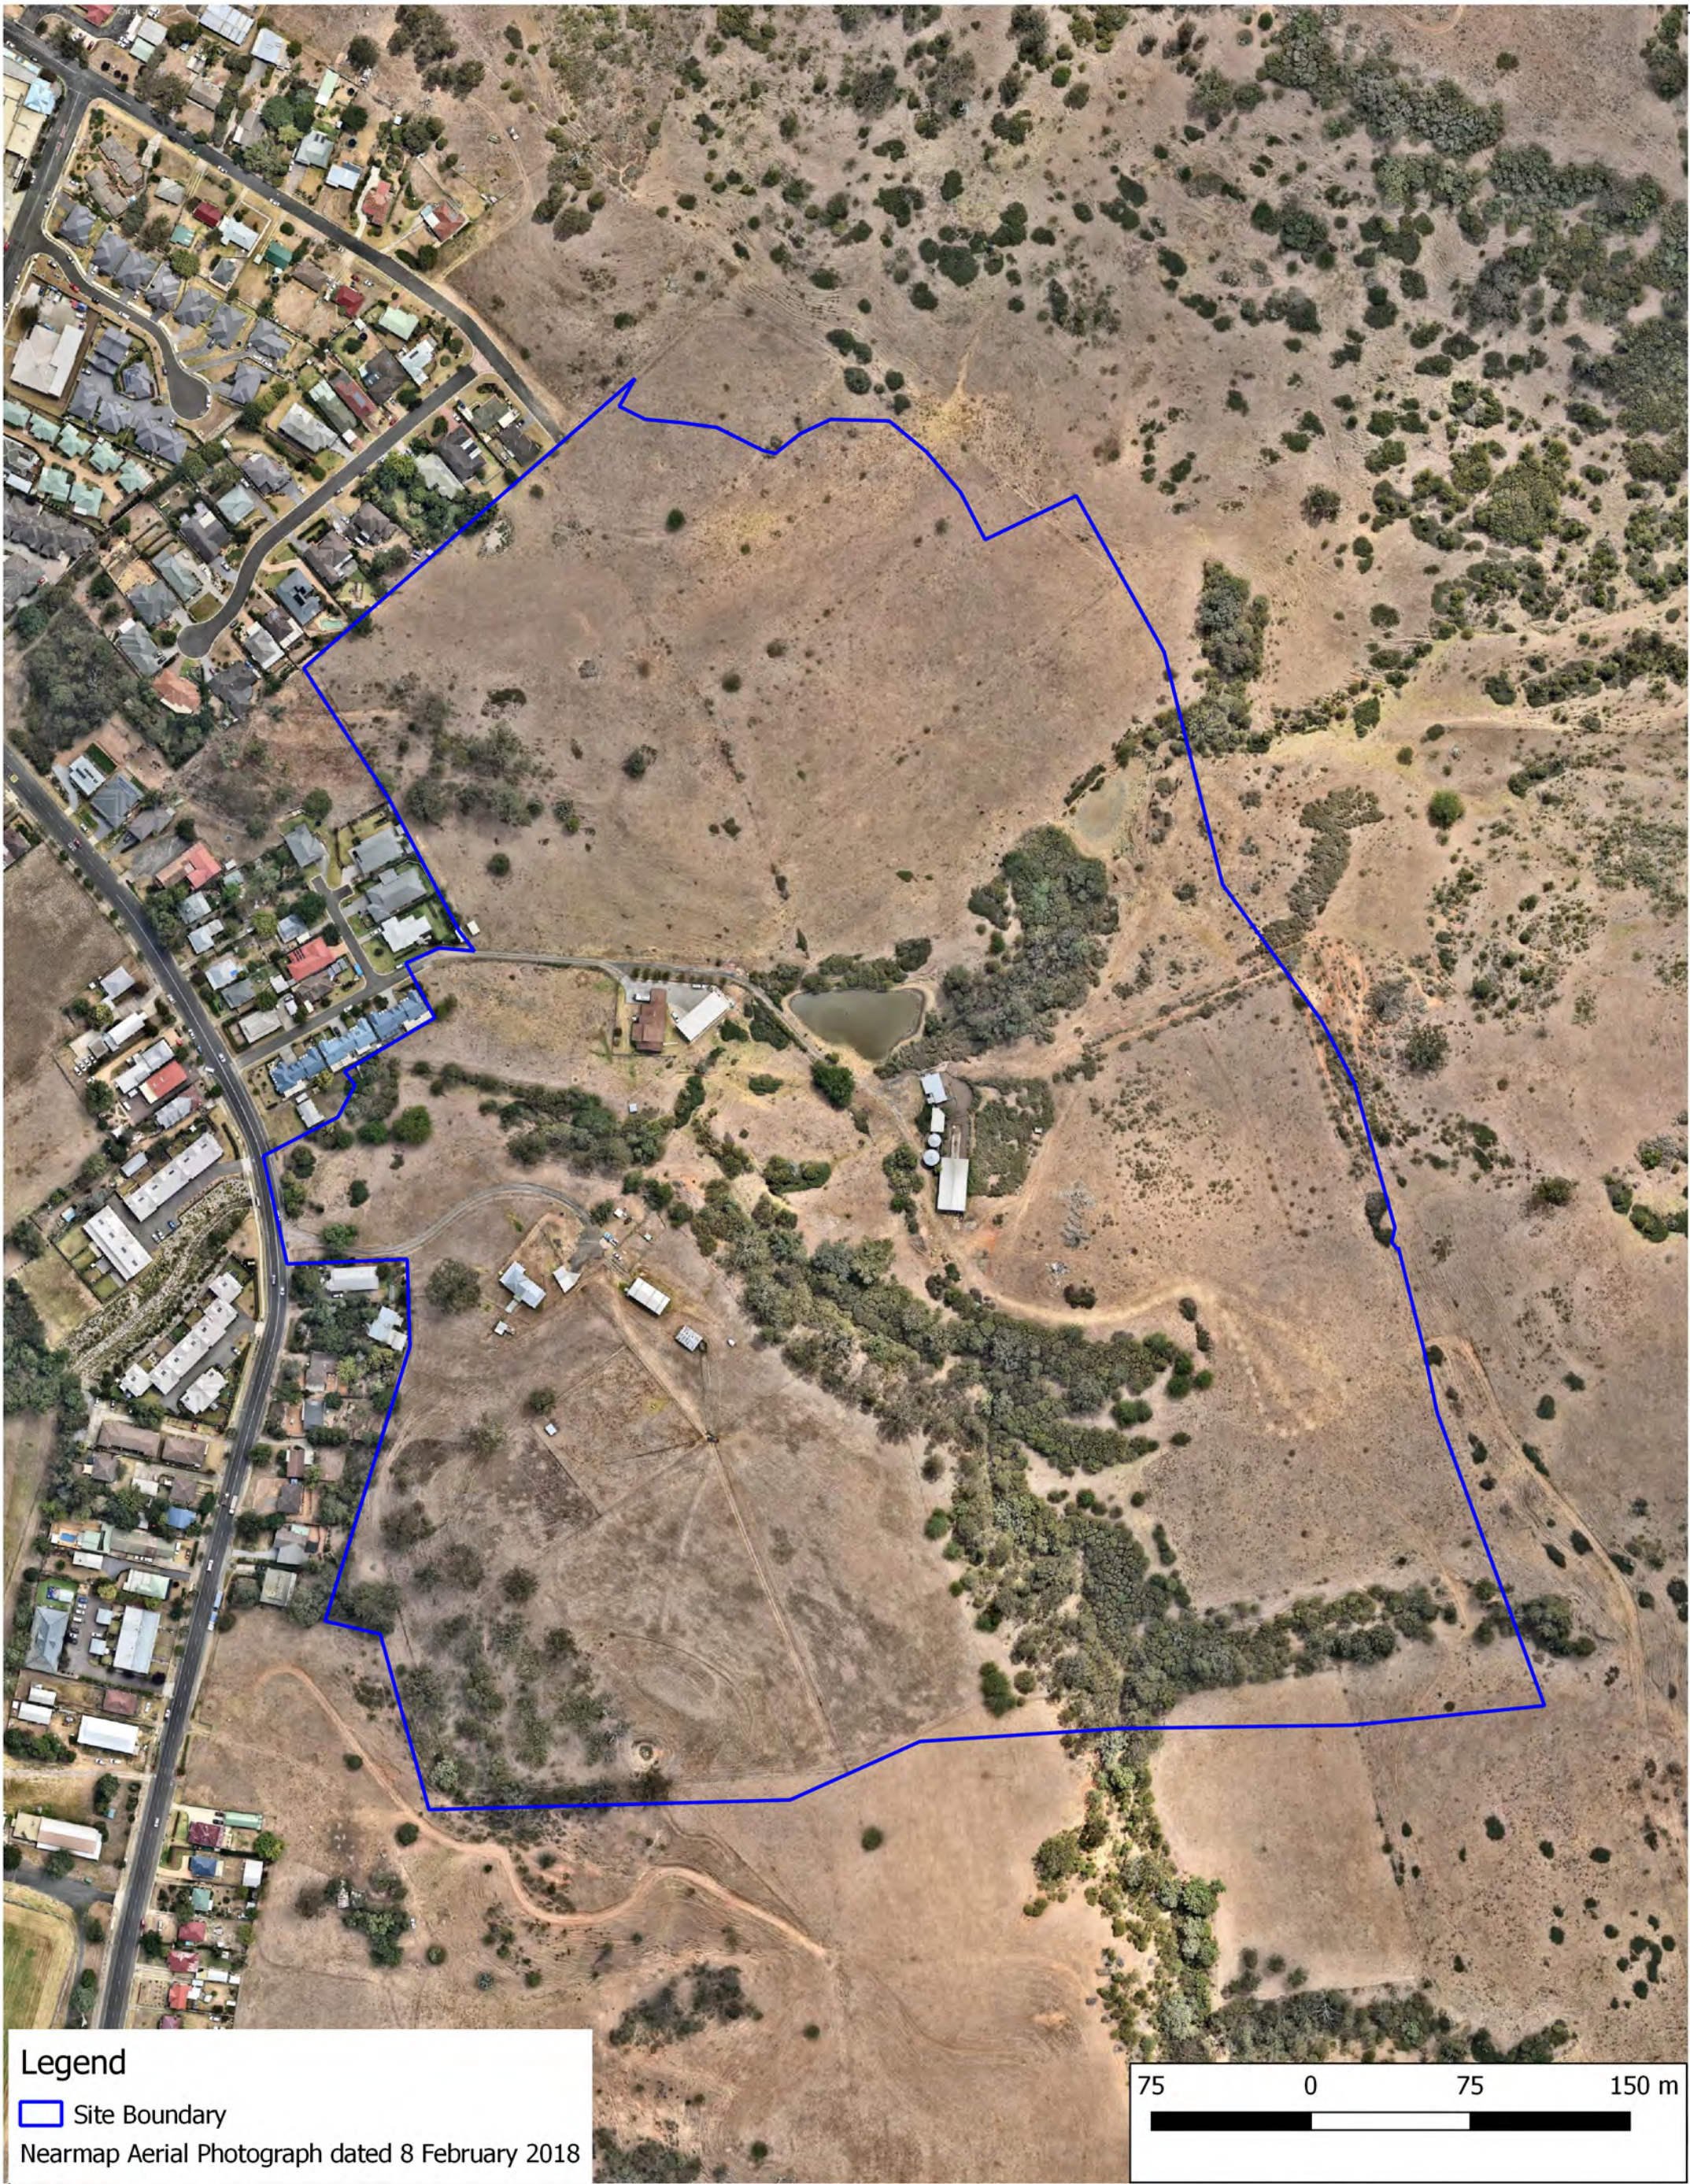
Aerial Photograph No: 4

**8 February 2018 (Aerial 4):** The site in general appears relatively unchanged from the November 2016 aerial image.

**Summary:** From review of the above aerial images, there appears to have been no significant changes to the site, or the AEC identified in the PSI report and up to the date of Aerial 4 with the exception of stockpiles of wood and metal located east of the dairy.

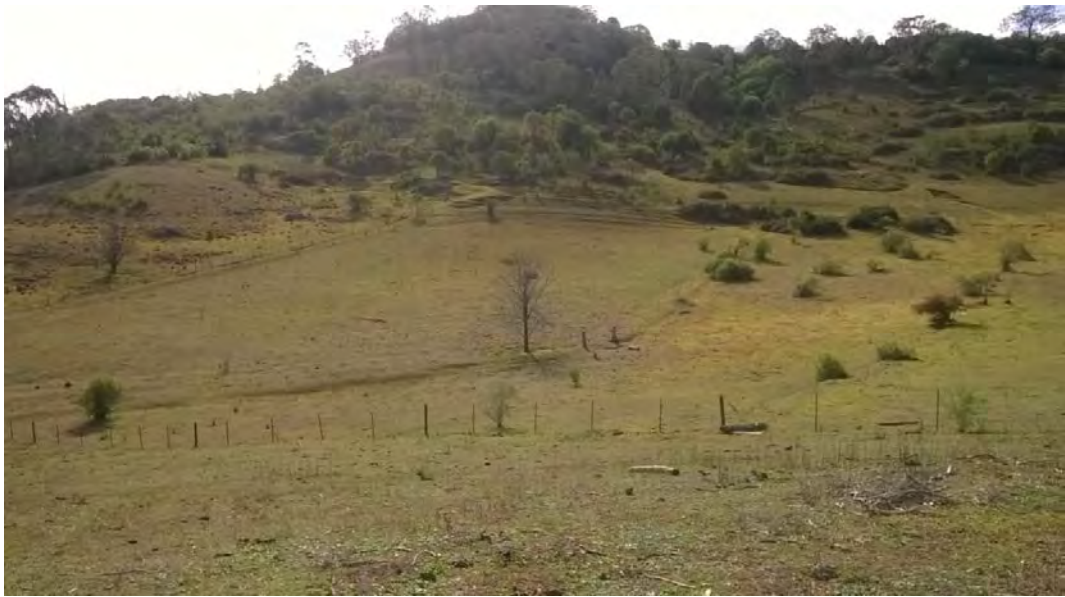
Photograph 1 - Vacant paddocks used for cattle grazing (looking north)

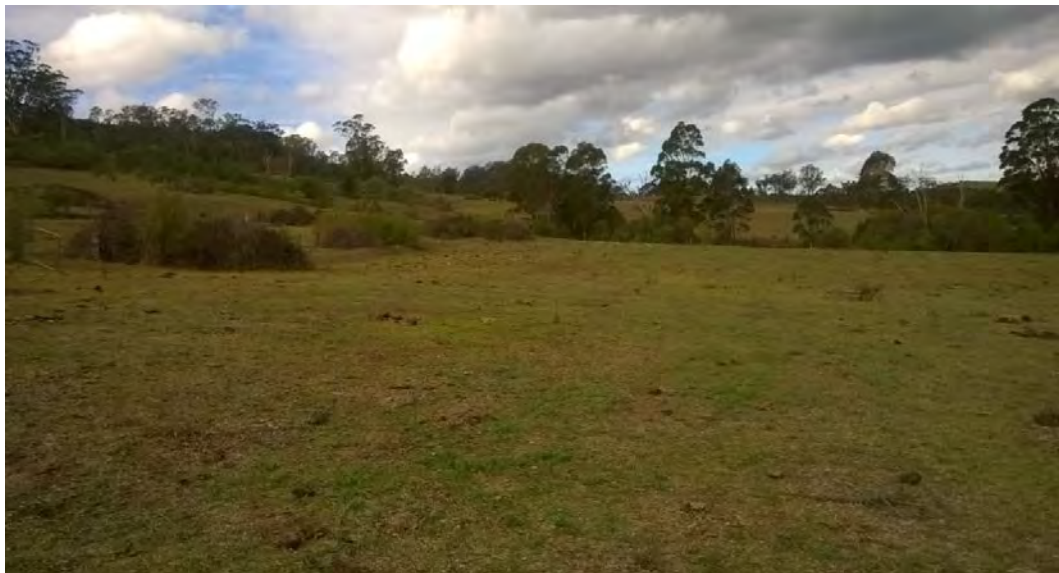
Photograph 2 - Vacant paddocks used for cattle grazing (looking south). Photograph taken 2/7/18

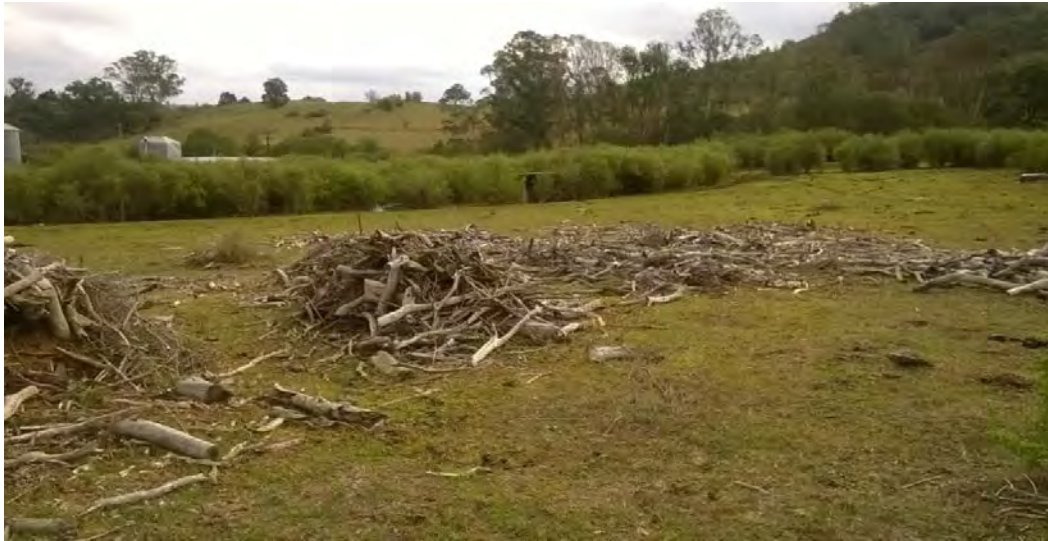
- Multiple stockpiles of timber/wood (identified in the aerial imagery – Section 4.1) were observed east of the dairy. The northernmost stockpiles were reduced to a scattering of wood on the surface. No anthropogenic material was observed in the stockpiles (Photograph 3);

Photograph 3 - Stockpiles of wood located east of the dairy (looking north). Photograph taken 2/7/18

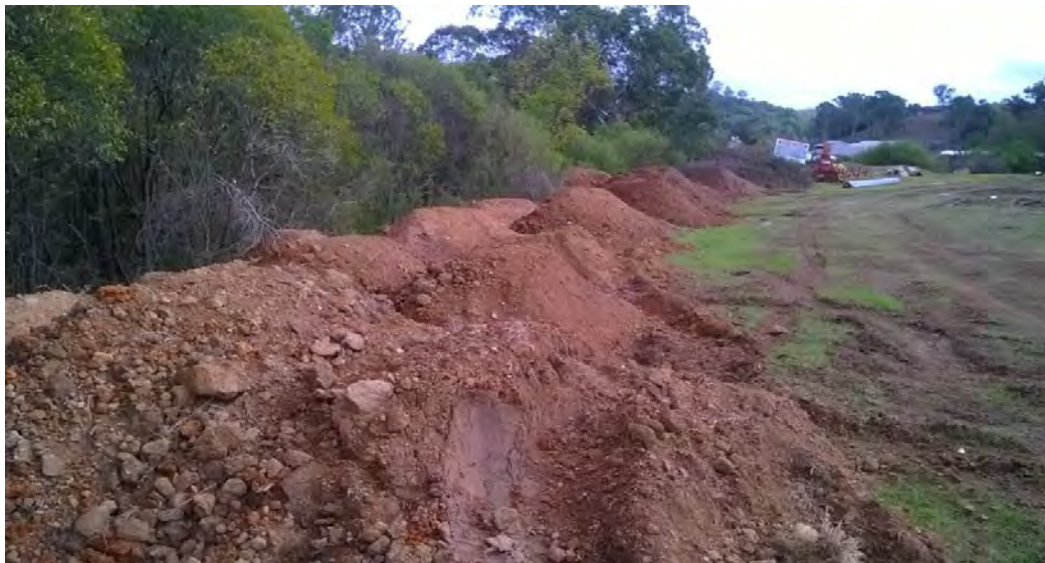
- Approximately 18 stockpiles of orange and brown silty clay fill and three stockpiles of dark brown topsoil fill had been deposited adjacent to the riparian corridor southeast of the dairy (Photographs 4 and 5). The clay fill contained inclusions of demolition waste including brick fragments, concrete and general refuse (Photograph 6). No suspected asbestos containing material (ACM) was observed on the surface of the stockpiles. No waste classification of this material was reviewed by DP, and DP was unable to substantiate the source of the stockpiles (refer Section 6);

Drawing 4 - Stockpiles of imported orange and brown clay fill (looking west). Photograph taken 2/7/18

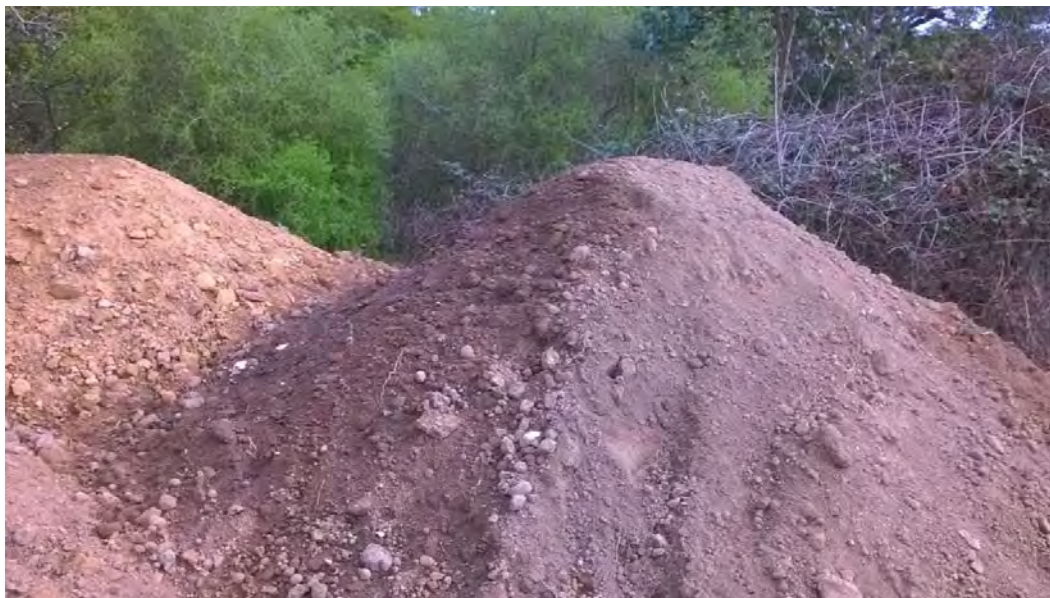
Regarding the importation of the stockpiled material, Mr Kellner stated that the topsoil stockpiles were sourced from a nearby property in Picton and were stored temporarily on the site as a favour between property owners, while the clay stockpiles were site derived during excavations for a site shed. The stockpiles were removed from site on 6 July 2018 and were reported by Mr Kellner to have been delivered to a nearby property in Picton, no further information was available at the time of writing this report. DP did not review any waste classification reports regarding this material and is unable to substantiate the source or destination of the material.

Photograph 5 - Stockpile of imported dark brown topsoil fill. Photograph taken 2/7/18
