John M. Daly & Associates Pty Ltd  
P.O. Box 25  
CAMPBELTOWN NSW 2560Project 92297.00  
17 July 2018  
R.001.Rev1  
CKM

**Preliminary Site Investigation (Contamination) - Addendum  
Proposed Residential Development  
Reeves Creek, Picton (East), NSW****1. Introduction**

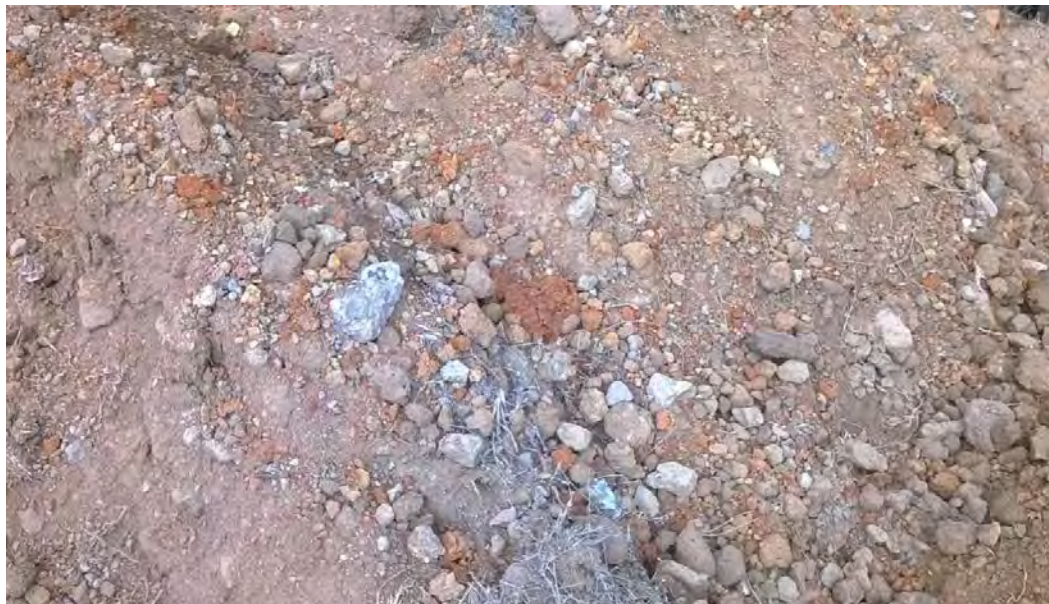
Photograph 6 - Close up of stockpiles containing trace concrete. Photograph taken 2/7/18

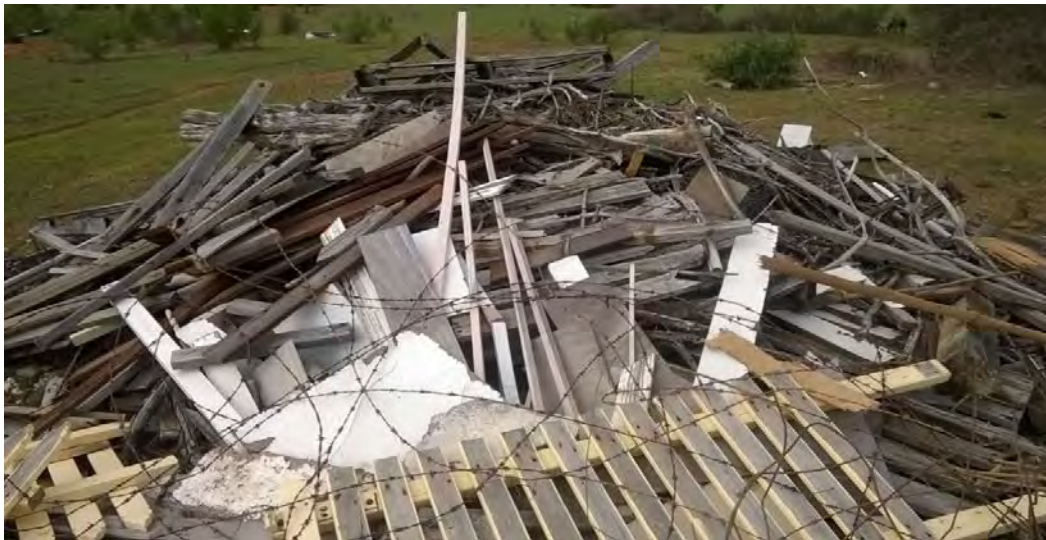
- The stockpile of corrugated tin sheeting and wood identified in aerial imagery (Section 4.1) did not appear to contain ACM on the surface of the stockpile. Barbed wire, chipboard and plastic was also observed in this stockpile (Photograph 7);

Photograph 7 - Stockpile of wood, tin, barbed wire adjacent to the dairy. Photograph taken 2/7/18

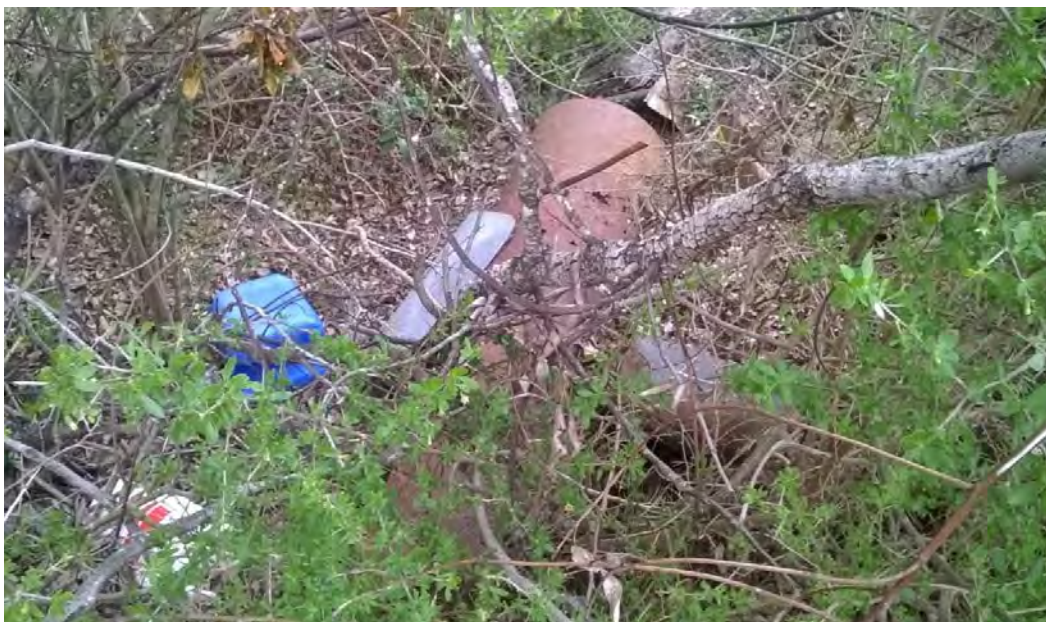
- The dairy had ceased operation and the dismantling of infrastructure/demolition was underway; and
- Surficial waste was observed on the edges of the riparian corridors (Photograph 8).

Photograph 8 - Surficial waste in the riparian corridors. Photograph taken 2/7/18

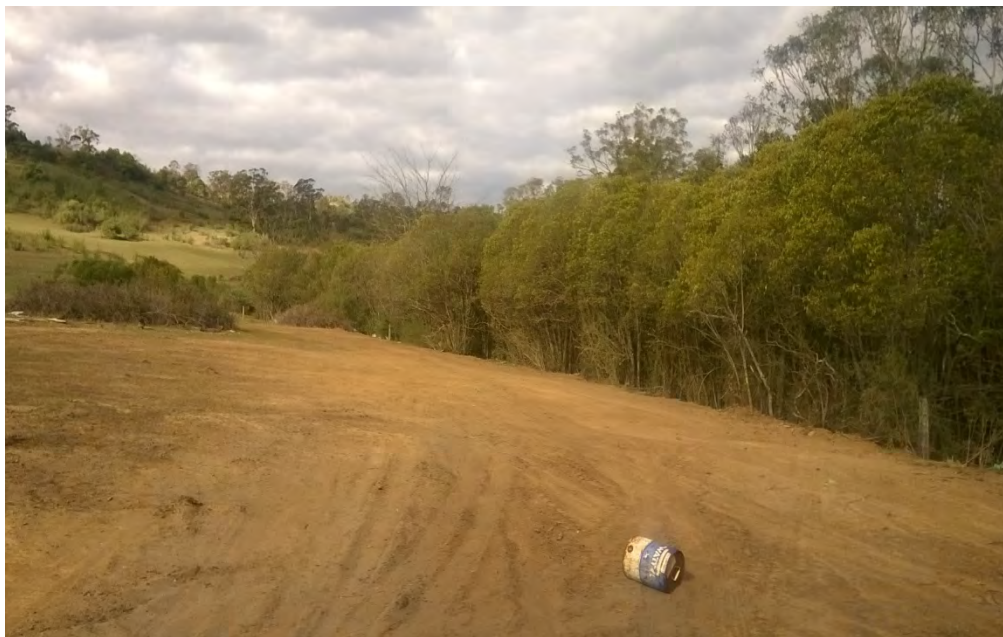
- The clay and topsoil stockpiles located south east of the dairy had been largely removed from site with remnant loose soil and some gravel remaining on the surface (Photographs 9 and 10);
- Two fragments of suspected ACM were observed on the surface within the stockpile footprints (Photographs 11 and 12);
- Multiple fragments of suspected ACM were observed on the ground surface approximately 10 m north of the former stockpiles, adjacent to three small (*i.e.* <1 m<sup>3</sup>) pre-existing stockpiles of gravel, soil and demolition rubble (Photographs 13 and 14);

Photograph 9- The site following removal of stockpiles (looking east). Photograph taken 9/7/18

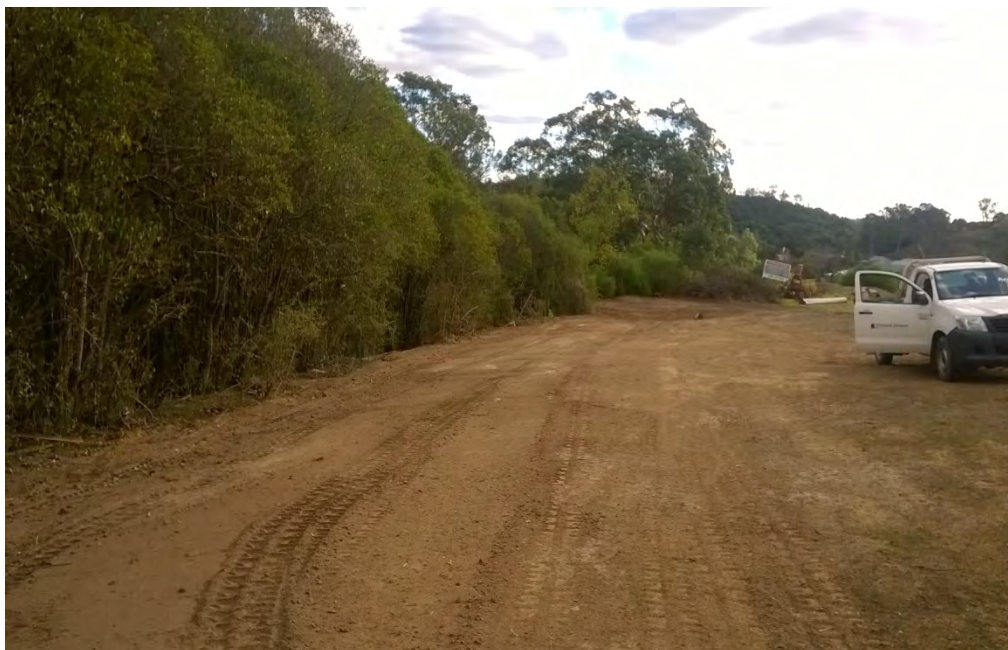
Photograph 10 - The site following removal of the stockpiles (looking west). Photograph taken 9/7/18

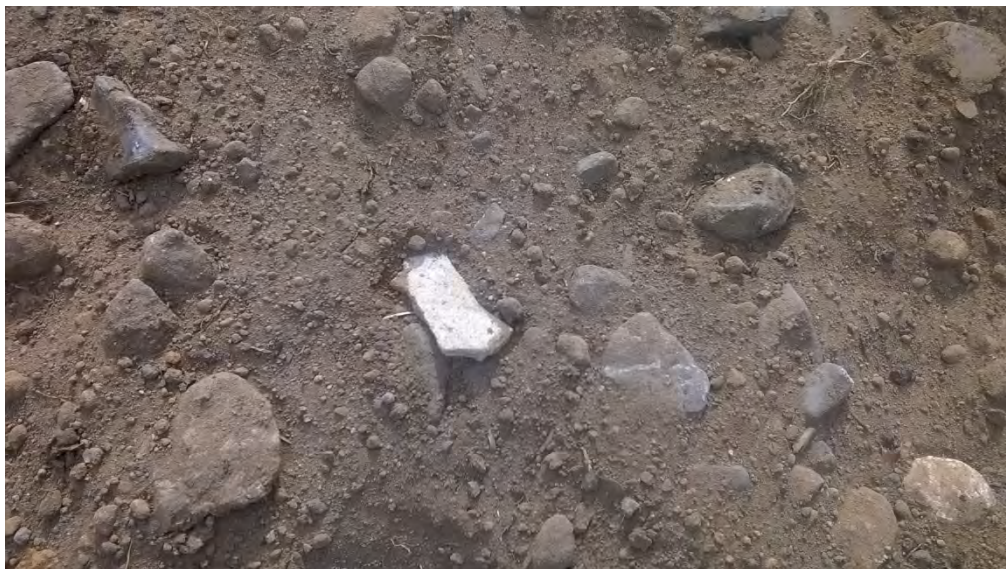
The suspected ACM appeared to be surficial (*i.e.* not in the underlying fill) and was in good condition.

Regarding the suspected ACM, Mr Kellner believed that the ACM was likely sourced during the demolition of a former outside toilet on site and during demolition of parts of the dairy. All other pre-existing stockpiles were derived on site during land clearing activities, upgrades to the residential building, and demolition of sheds and the dairy. All stockpiles and surficial waste were to be removed as a part of re-development. Mr Kellner also stated that the riparian corridors were to be cleared of all waste and weeds, and revegetated as part of the proposed development of the site.

Photograph 11- Suspected ACM in the footprint of the former stockpiles. Photograph taken 9/7/18

- Due to the presence of suspected ACM on the ground surface southeast of the dairy, this area should be further assessed and remediated as a part of re-development. The small stockpiles adjacent to the suspected ACM should be also be assessed for asbestos and other possible contaminants (waste classification) prior to removal from site. Given the proximity of the suspected ACM and stockpiles to the dairy, and given that the dairy is the likely source of the suspected ACM and stockpiles, these locations are included with AEC 6 (the dairy);

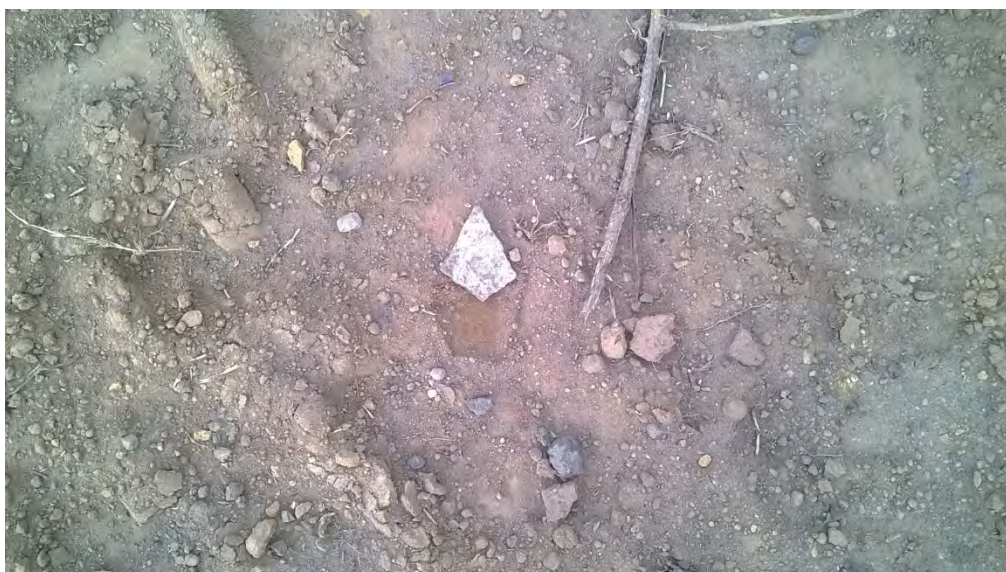
Photograph 12 - Suspected ACM in the footprint of the former stockpiles. Photograph taken 9/7/18

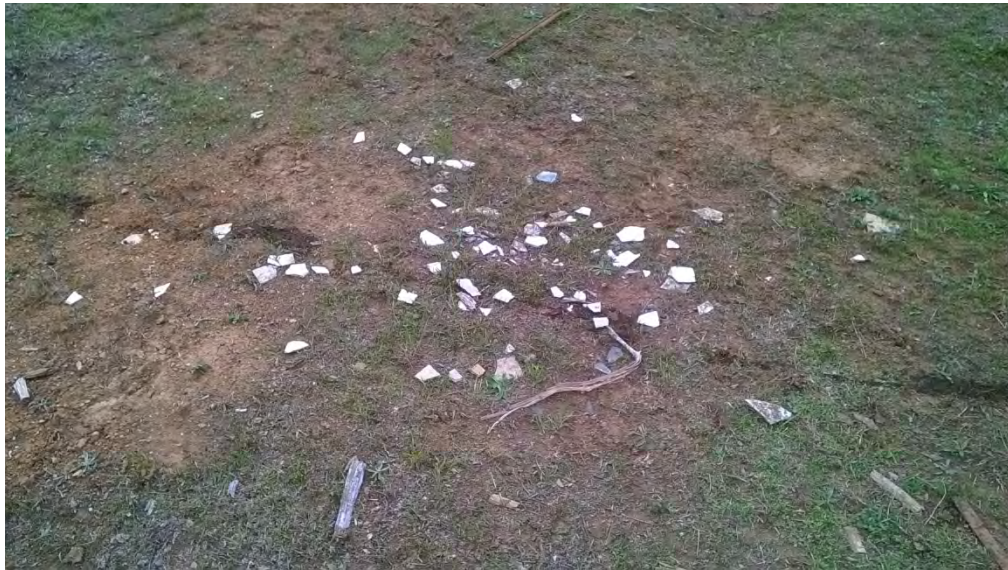
Photograph 13- ACM on the ground surface 10 m north of the former stockpiles. Photograph taken 9/7/18

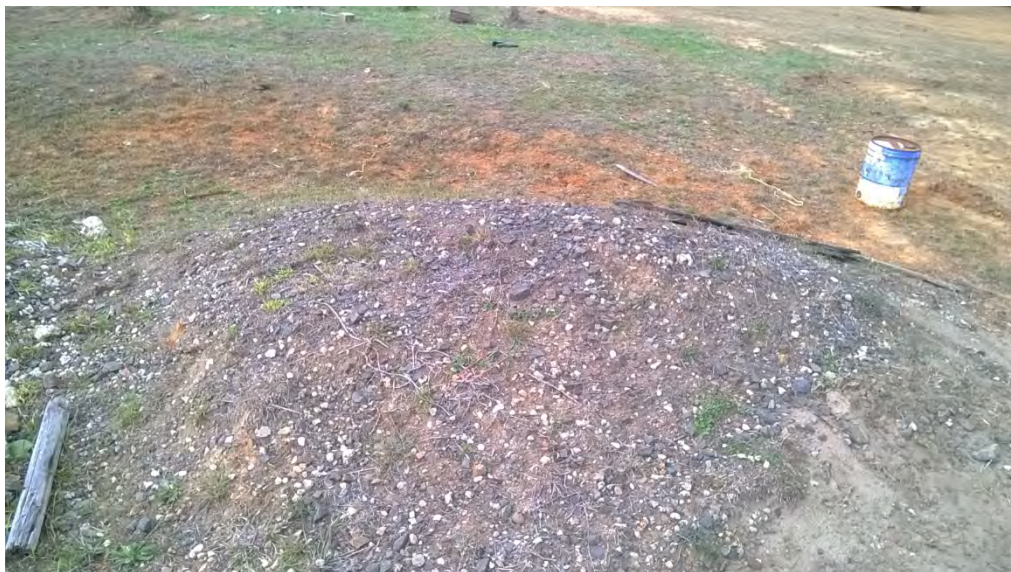
Photograph 14 - Small stockpile of pre-existing gravel, soil and demolition rubble. Photograph taken 9/7/18
