PHASE 1 ENVIRONMENTAL SITE ASSESSMENT

20 Tylers Road

BARGO

Job reference: 201559

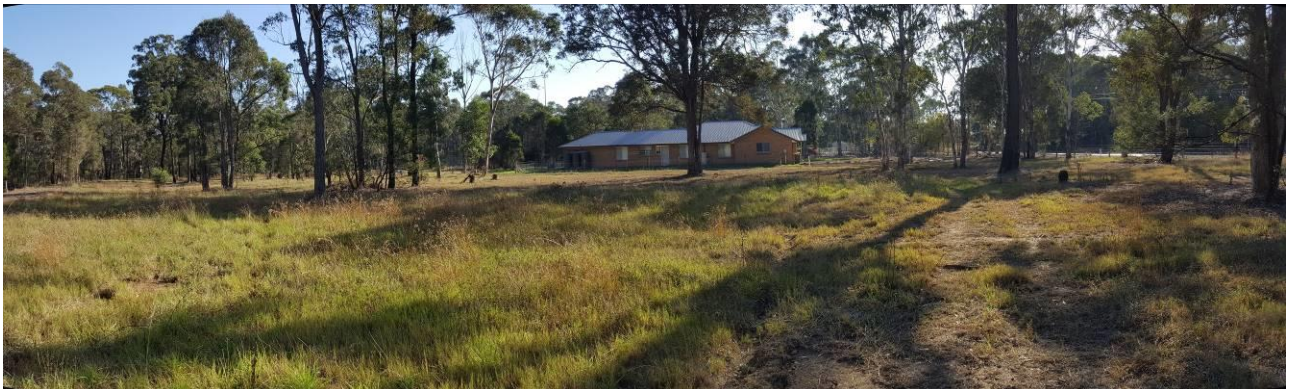
Plate 1: View looking north from the southern corner of the proposed development area

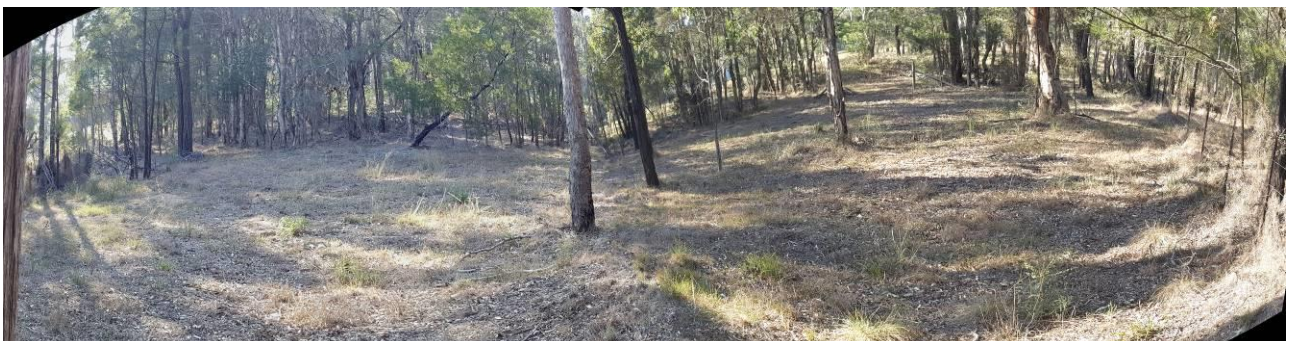
Plate 2: General view of the Property looking easterly along the northern boundary

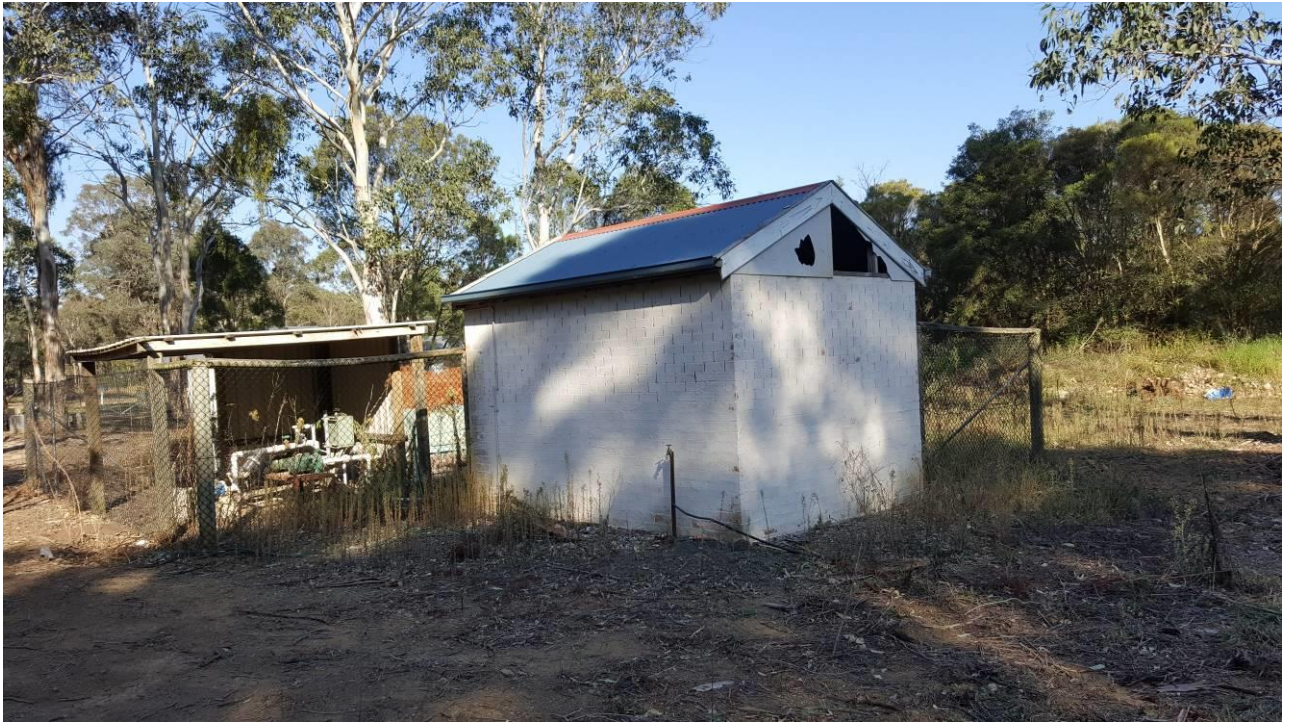
Plate 3: Remnants of WWTP observed from Tylers Road and looking north-westerly.

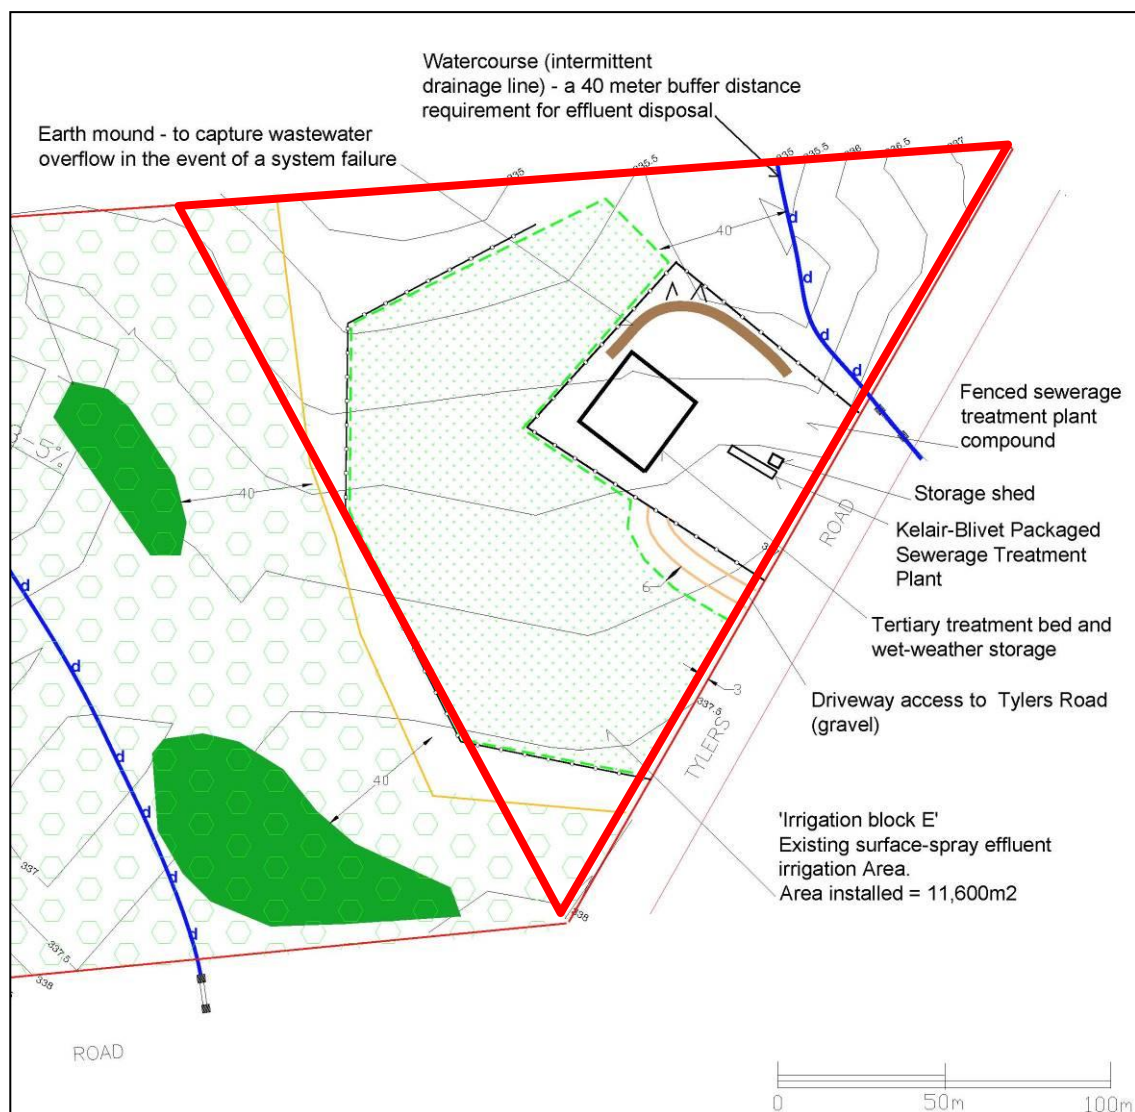
It should be noted that the site under investigation was the focus of a Waste Water Treatment Plant (WWTP) which serviced the adjoining Waratah Highlands retirement village during 2004 and 2015, after which it was decommissioned. The facility, which treated both “grey” and “black” water, operated under two separate approvals. These included:

AEC	Potentially Contaminating Activity	Contaminants of Concern	Likelihood of Contamination*
The area in and around the fenced enclosure (Figure 3) hosting the disused WWTP. Demonstrates minor amounts of dumped building rubble, including fragments of fibro, plastics and painted timber panelling (Plates 3 and 9 in text);	Uncontrolled imported fill and construction waste. Long term leaching of contaminants.	Hydrocarbons, metals, OC/Ops, asbestos	Slight to moderate
Various piles of construction waste and bitumen road gravel (Plates 4, 5 and 6 in text)	Long term leaching of contaminants from imported fill materials, spillage of oil and grease	Hydrocarbons, metals, OC/Ops, asbestos	Slight
Waste water settlement dam and surrounding paddock area.	Settlement dam could be host to a range of metals derived from waste stream.	Hydrocarbons, metals, OC/Ops, nutrients	Slight

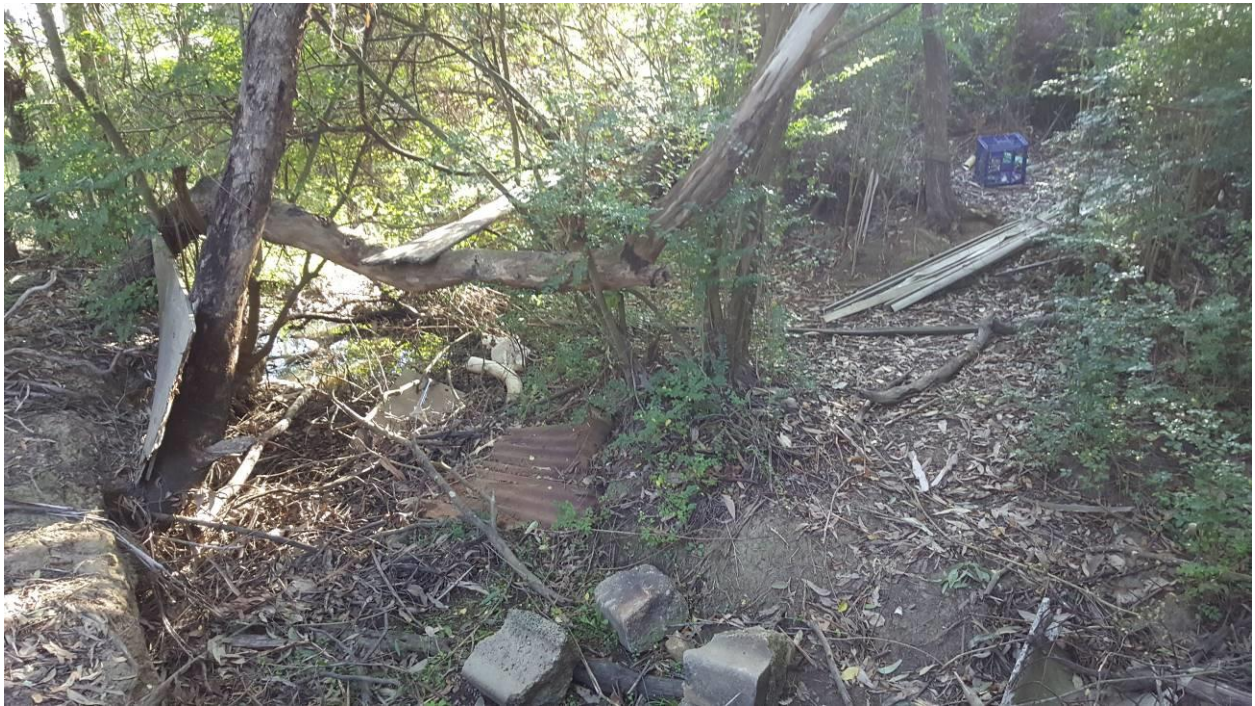
Plate 4: General refuse found in drainage line located at the eastern corner of the Property

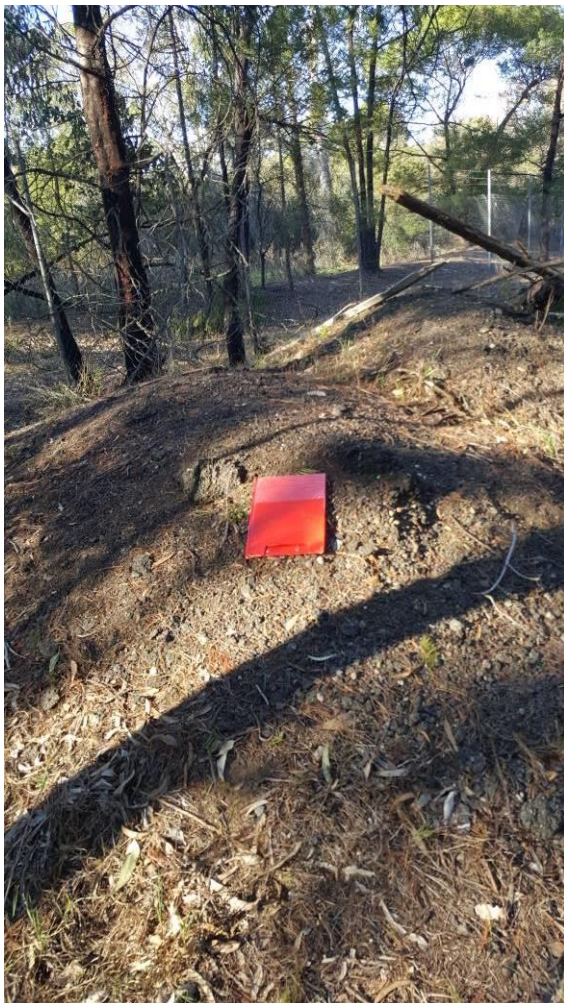
Plate 5: Pile of bitumen road gravel located on northern side of WWTP.

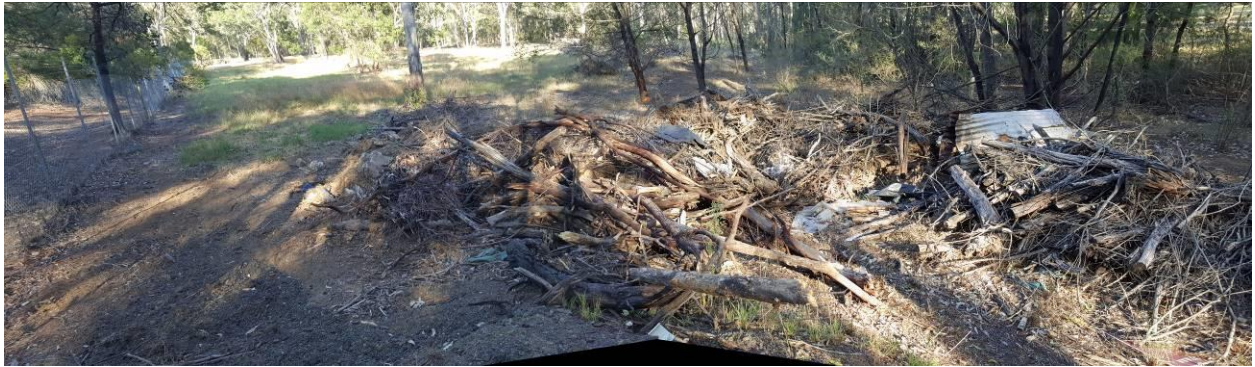
Plate 6: Large pile of refuse located on northern side of WWTP (noted fenced enclosure for WWTP on RHS)

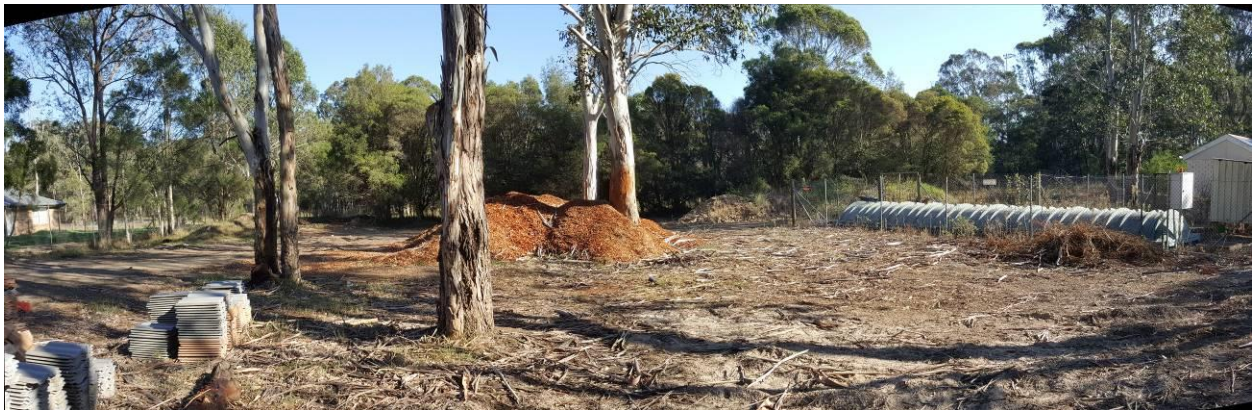
Plate 7: Remnants of WWTP – pumping shed and covered absorption trenches on RHS. Single residence located on LHS. Looking south-west from Tylers Road.

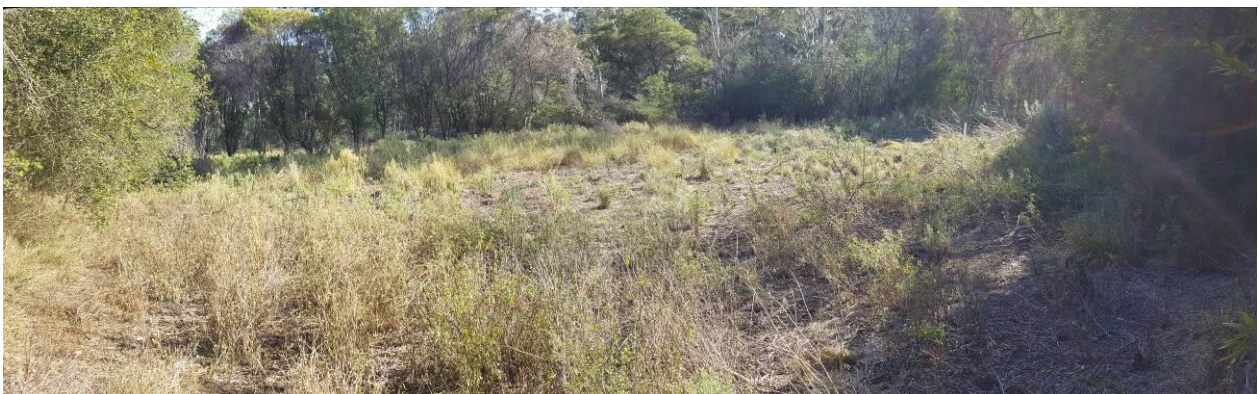
Plate 8: Abandoned settlement dam located within WWTP enclosure

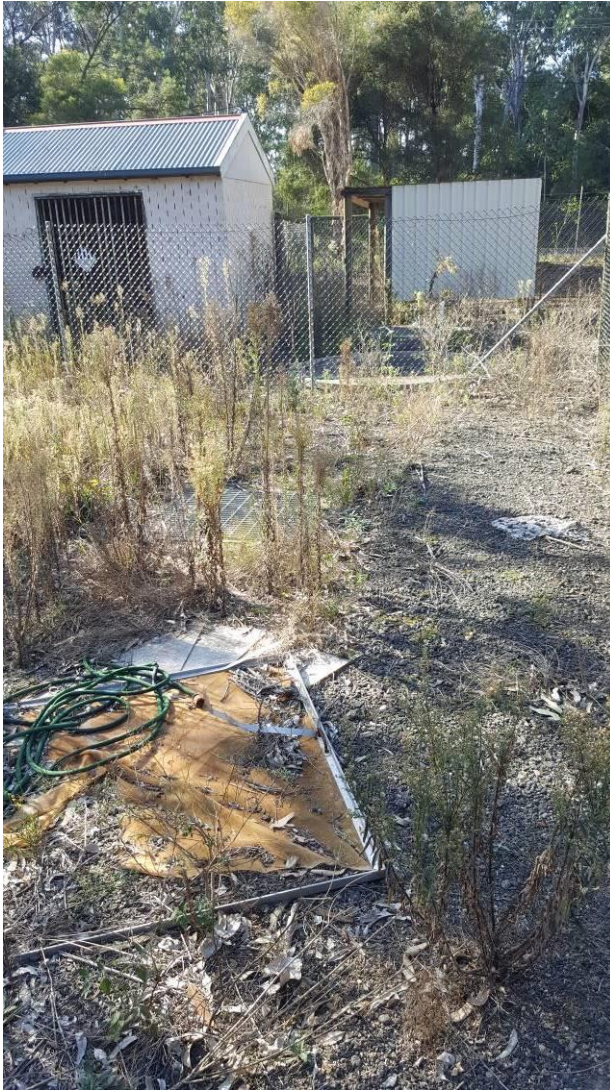
Plate 9: Remnants of WWTP infrastructure including a pump shed, in-ground treatment tanks, grated underground service hole and general rubbish.

- Activities associated with the WWTP infrastructure may have resulted in some contamination due to the importation of construction materials (including fibro), road base and other fill materials. Degradation of these materials over time may have resulted in contaminating fragments taken up by the near surface soil profile;

- A Phase 2 contamination assessment is recommended which would focus on an assessment of the near surface soil profile, soil sampling and laboratory analysis;
- The need for a groundwater investigation would be subject to the results of this Phase 2 assessment and furthermore, whether groundwater was encountered during the Phase 2 investigation;
- The main tool for a subsurface investigation would entail the use of a small backhoe, capable of retrieving adequate soil samples in a controlled manner and submission of appropriate samples to a NATA registered laboratory.
