43677.40.R.004.Rev0
2 December 2015
DW:mm

Preliminary Contamination Investigation
Fairways East -Stage 1J (2)
Bingara Gorge Estate, Wilton

Fairways East -Stage 1J (2)

Bingara Gorge Estate, Wilton

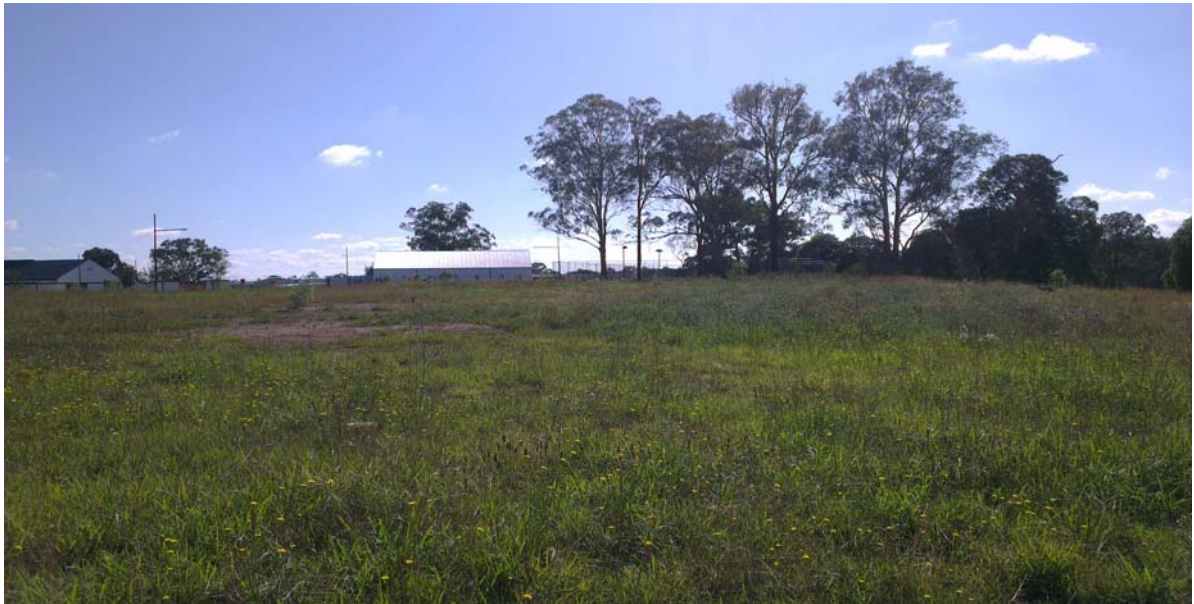
The site is absent of structures and is bound by The Irons Drive to the north and Ambrose Drive to the west. Patches of bare soil are surrounded by grass and some mature trees are present near the eastern boundary (Photograph 1, attached). Infrequent general waste materials were encountered on the ground surface (such as plastic, PVC pipes and concrete pieces) (Photograph 2, attached). A small stockpile (approximately 2 m³ in volume) of soil, grass and rootlets was present and appeared to be the returns from aeration works at the nearby golf course (given the small cylindrical clumps of soil, grass and roots of the same size) (Photograph 3, attached). Fences were present along the northern and western boundaries.

Photograph 1 - Site

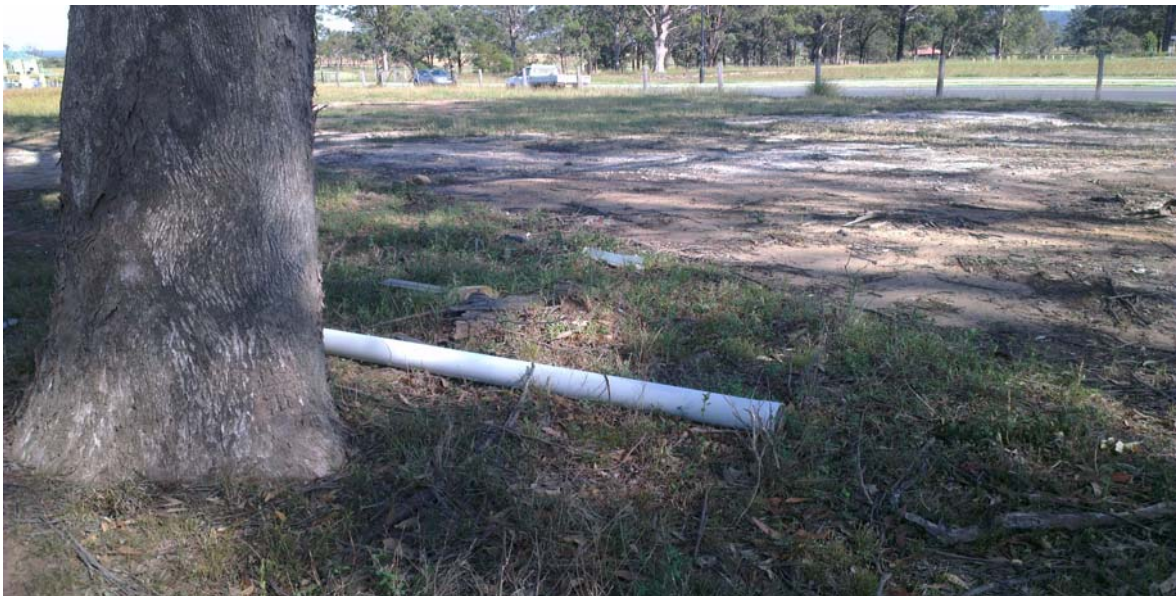
Photograph 2 - Some general waste materials next to tree

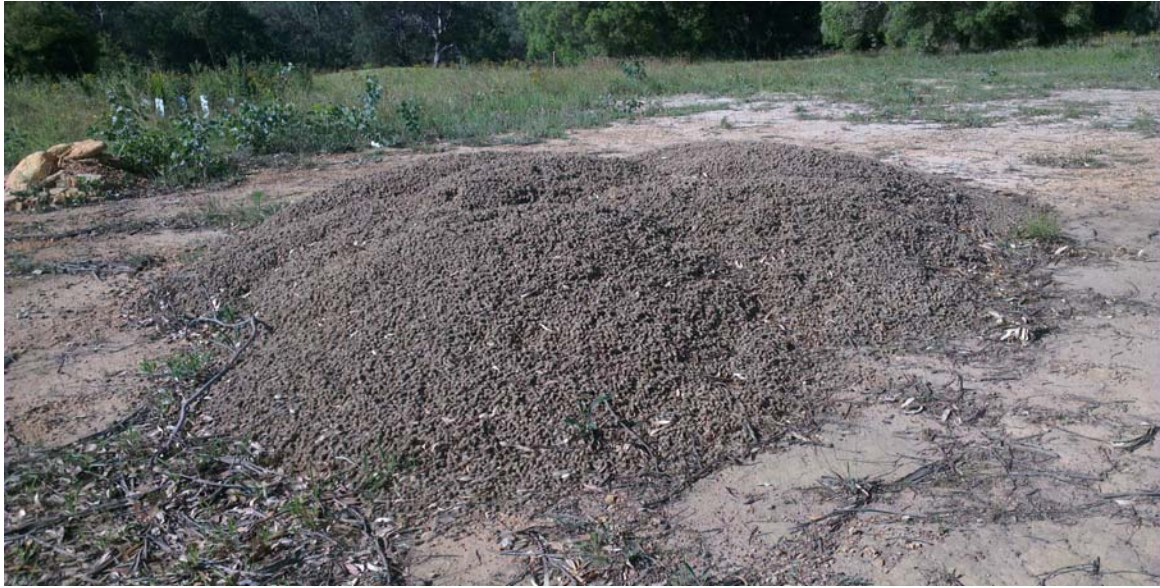
Photograph 3 - Small soil stockpile

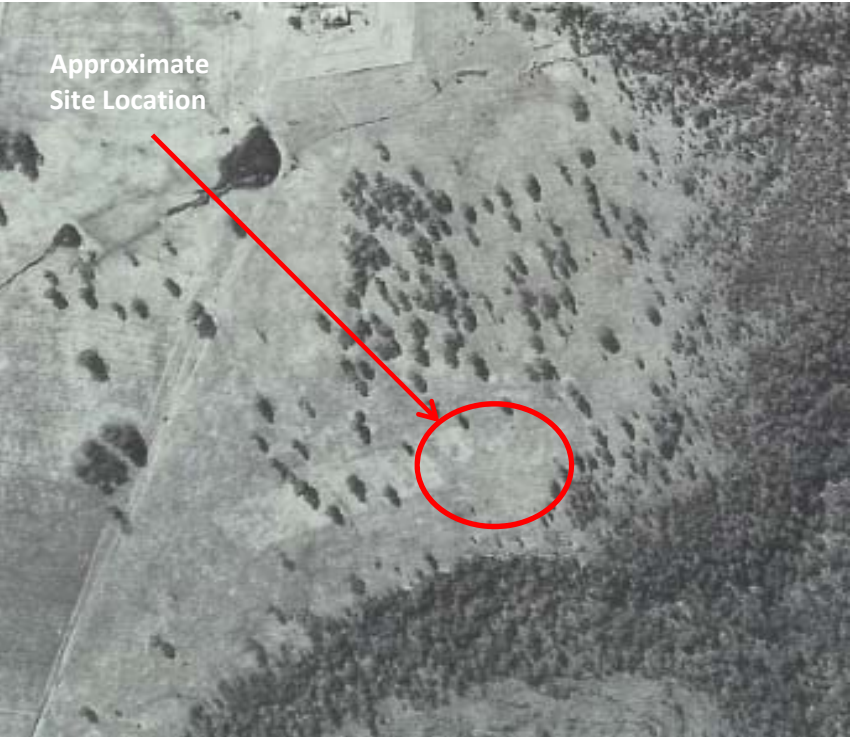
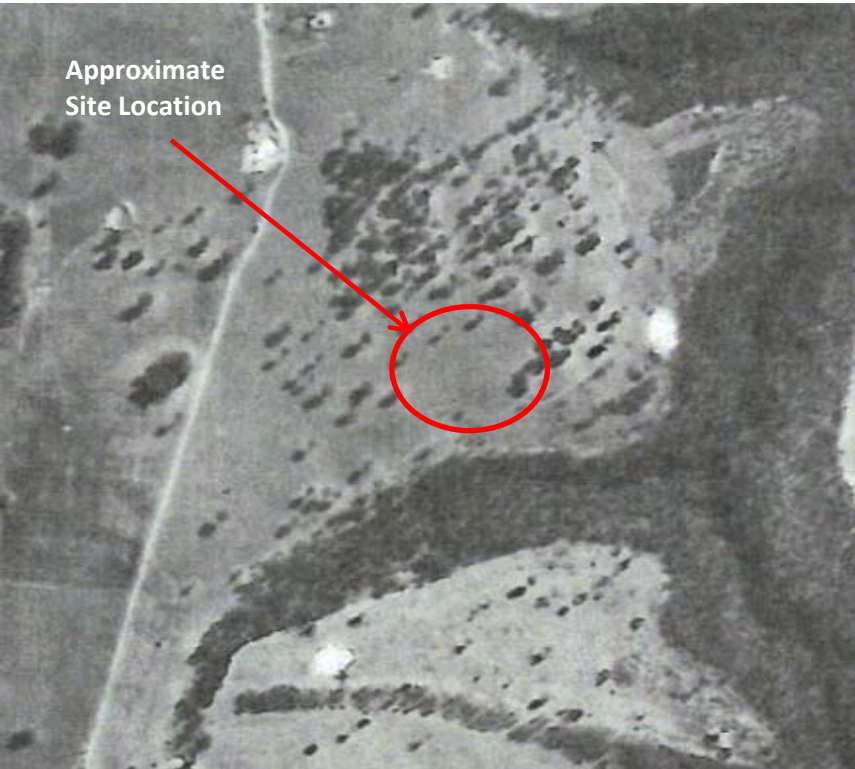
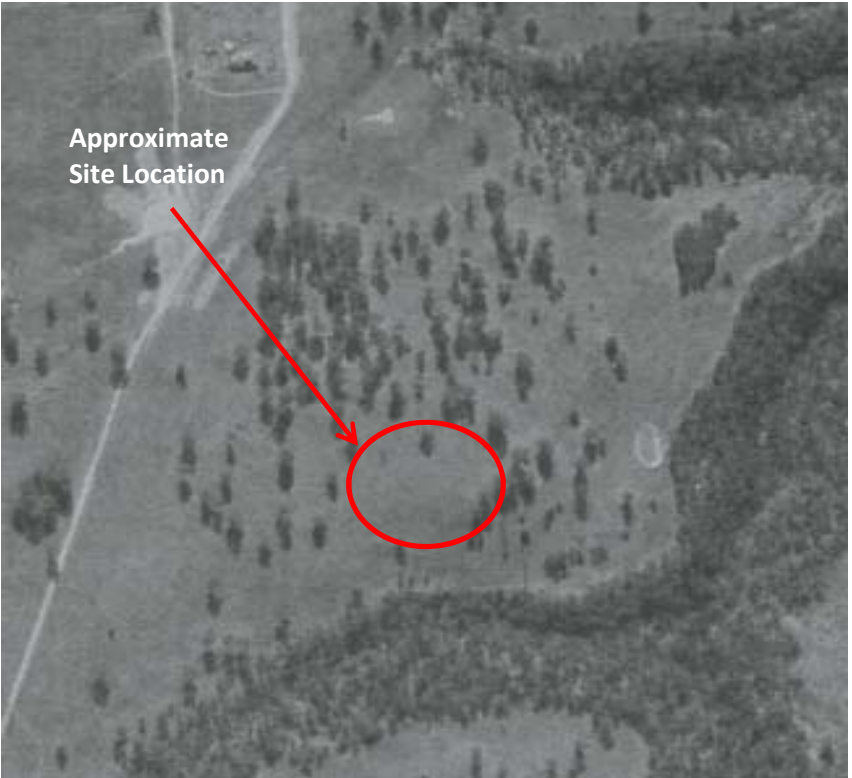
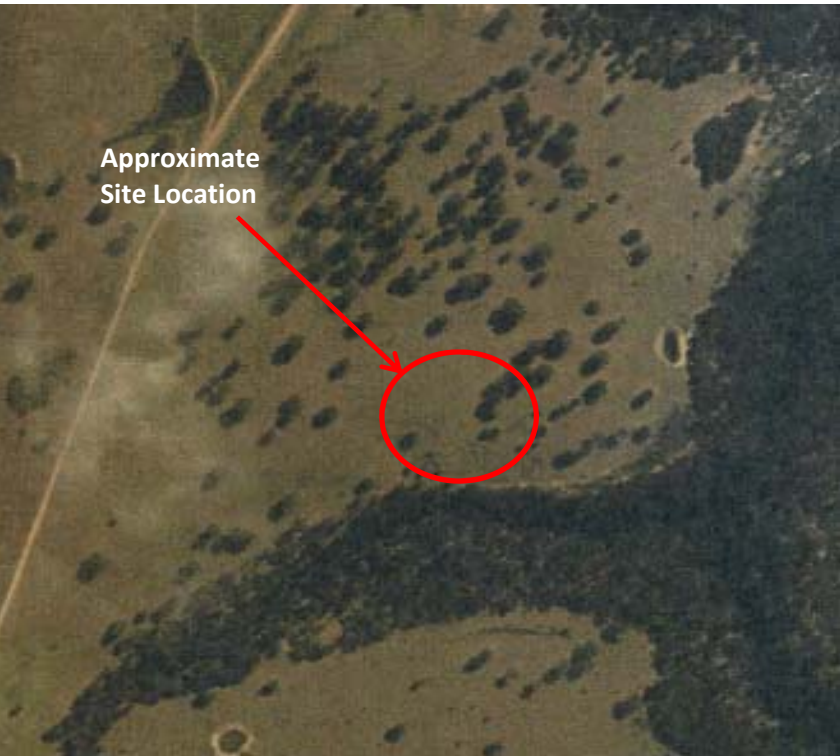
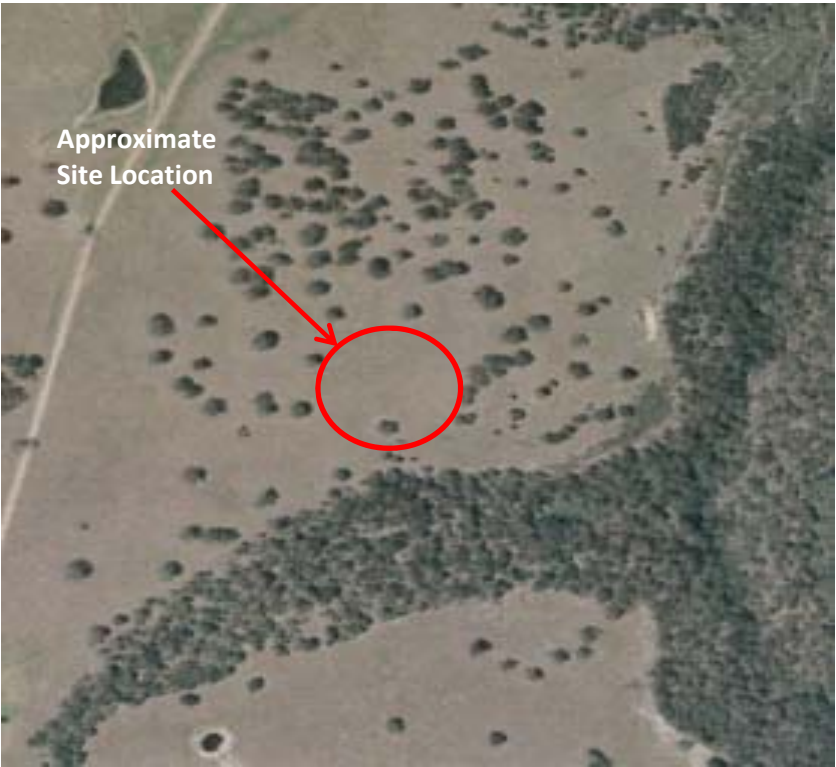
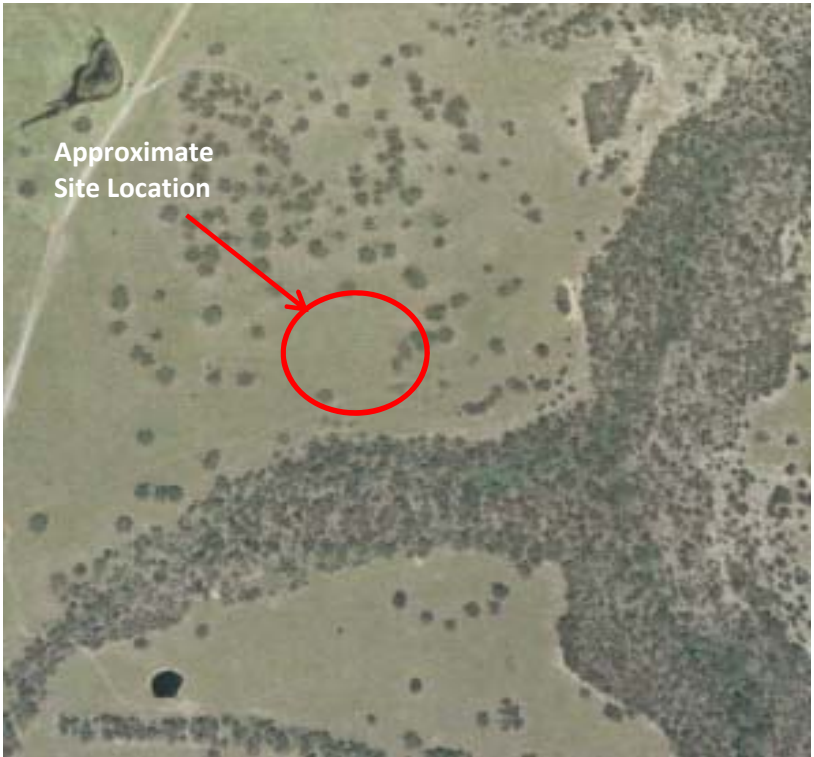
Aerial photographs from 1956, 1966, 1979, 1988, 1994 and 2005 were review to determine possible historical uses of the site. The photographs are shown on Plate B1, attached. In each of these aerial photographs, the site appears to have been part of land used for animal grazing. No structures or dams were present at the site.

Historical aerial photographs indicate that the site was probably used for animal grazing between 1956 and 2005. Potential contaminating activities at the site or surrounding land were not identified in the reviewed aerial photographs for this period.

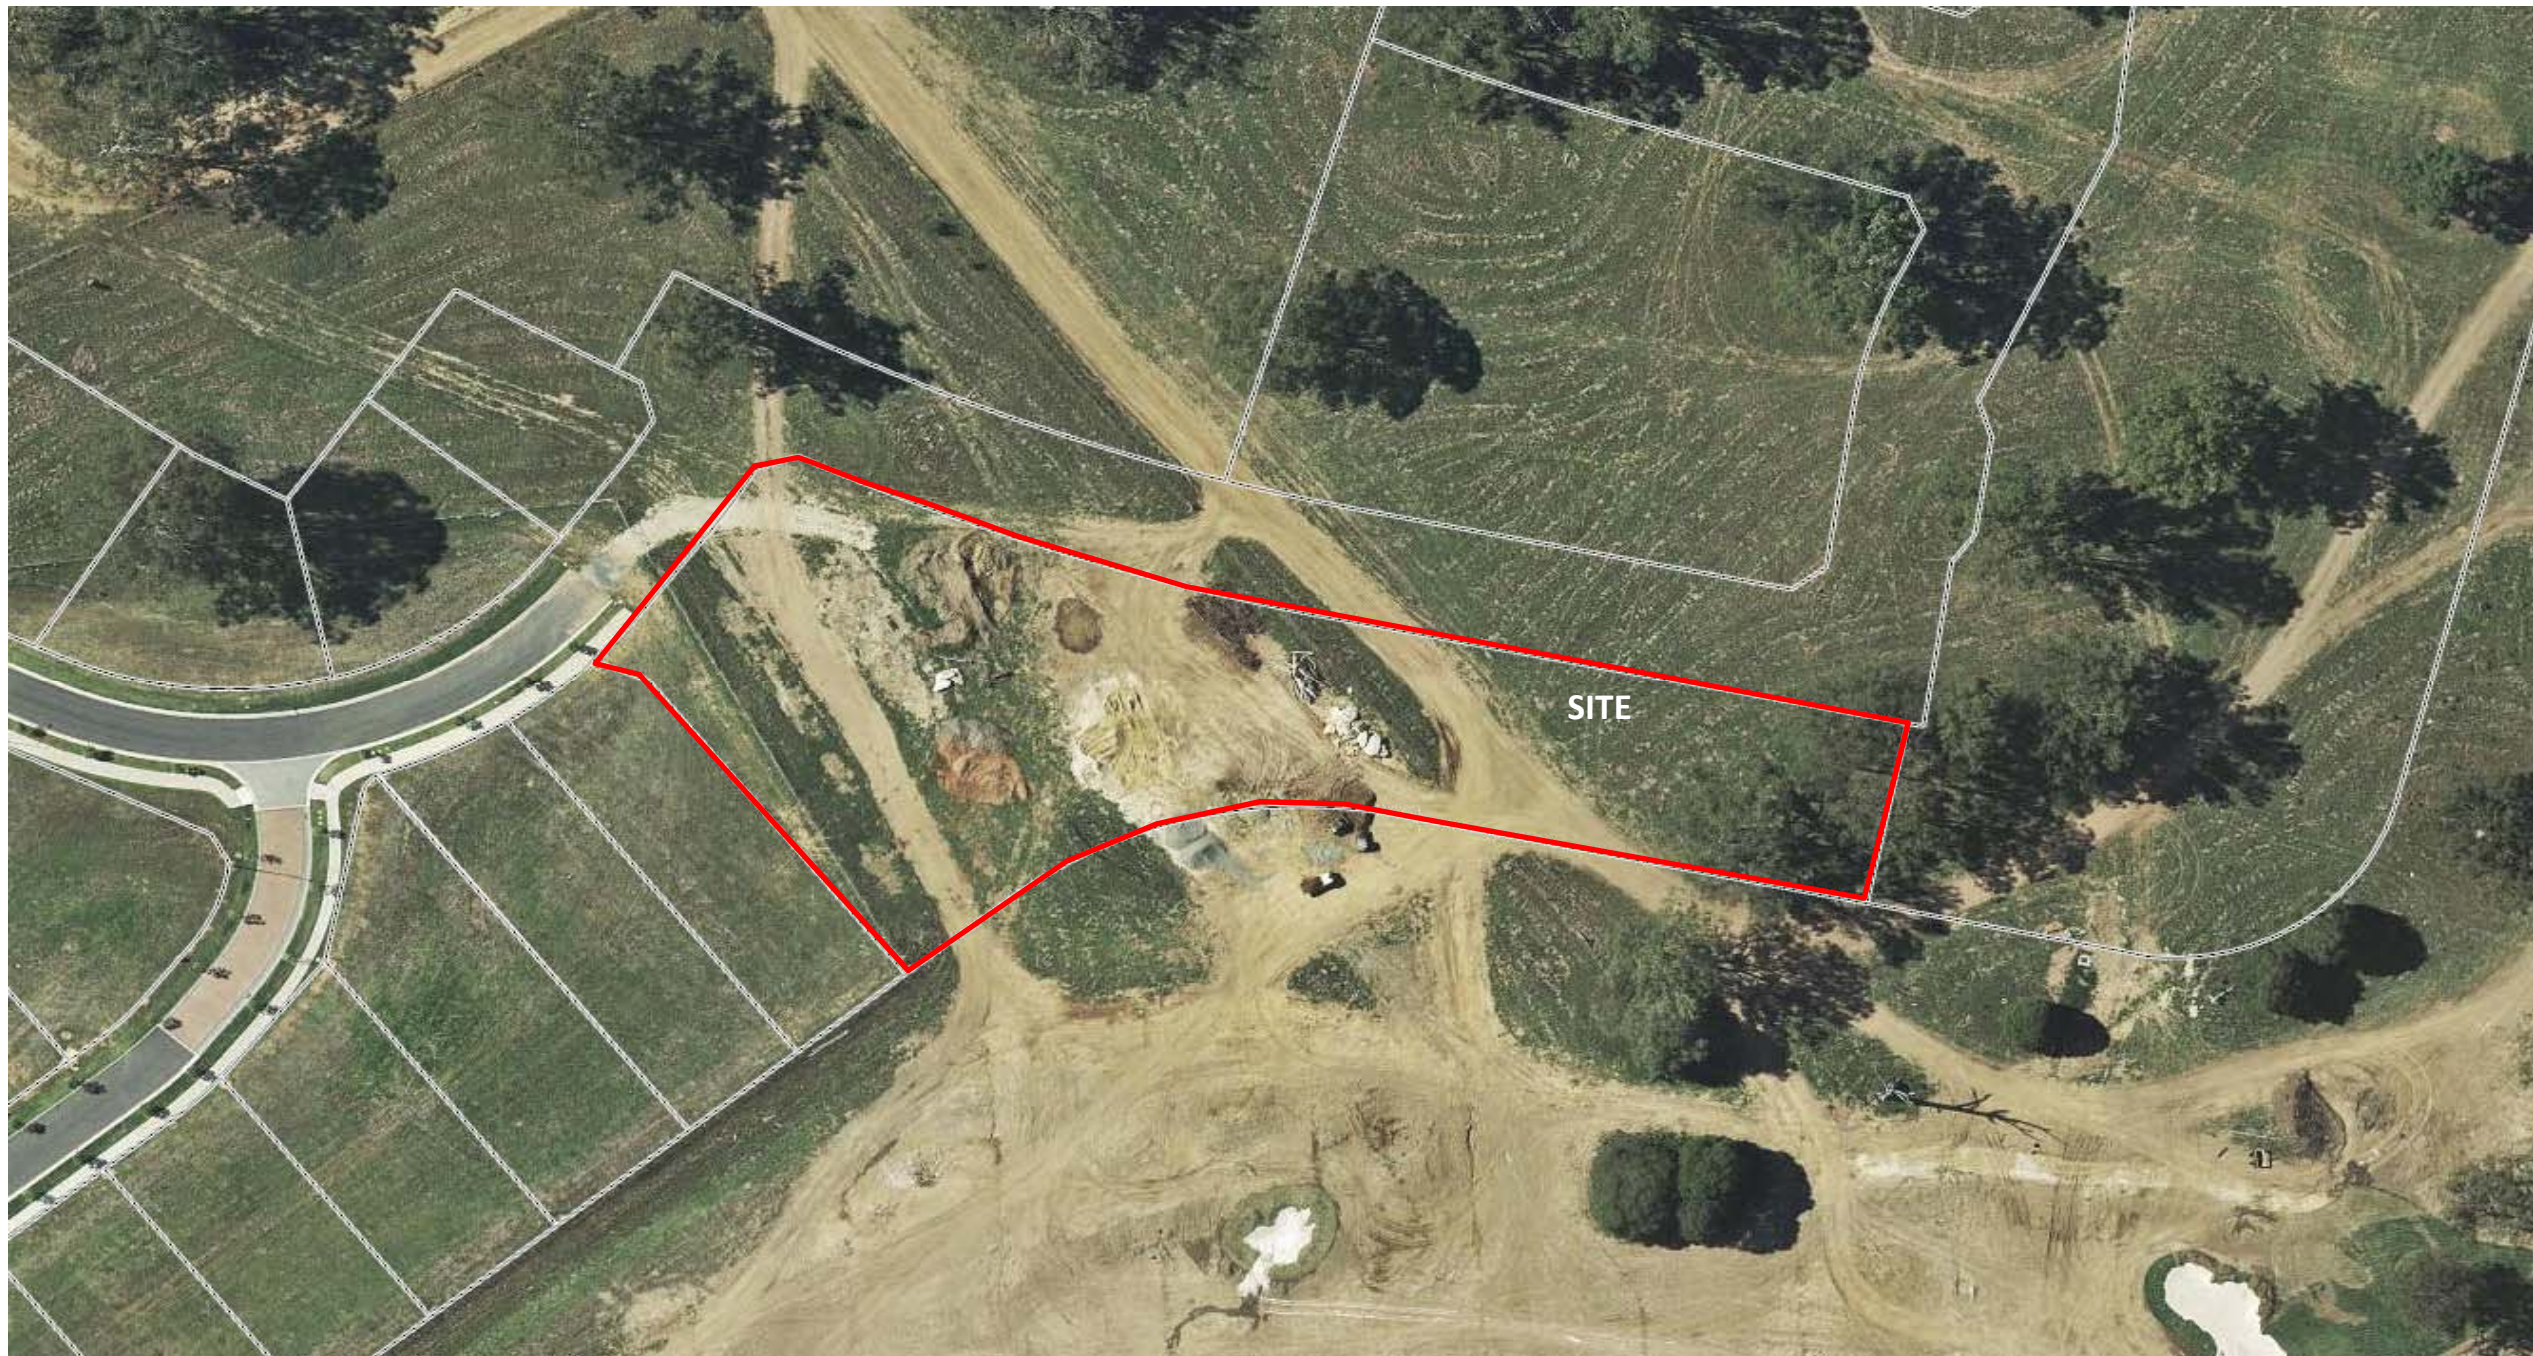
The 2013 aerial photograph is shown on Plate B2, attached. The site appears to have been used to access the neighbouring golf course construction site to the south. Stockpiles were present at the site and are likely to have been associated with the golf course earthworks/construction. Ambrose Drive had been constructed to the east. Apart from the road construction and golf course development, land surrounding the site had not been subject to development.

In recent years, the site has probably been disturbed due to the general ongoing development of the Bingara Gorge Estate (including the golf course) as indicated by the 2013 aerial photograph. Given that historical potential contaminating sources or activities have not been identified at the site or surrounding land, it is considered that there is a low potential for contamination to be associated with this land disturbance.

The considered low potential for contamination is consistent with the conclusions of the JET report (listed in the Statement of Environmental Effects). The approach recommended by JET that *if previously undetected contaminated material is encountered during construction, such as zones of filling or waste dumping, all work on site will cease until further investigations are undertaken*, is considered reasonable for the development of the site. This approach is otherwise known as an Unexpected Finds Protocol (UFP), whereby if signs of contamination are encountered (in filling or natural soil), an environmental consultant should be engaged to investigate and assess the potential contamination. It is assumed that a UFP (or similar) is in place for the case that unexploded ordnance is encountered during site development.
