ARBORICULTURAL IMPACT ASSESSMENT REPORT

STAGE 1 STATION STREET, MENANGLE

DOC No: ARB-1819-001
JOB No: 1819
REV: C
DATE: 16.11.2018

PREPARED BY:
Guy Sturt
B L Arch (UNSW) AILA Registered Landscape Architect
Dip. Arboriculture AQF5 Consulting Arborist

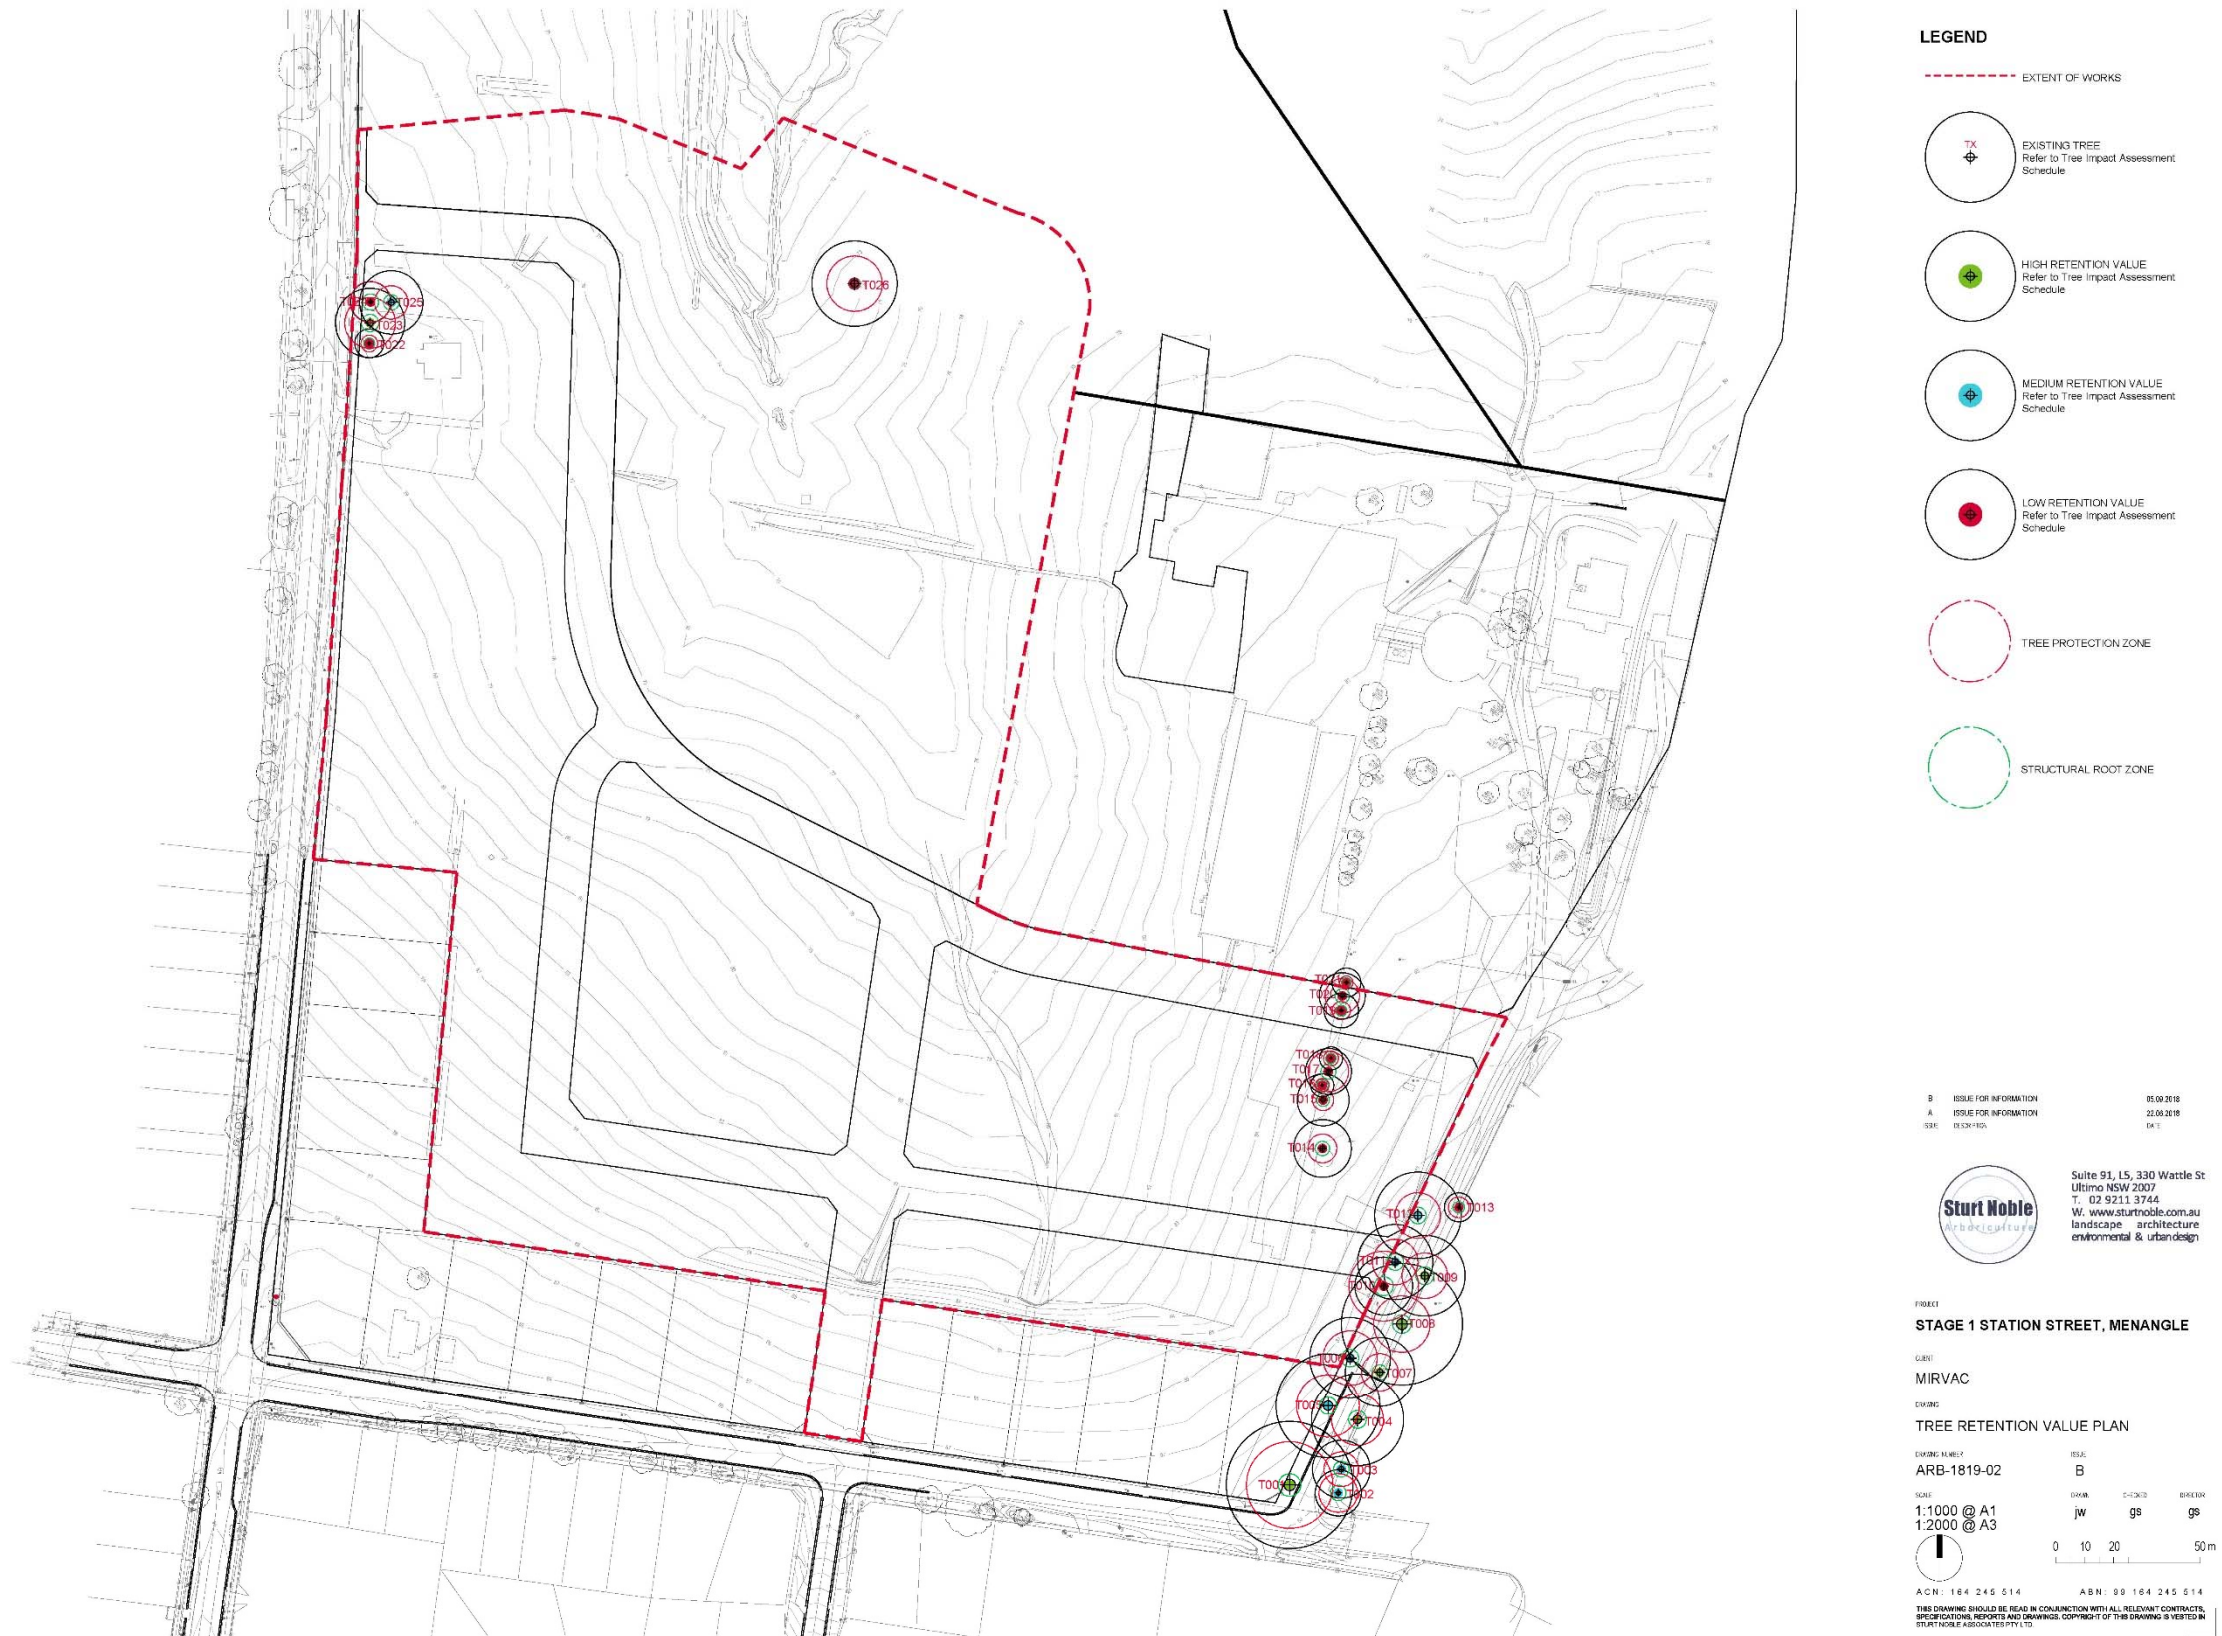
A2.3 Tree Retention Values

Site filling/ construction works critical to the following trees	Other (poor condition, other studies, etc)	Tree species to be removed (exempt and can be removed without consent)
Tree numbers 6, 11, 12, 14-21,25,26	Tree number 10,22	Tree number 24
