# ARBORICULTURAL ASSESSMENT AND IMPACT REPORT

PROPOSED RESIDENTIAL SUBDIVISION AND HOUSING DEVELOPMENT STAGES 1 AND PART STAGES 2 AND 3 WILTON, NSW

19<sup>th</sup> April 2018

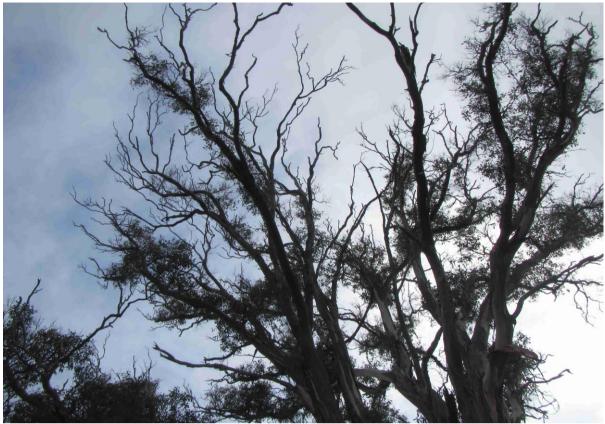
Figure 8 Shows the typical poor condition of the upper canopy of site trees.

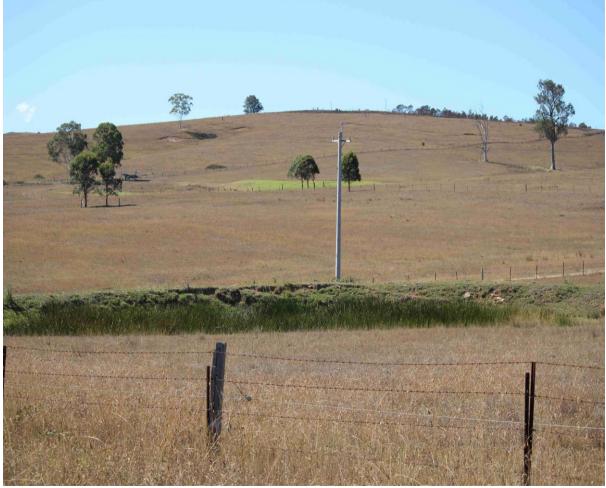
Figure 9 Shows minor group plantings with the paddocks to be removed.

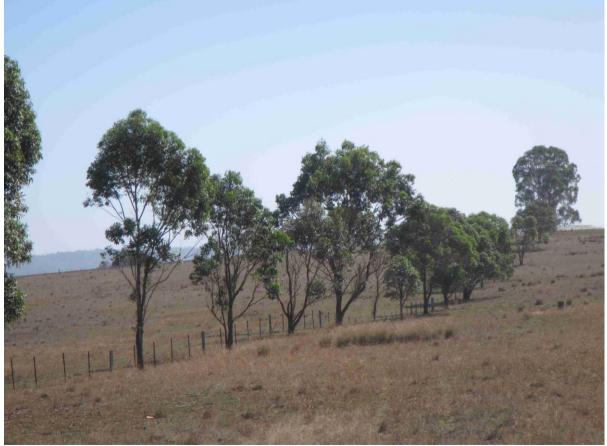
Figure 11 Shows a typical boundary planting numbered 44.

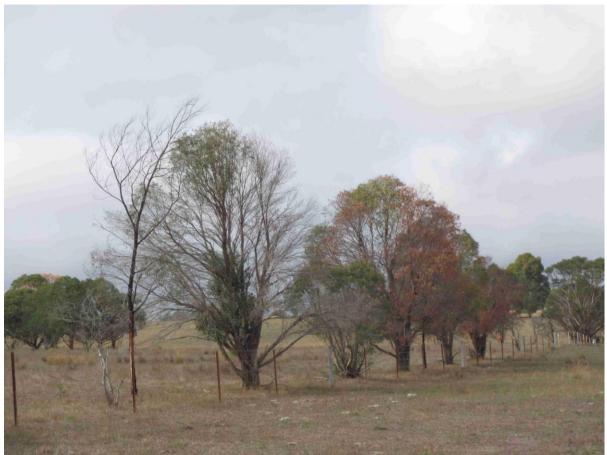
Figure 12 Shows poor boundary screen planting numbered 9.

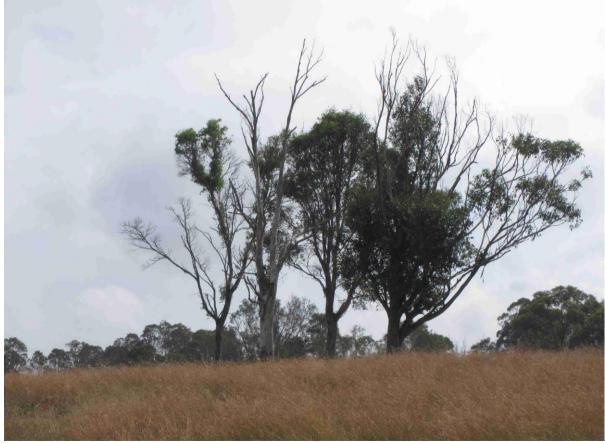
Figure 13 Shows typical poor upper canopy foliage of site trees.

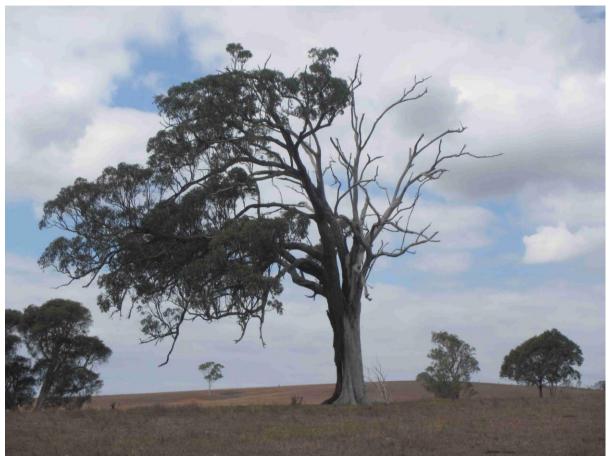
Figure 14 Shows Tree 79 half dead from lightning strike.

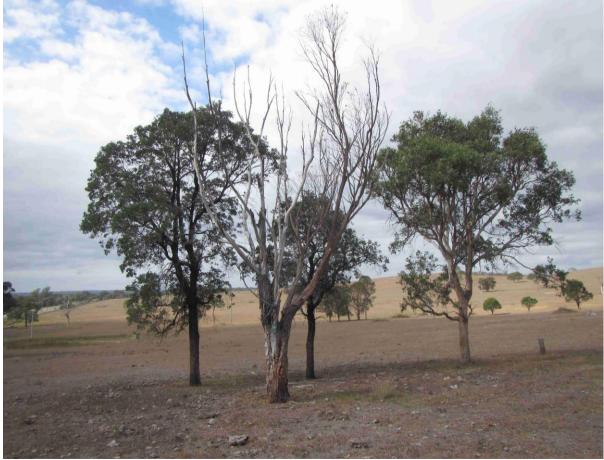
Figure 15 Shows typical minor eucalypts to be removed and replaced.
