Report on
Preliminary Site Investigation for Contamination

Future Development Areas
& Associated Trails
Bingara Gorge Estate, Wilton

Prepared for
Lend Lease Communities (Wilton) Pty Ltd

Project 43677.40.R.003.Rev1
March 2016

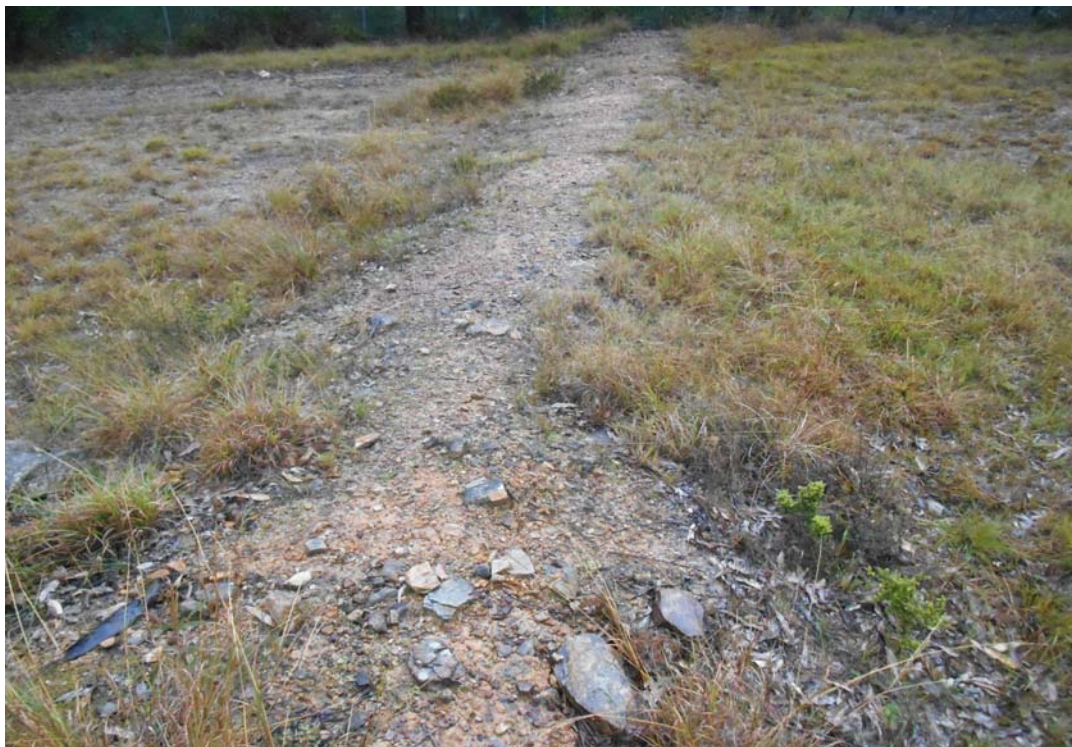
Stockpile or fill mound description	Photograph No. (see Appendix B)	Location Coordinates
A series of small, elongated fill mounds comprising soil and rock at the south-eastern part of the southern area. No anthropogenic materials or signs of potential contamination were observed on the surface.	Photograph 1	From: E: 288214, N: 6209740 To: South-eastern corner of area
Grass covered stockpile of approximately 500 m ³ of soil and rock in amongst trees at southern area. No anthropogenic materials or signs of potential contamination were observed on the surface.	Photograph 2	E: 288020 N: 6209800
Small stockpile (~2 m ³) of soil with general waste materials observed on the surface including bricks and plastic, at northern area.	Photograph 3	E: 288052 N: 6210108
Small stockpile (~4 m ³) of soil and rock with waste materials on the surface including bricks and concrete, at northern area	Photograph 4	E: 288057 N: 6210224

Photograph 1 - Elongated fill mound

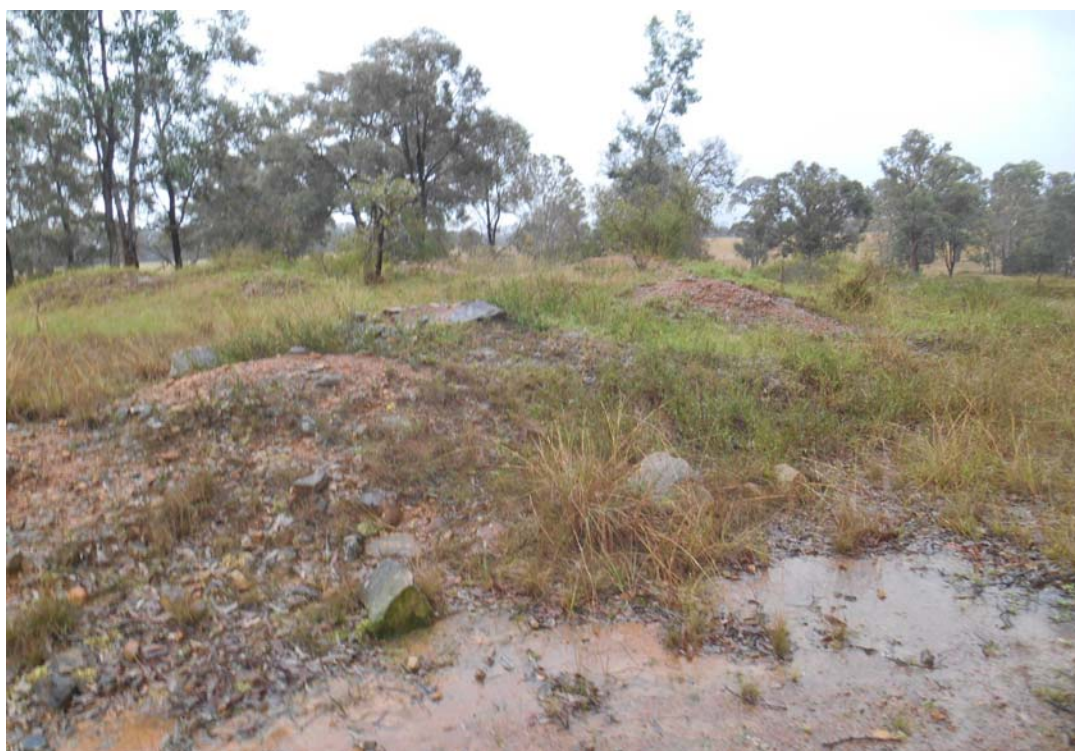
Photograph 2 - Stockpile

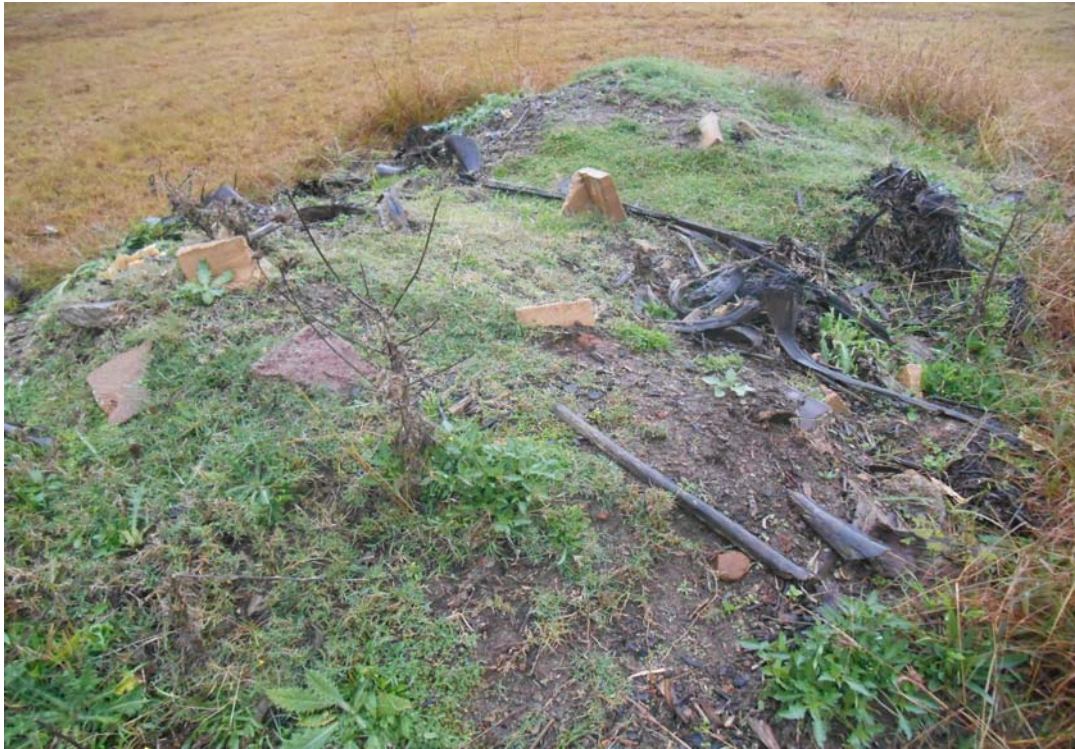
Photograph 3 - Small soil stockpile with bricks and plastic

It is recommended that stockpiles observed to contain substantial general waste materials mixed in with soil (such as those shown in Photographs 3, 4 and 8, Appendix B) should be designated for off-site disposal or otherwise tested and assessed by an environmental consultant if the stockpiles are to be reused at the site. Soils designated for off-site disposal need to be classified in accordance with NSW EPA, *Waste Classification Guidelines*, November 2014.

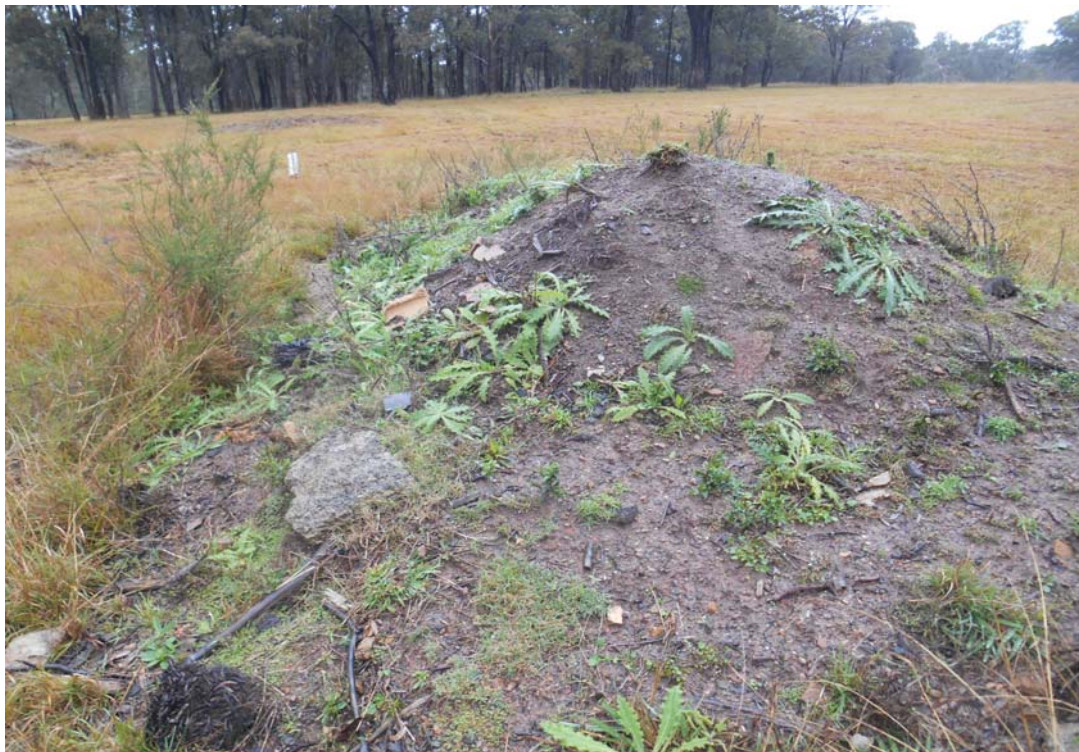
Photograph 4 - Small soil stockpile with concrete and bricks

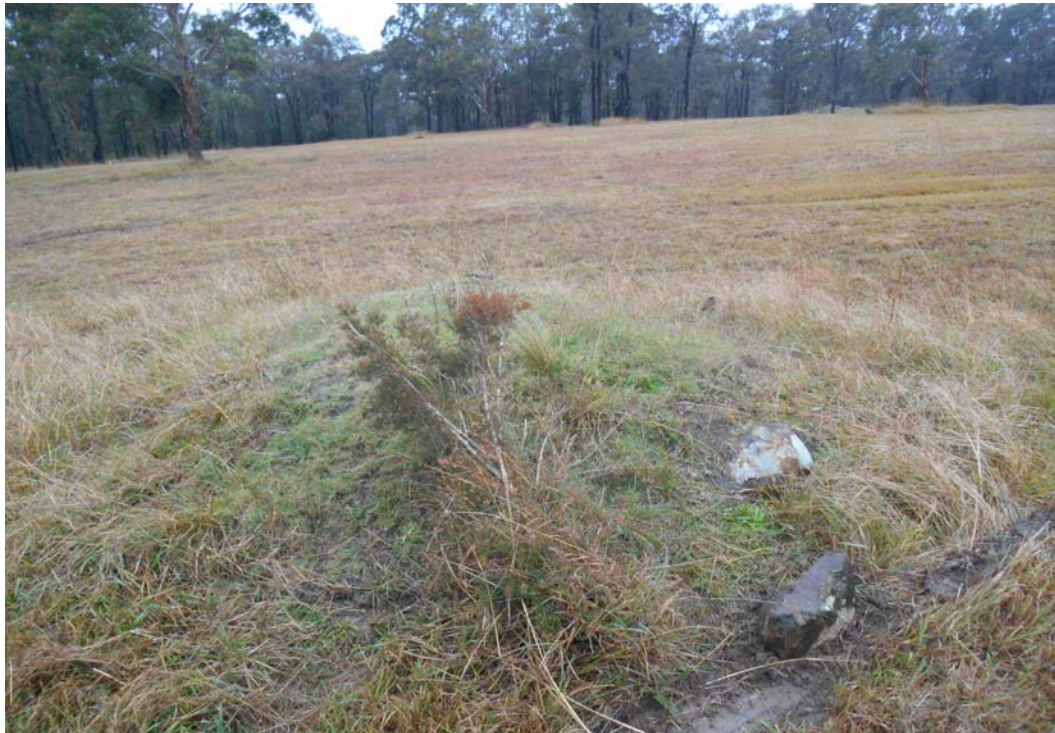
Small stockpile (~2 m ³) of grass covered soil and rock at northern area. No anthropogenic materials or signs of potential contamination were observed on the surface.	Photograph 5	E: 287977 N: 62010246

Photograph 5 - Small stockpile

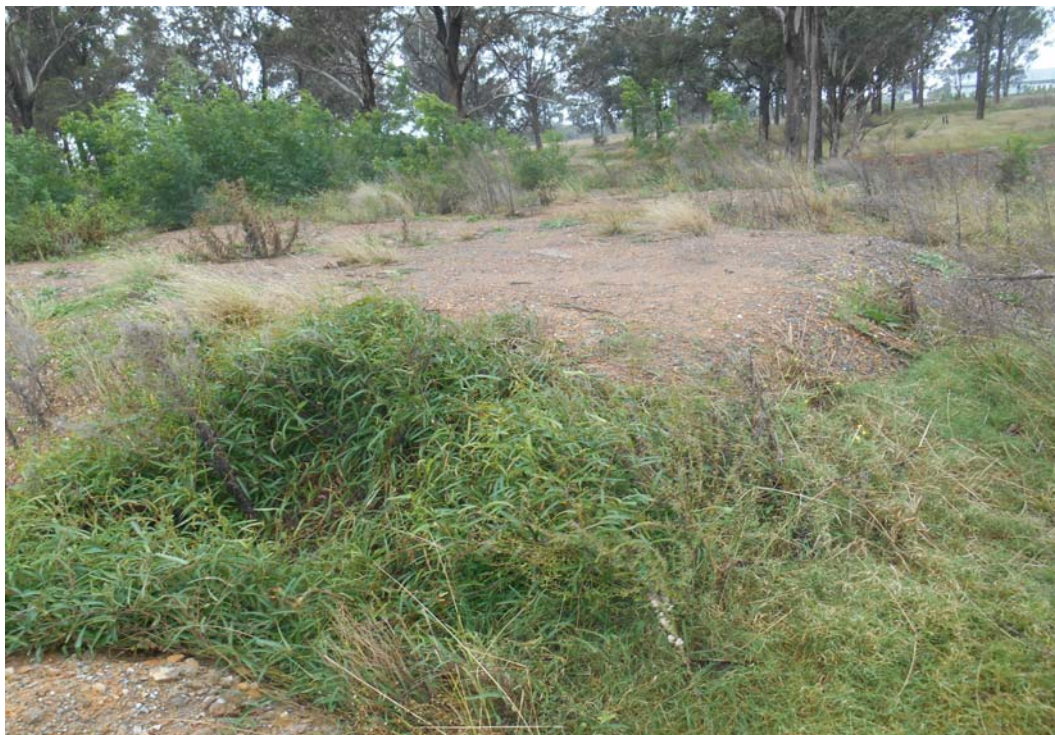
There are several small fill mounds and stockpiles of soil and rock within the western parts of the area (see Photographs 6 and 7, Appendix B). A small stockpile (~4 m³) within this part of the site (E: 286634, N: 6210804) was observed to contain a mix of soil and asphalt (Photograph 8, attached). Apart from this stockpile, anthropogenic materials were not observed on the surface of fill mounds and stockpiles. Signs of potential contamination were not observed on the surface of the fill mounds or the surface of the stockpiles.

Photograph 6 - Soil mound (filling)

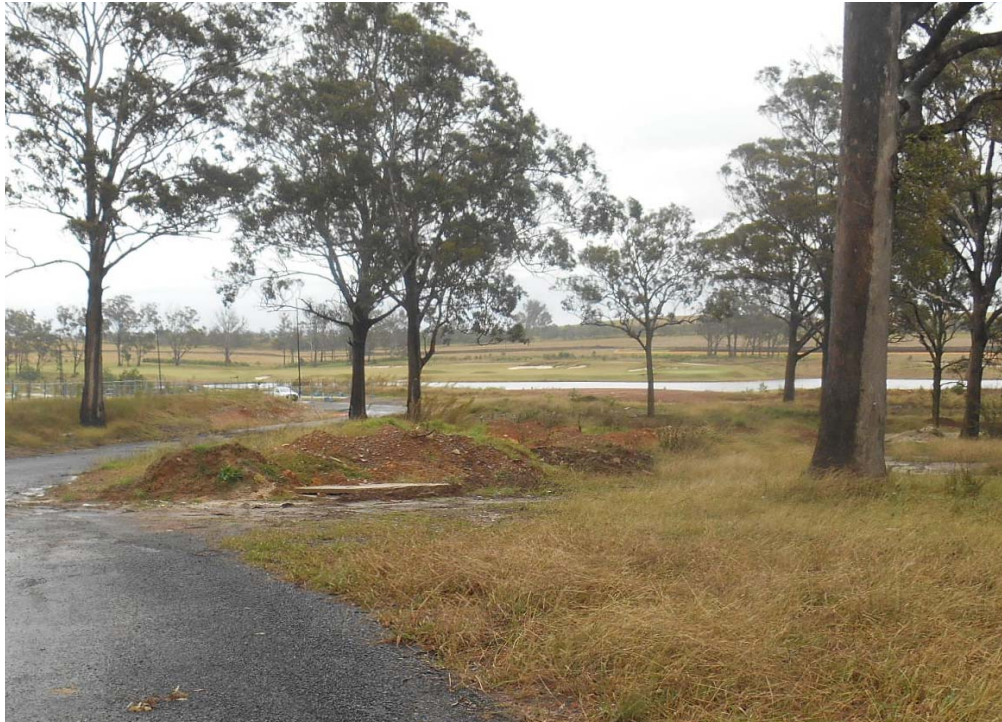
Photograph 7 - Stockpiles next to roadway

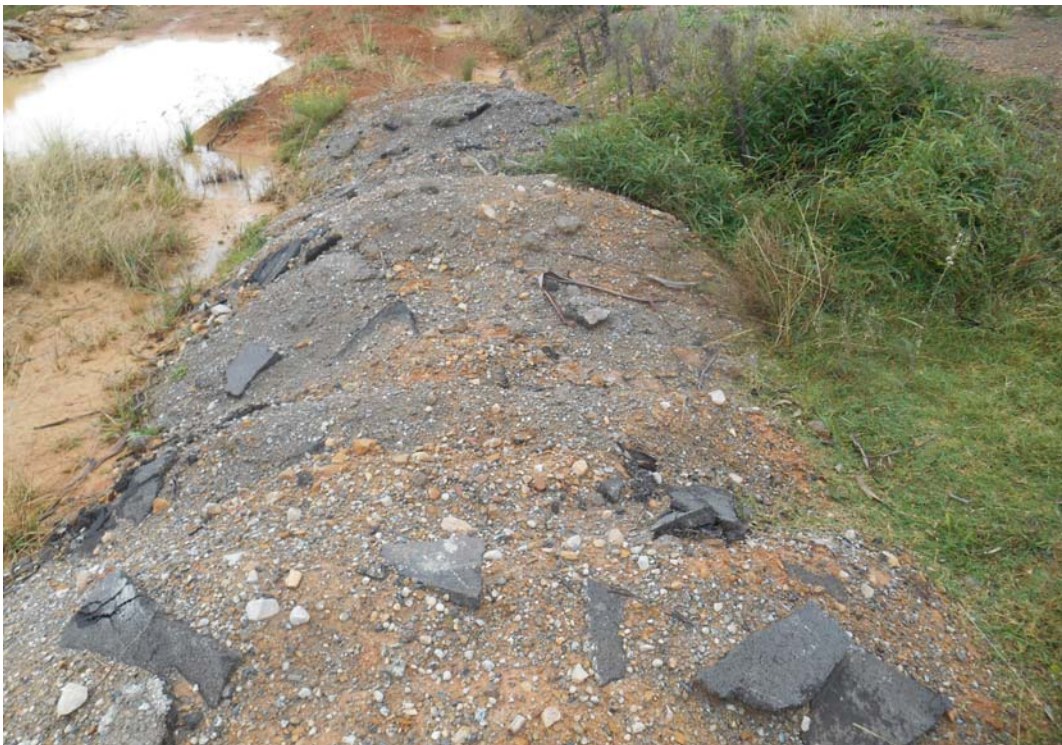
Photograph 8 - Asphalt in stockpiled soil

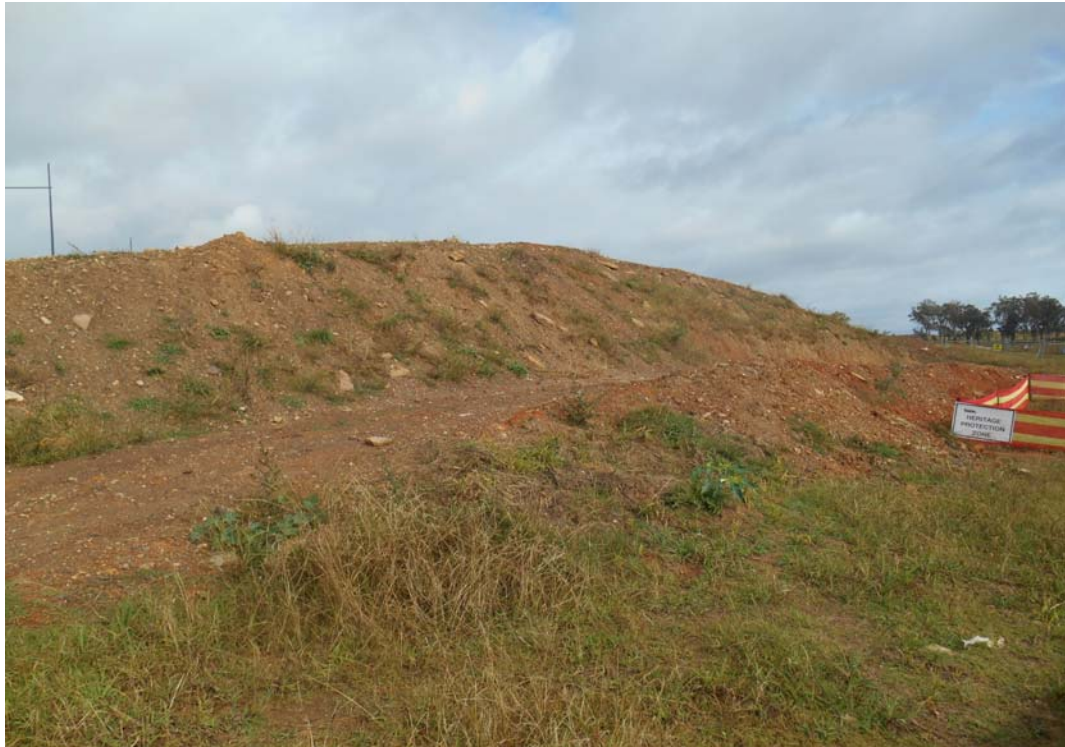
The northernmost two areas of Fairways East Stage 1M(b), at Fairway Drive, were occupied by large stockpiles as well as a contractor compound (see Photographs 11 to 14, Appendix B). [These stockpiles are from approved subdivision works carried out on Fairways East (DA 010.2013.411.001) and Stage 1M (DA ID993.05). All stockpile placement was observed by a geotechnical engineer at the time]. The surfaces of four large stockpiles were observed to contain soil and rock with infrequent anthropogenic materials such as plastic. A stockpile of sandstone boulders and a stockpile of trees were located next to a soil stockpile. Signs of potential contamination were not observed on the surface of the stockpiles. The contractor compound comprised site sheds, a container, a skip bin, building materials and some general waste materials. A new substation was present adjacent to the compound (see Photograph 13, Appendix B). The presence of stockpiles and site sheds meant that most of the ground surface could not be observed, however, signs of potential contamination were not observed on exposed ground surfaces.

Photograph 11 - Large soil and rock stockpile at north of Fairways East Stage 1M (b)

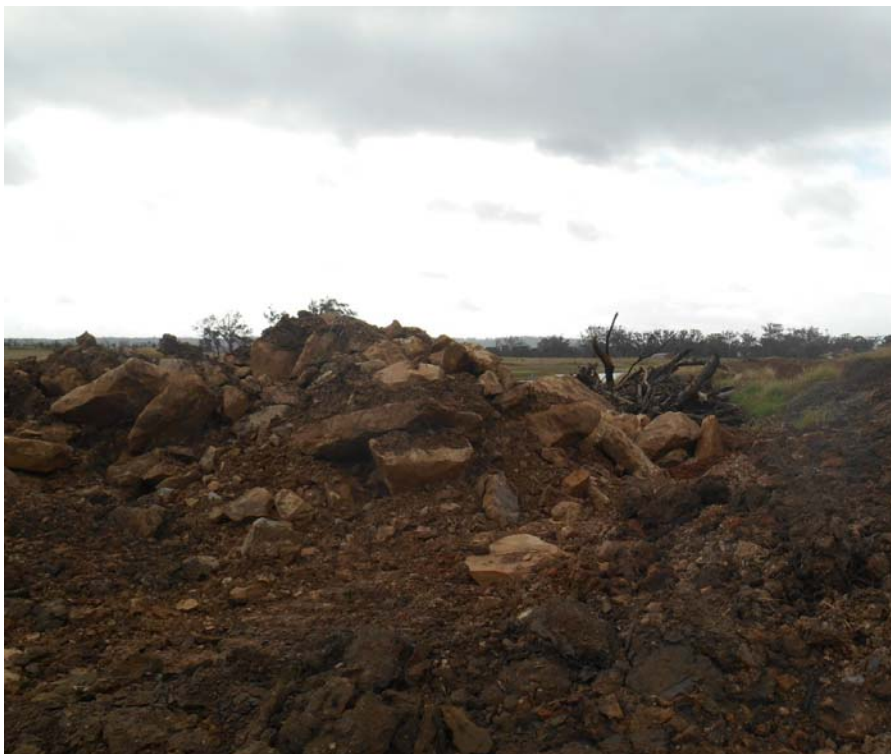
Photograph 12 - Sandstone boulders stockpile. Stockpile of trees behind sandstone boulders

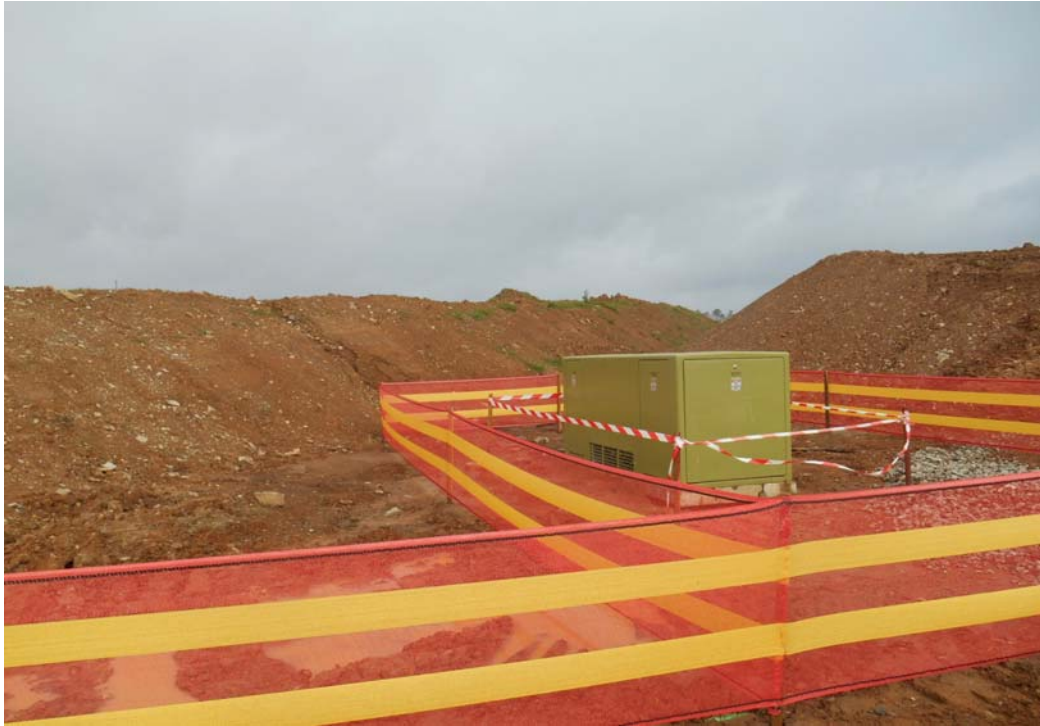
Photograph 13 - Large soil and rock stockpiles at north of Fairways East Stage 1M (b)

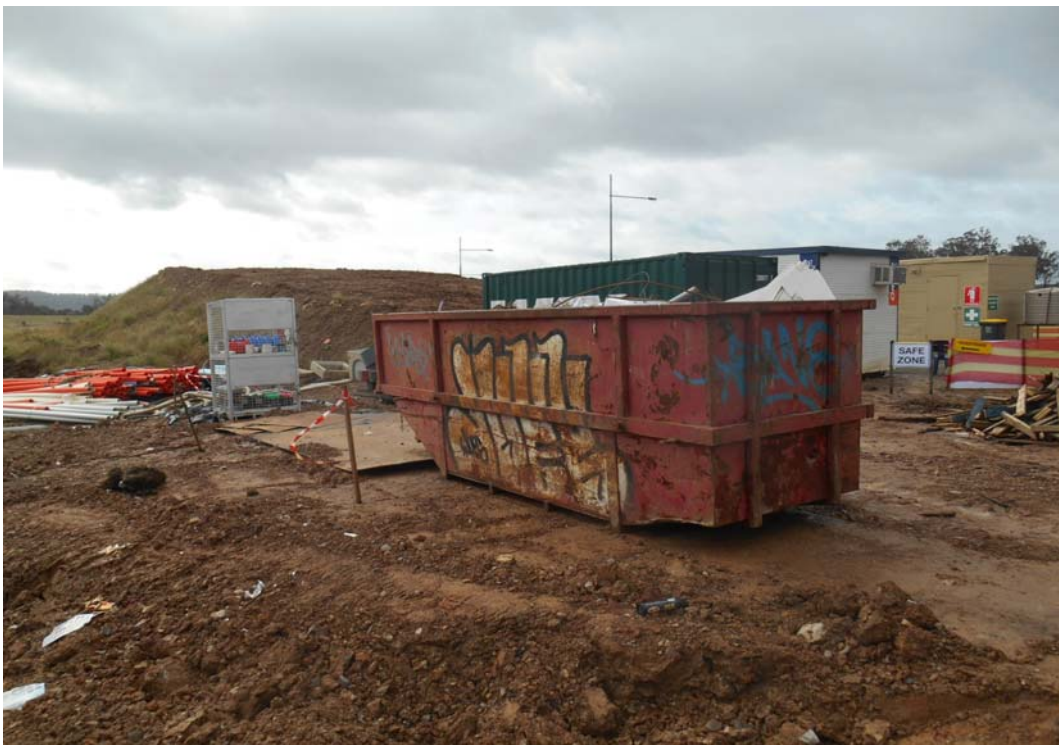
Photograph 14 - Contractor compound

It is recommended that parts of the site used for the storage of contractor's equipment or fuel, as a minimum, be inspected for signs of contamination once the area is no longer used for that purpose. Further assessment (or remediation) will be required if signs of contamination, such as staining of the soil surface, are observed during the inspection.

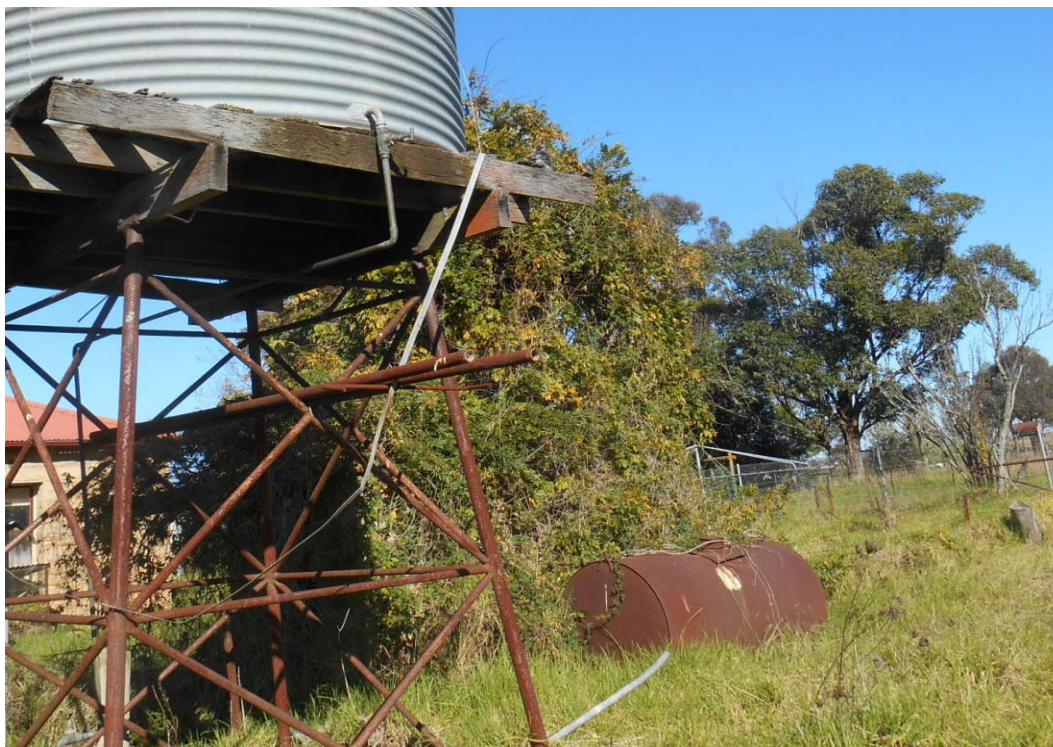
Photograph 16 - Derelict tank on ground

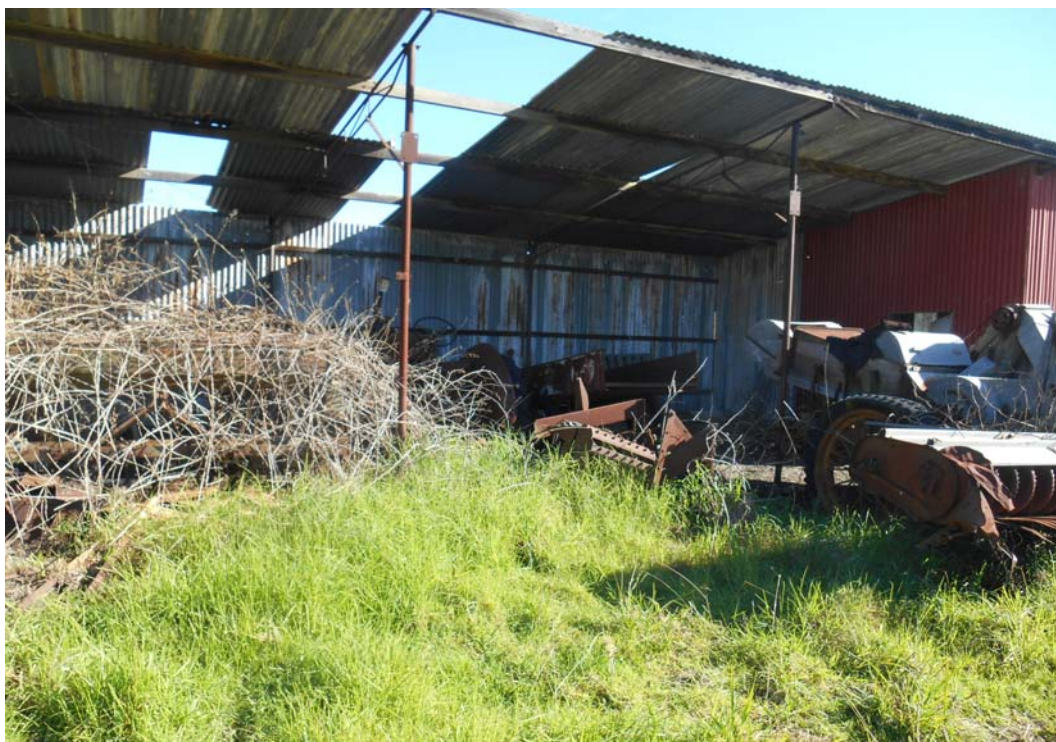
Photograph 17 - Shed with old farming equipment

In addition to the UFP, some soil sampling should be undertaken from around the cottage and nearby shed and remnants of previous structures at the western Future Development Area to confirm (or otherwise) that the soil has not been impacted by possible spills or leaks of oil or fuel or by hazardous building materials. Soil should be tested for contaminants associated with fuel or oil storage (petroleum hydrocarbons, metals and polycyclic aromatic hydrocarbons) as well as asbestos, PCB, lead and zinc. It is noted that this part of the site, where sampling is recommended, is not within areas that are proposed to have significant vegetation removal.

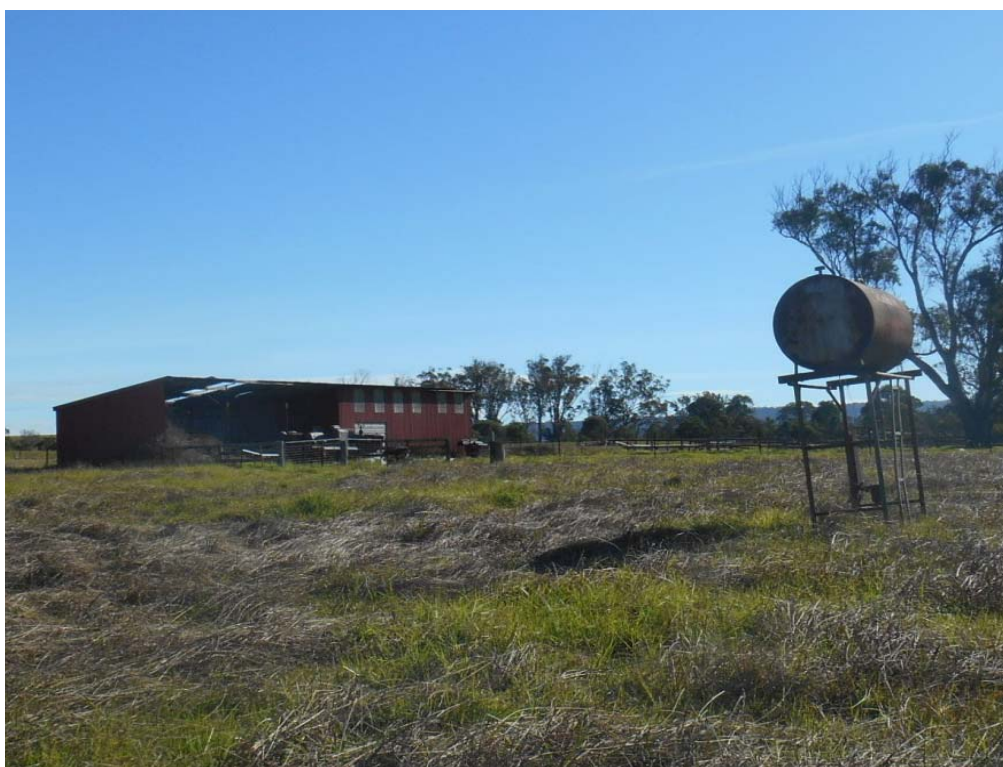
Photograph 18 - Aboveground tank (shed in background)

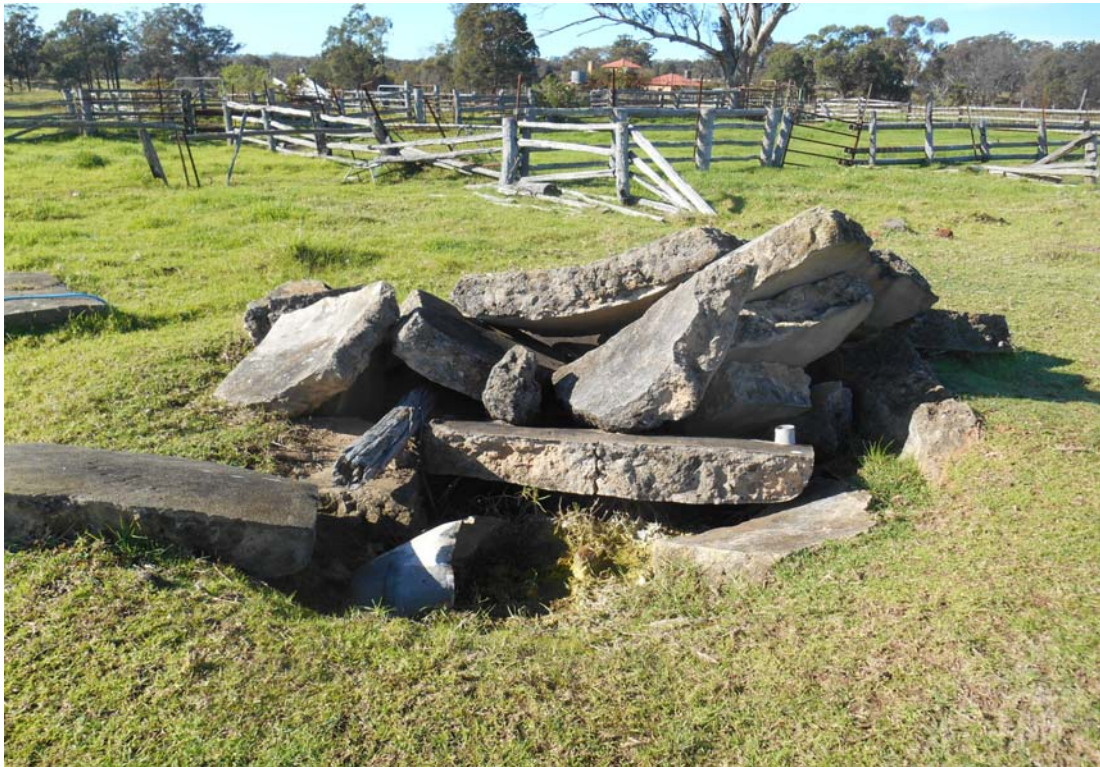
Photograph 19 - Remnants of unknown structure

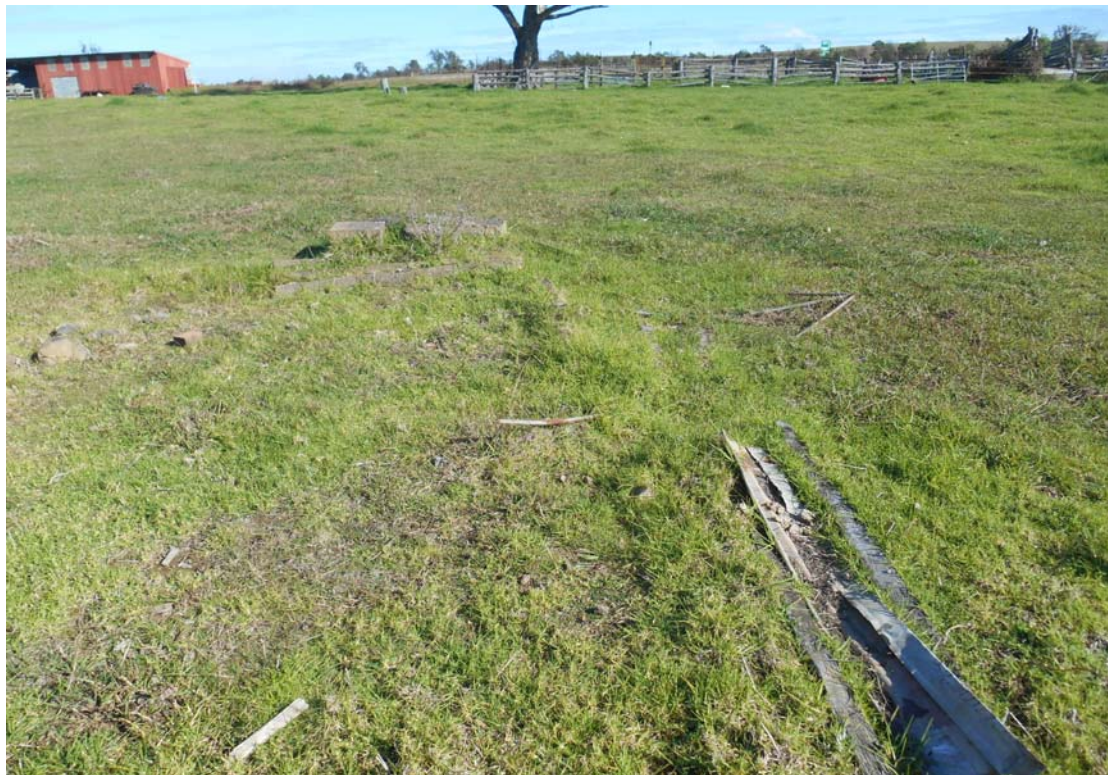
Photograph 20 - Remnants of unknown structure

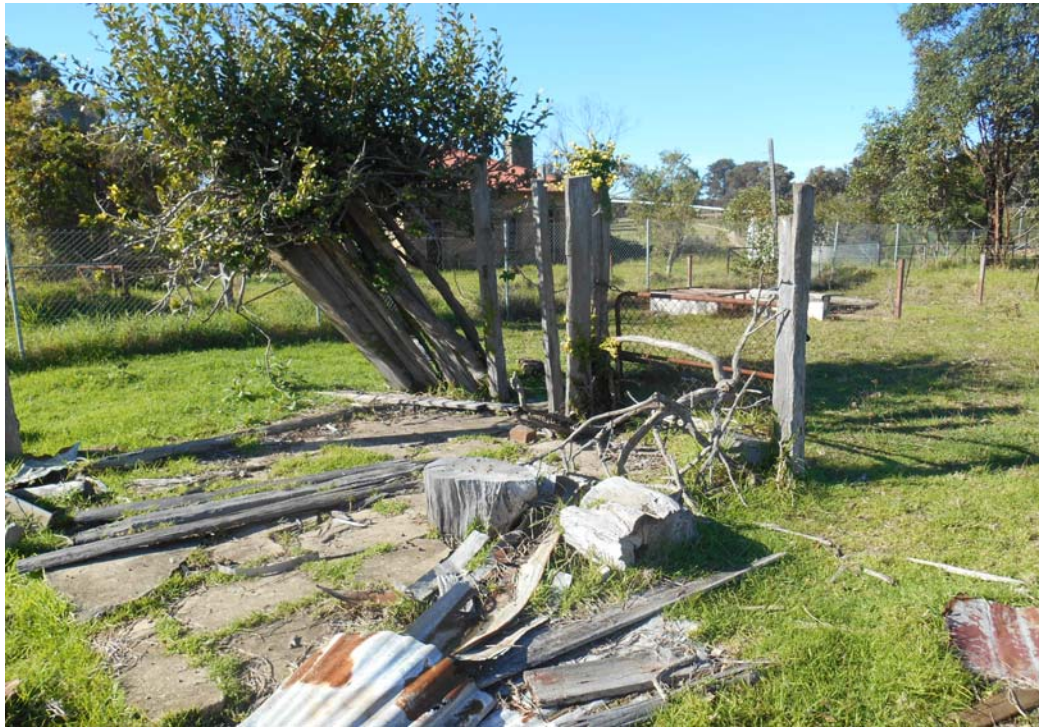
Photograph 21 - Remnants of unknown structure

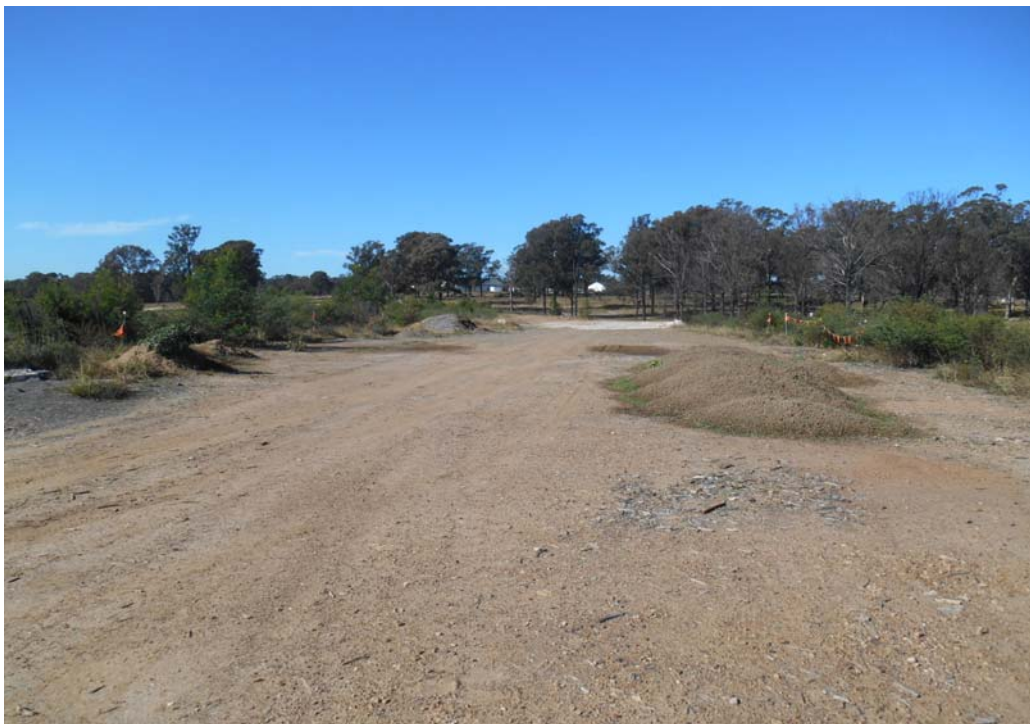
To the south of the cottage was a filled area to create a dam wall that adjoins and provides vehicle access to Fairways East Stage 1J. Small stockpiles of mulch, fertilizer and sand were observed in this filled area (see Photograph 24, Appendix B).

Photograph 24 - Filled area to create a dam wall with stockpiles on ground surface

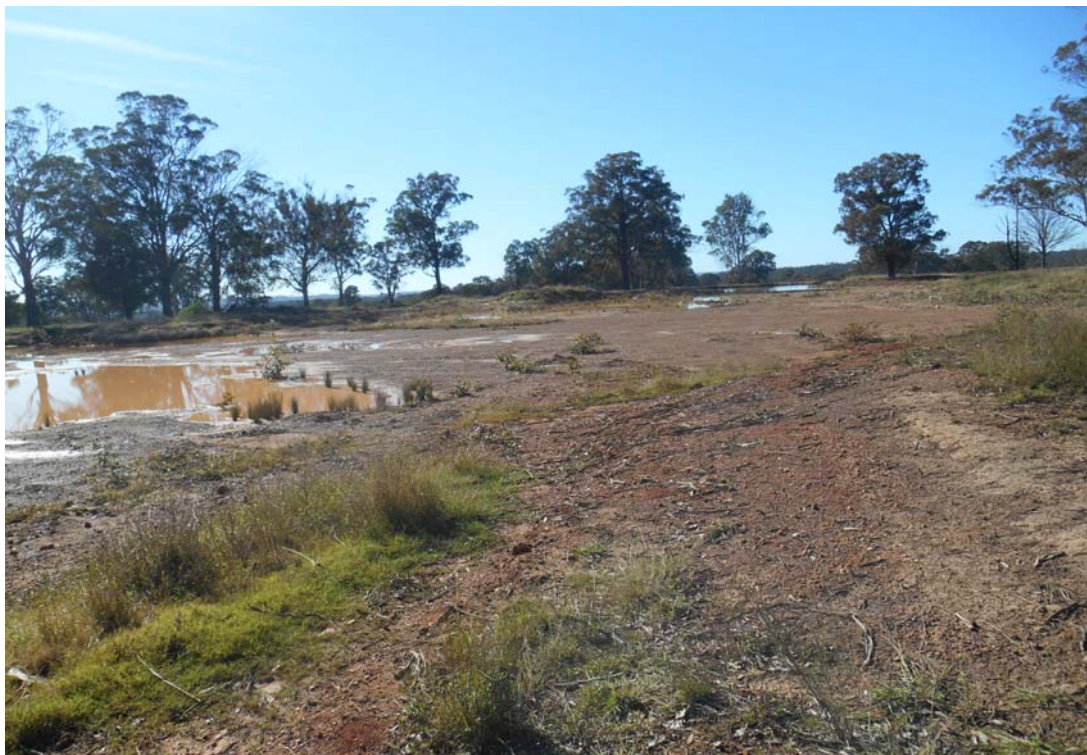
In the northern half of the western Future Development Area, a relatively elevated area that had been disturbed (scraped) and subject to removal of soil was observed, leaving exposed soil and pools of turbid water (E: 286877, N: 6211353) (see Photograph 25, Appendix B). Some piles of soil were present surrounding this area and were presumed to have been sourced from this disturbed area (see Photograph 26, Appendix B). A small dam was located to the south of the disturbed area (E: 286758, N6211273) (see Photograph 27, Appendix B).

Photograph 25 - Disturbed land and pooled water

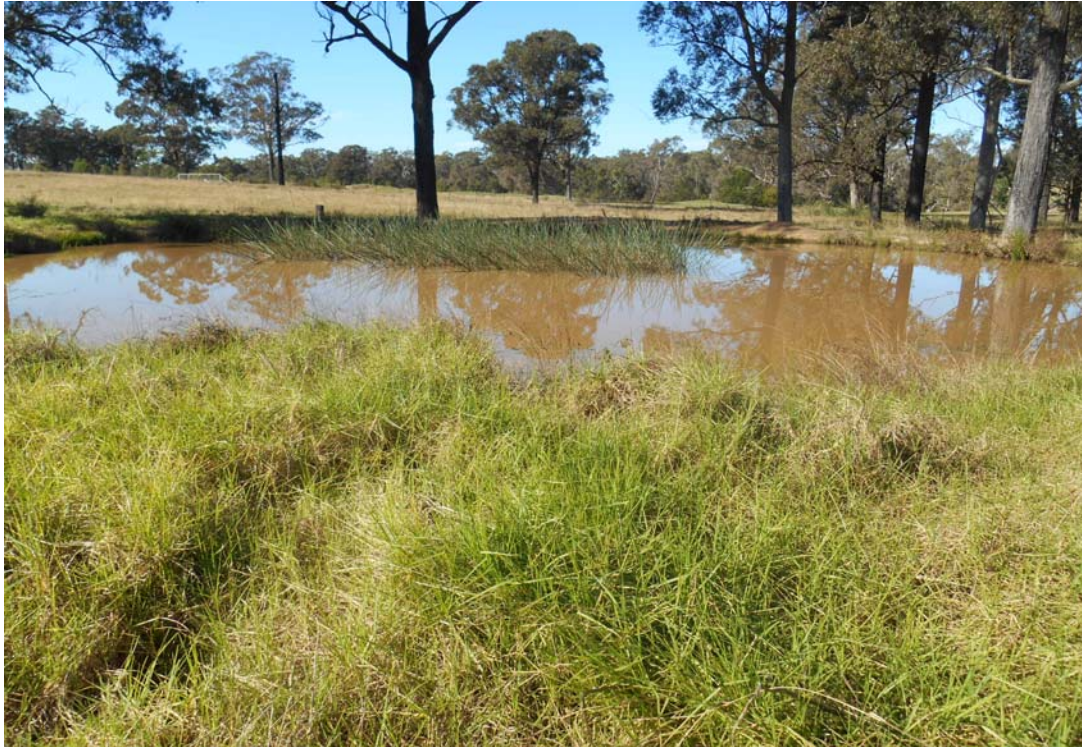
Photograph 27 - Small dam

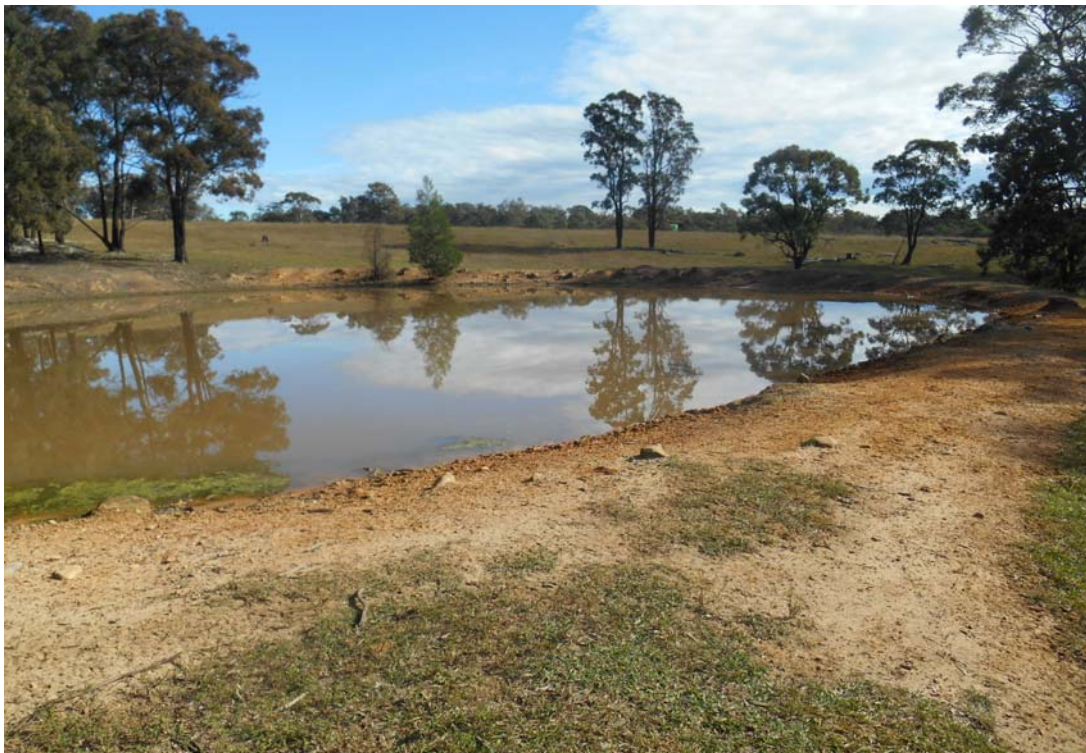
The northern end of the western Future Development Area was subject to horse grazing. Rock outcrops were observed at this part of the site. A dam (E: 287190, N6211715) (see Photograph 28, Appendix B) and grass-covered small soil and rock mounds (one at E: 287430, N: 6211461 and four at 287319, N: 6211586) (see Photographs 29 and 30, Appendix B) were observed. Anthropogenic materials were not observed on the surface of the soil mounds.

Photograph 28 - Dam at North of Western Future Development Area

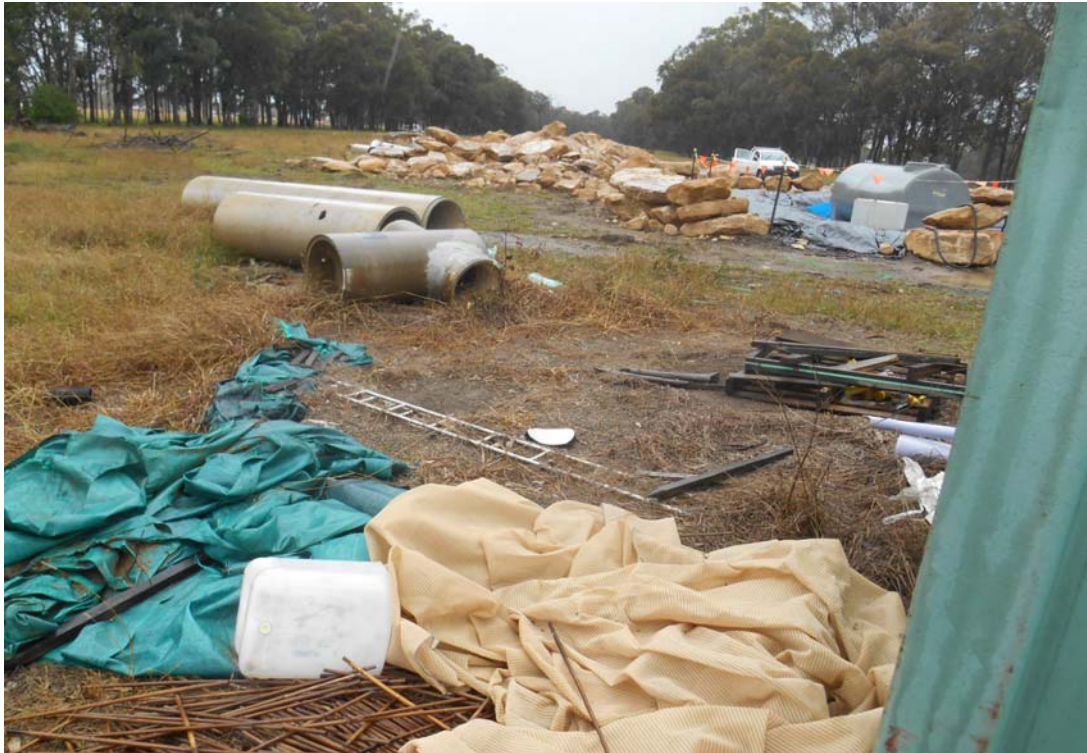
Photograph 31 - Contractor storage area

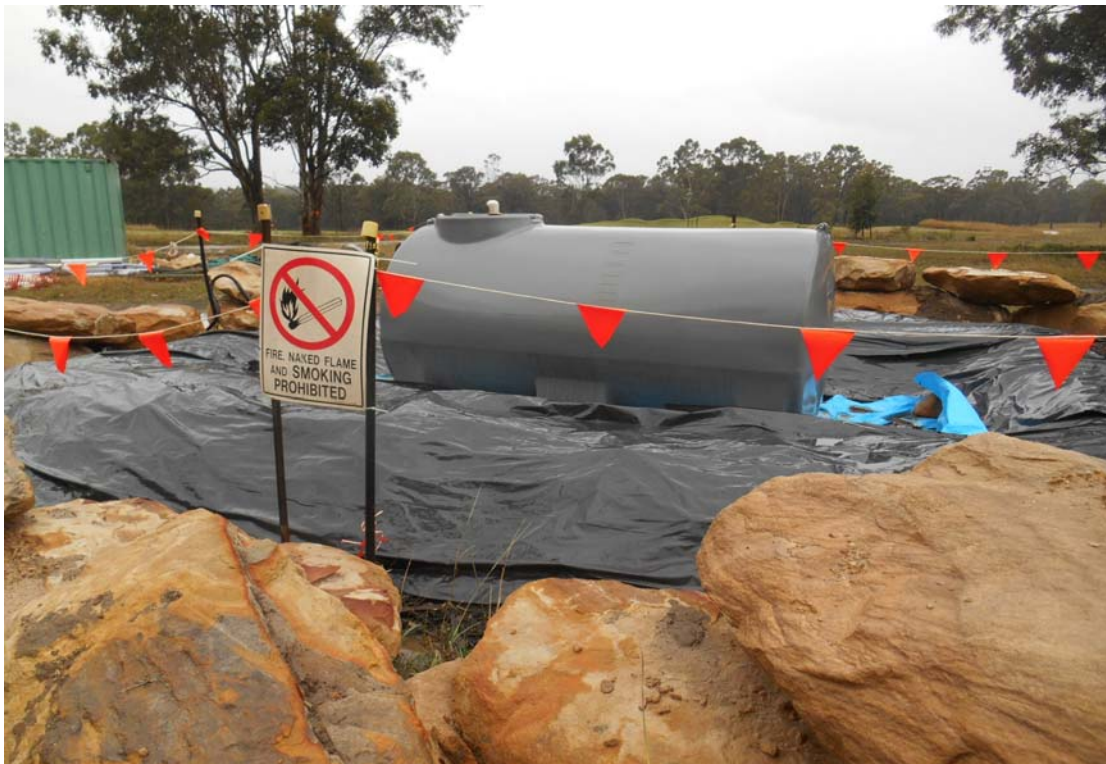
Photograph 32 - Aboveground tank

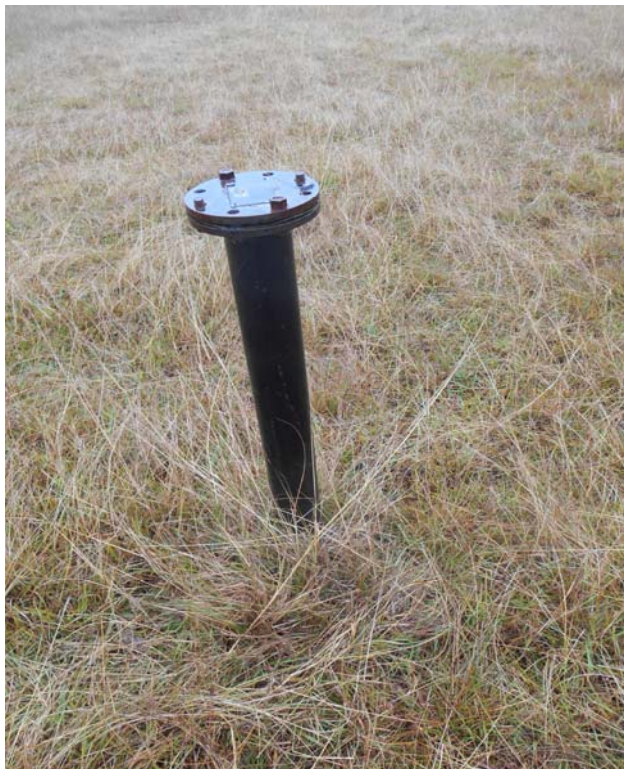
A sealed standpipe, labelled as a bore, was observed in an open, grassed area (E: 287670, N: 6210480) (see Photograph 34, Appendix B).

Photograph 34 - Standpipe (bore)

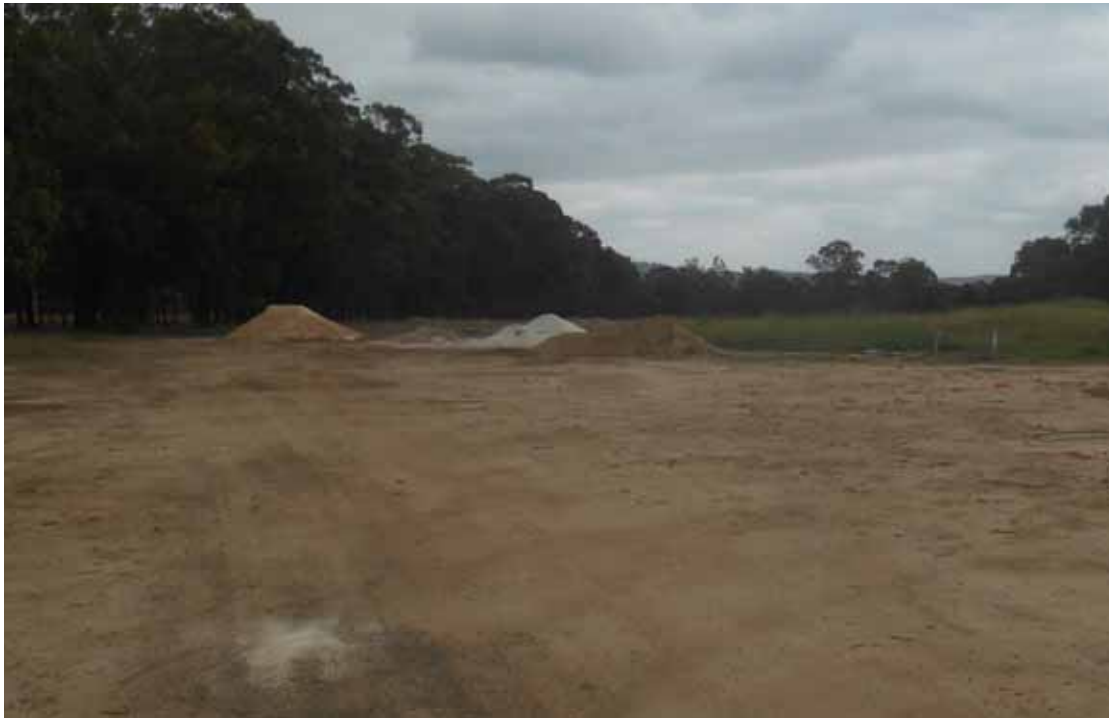
- Some small stockpiles had been removed from the dam wall at the western Future Development Area; and
- Some additional (imported) sand stockpiles were observed at the contractor storage area at the eastern Future Development Area (Photograph 41, Appendix B).

Photograph 41 - Stockpiles at contractor storage area, western Future Development Area
