TECHNICAL REPORT

GEOTECHNICAL FEASIBILITY STUDY

REMEMBRANCE DRIVE and ARGYLE STREET, PICTON, NSW

Project No.: 2022-095

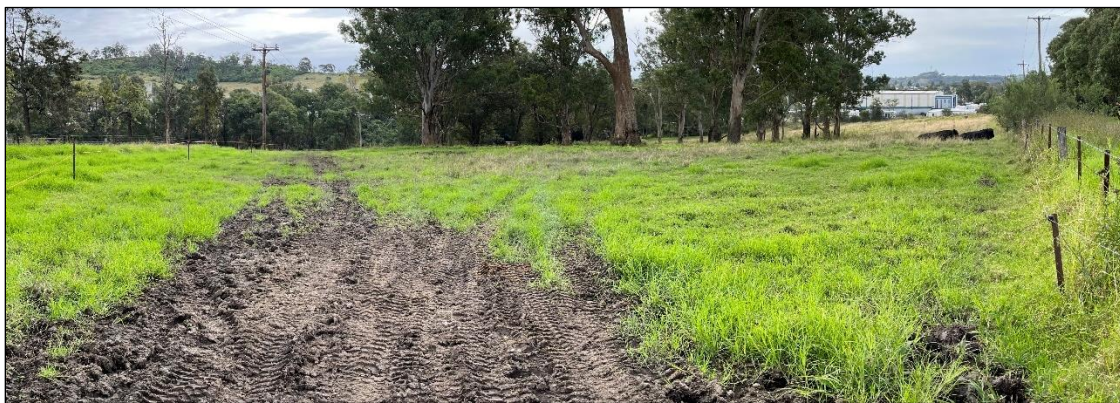
Photograph 2: View looking north to east from near the south boundary of Lot 10 DP583245

Signs of excessive erosion, potential areas of landslip, discoloured grass/vegetation were not observed within the lot. A watercourse (Redbank Creek) lies adjacent to the north boundary of the lot. Areas of suspected fill were not observed from outside the lot.

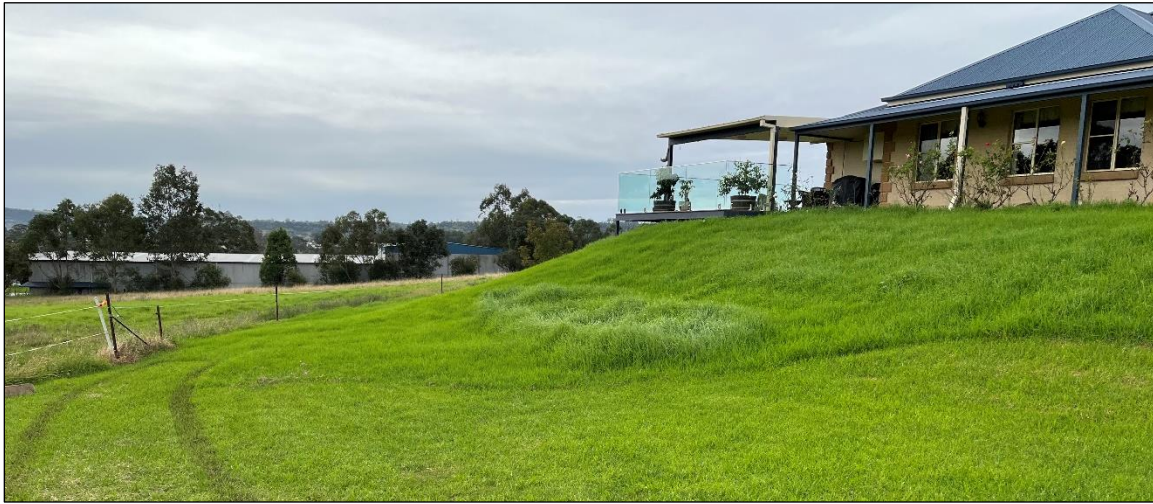
The ground surface surrounding the main residence and rear shed to the east appeared elevated in comparison with the adjacent properties/natural contours. It has been interpreted that some minor cut/fill of the lot has been undertaken previously in order to construct a level construction pad.

Photograph 5: View looking north from near the main residence within Lot 2 DP583247

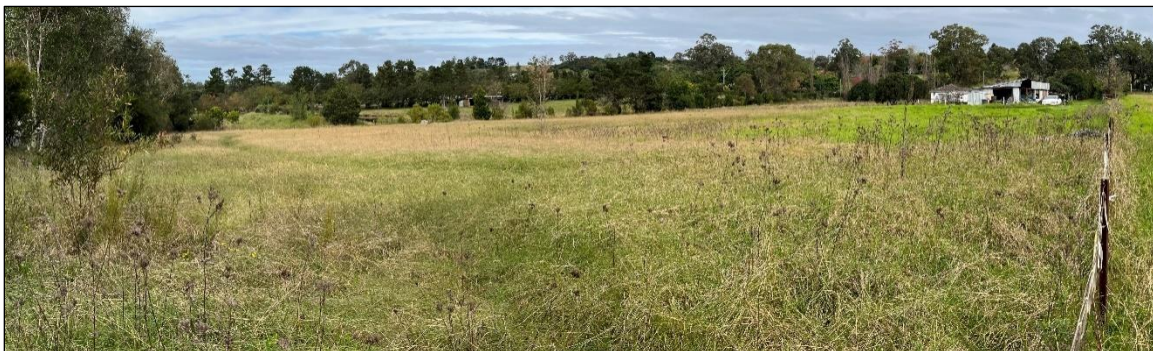
Photograph 20: View looking south to west from near the center of Lot 11 DP1121899

Signs of surface erosion or potential landslip movements were not observed. No areas of discoloured grass or vegetation were observed to indicate the presence of potential contaminants or elevated salinity. The area directly to the south of the area of suspected fill appeared wet underfoot in comparison with the rest of the lot.

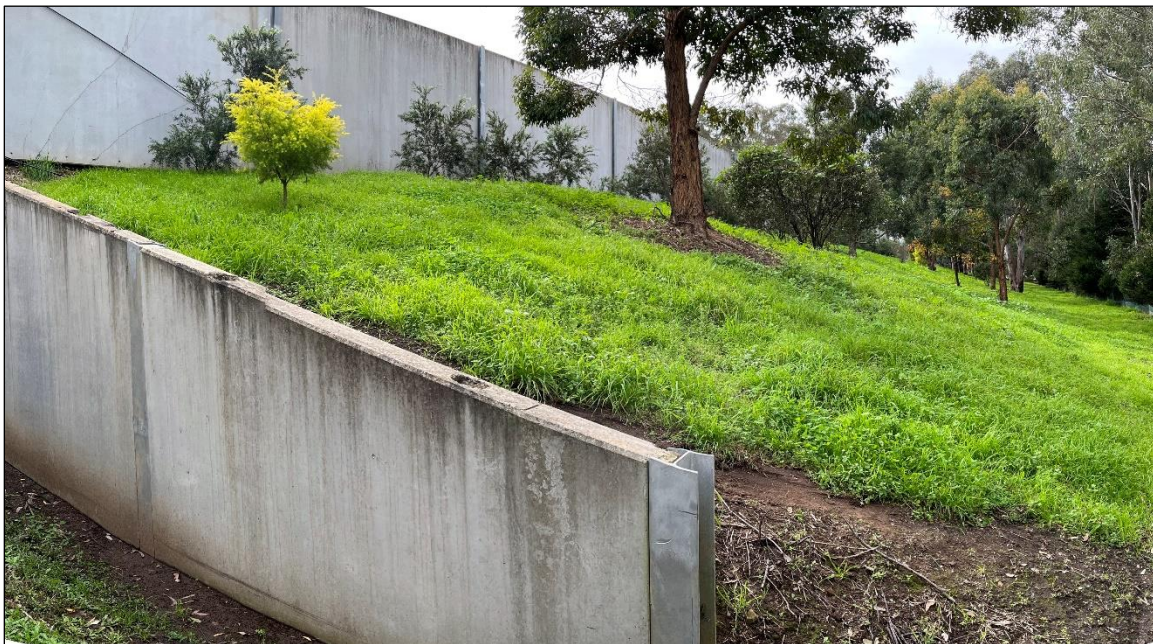
Photograph 23: View looking east from near the southwest corner of Lot 910 DP1121899

A fill batter sloping at around 12° to the south is present adjacent to the south end of the lot which did not appear to be slumping or displaying significant signs of erosion. Drainage within the site appears to be collected via a series of grated drains then diverted off site via an open drainage channel located within the southeast corner of the lot.

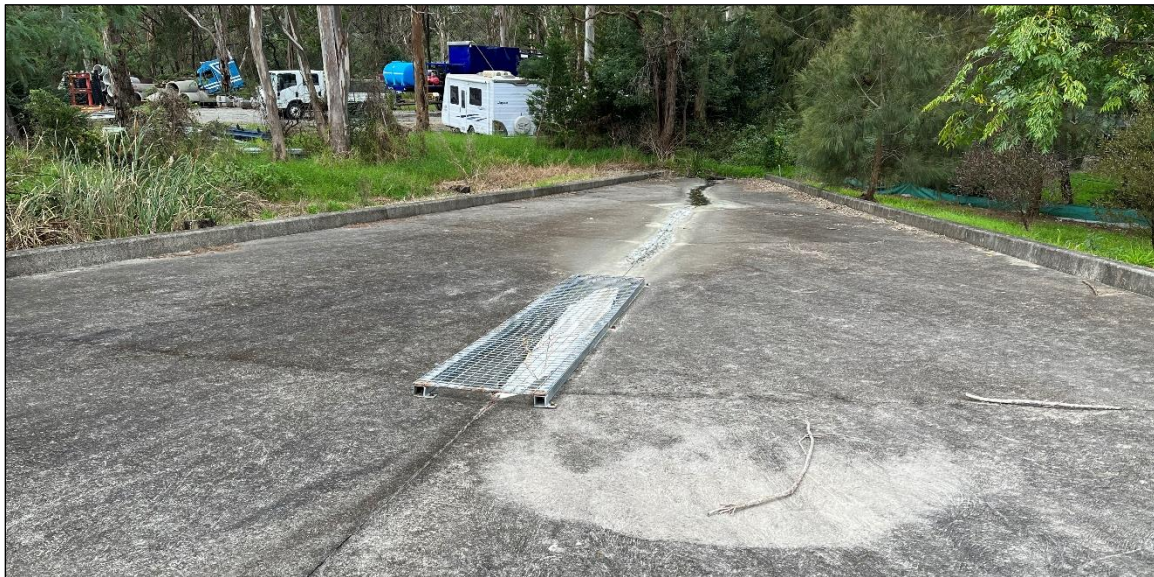
Photograph 24: View of the drainage channel within the southeast corner of Lot 910 DP1121899

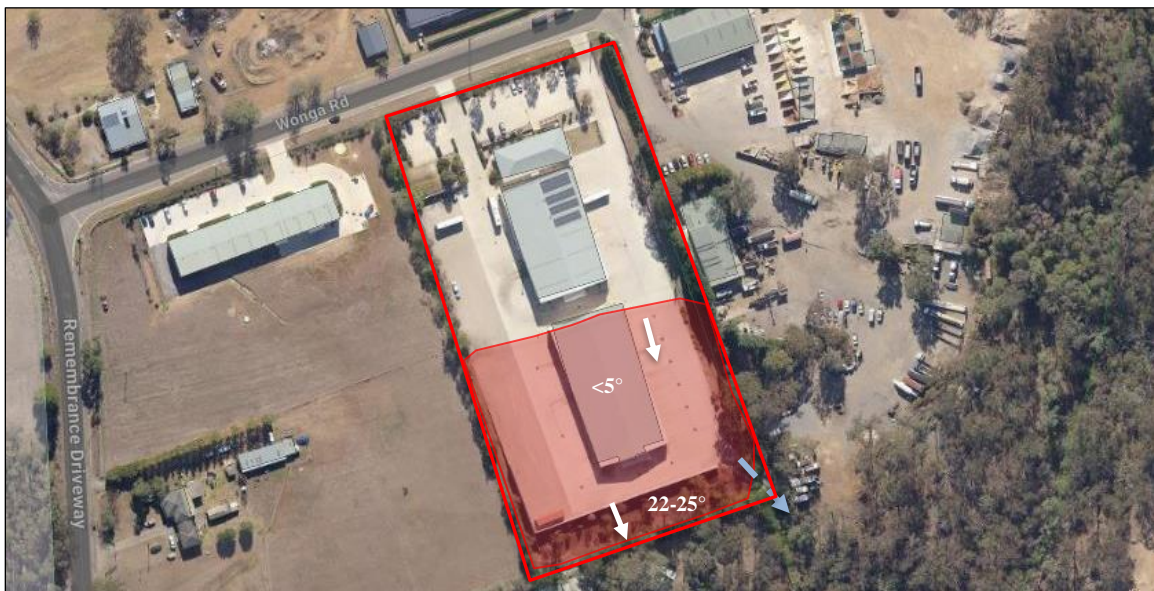
The existing slab did display some cracking and some evidence of cracking of the existing retaining wall within the southwest corner of the lot was observed.

Photograph 25: Aerial view of Lot 910 DP1121899

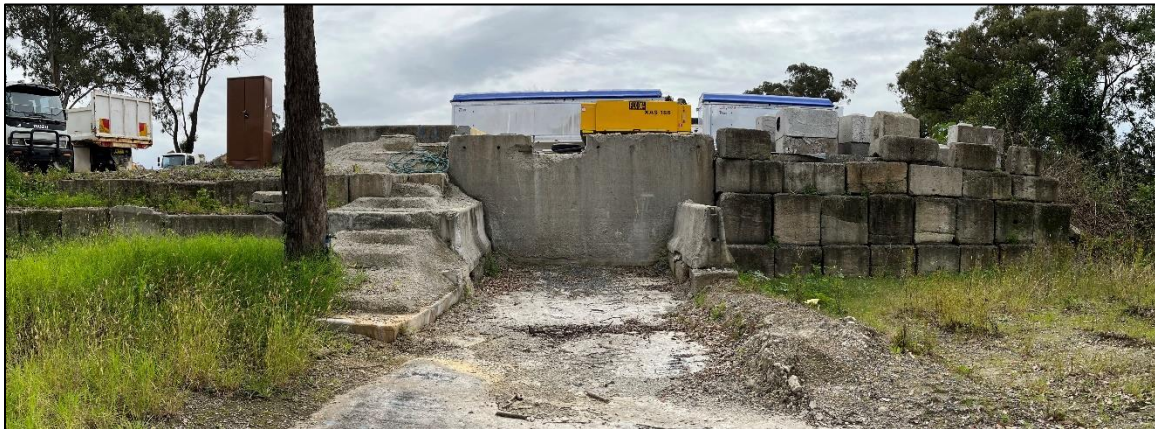
In general, the ground surface dips from north to south at $<5^\circ$ and it appears (although unconfirmed) that the useable space may have been extended in a series of cut/fill modifications which, in one area was supported by a concrete/blockwork retaining wall up to around 2.5m in height.

Photograph 28: View of the retaining structure within the south of Lot 2 DP570466

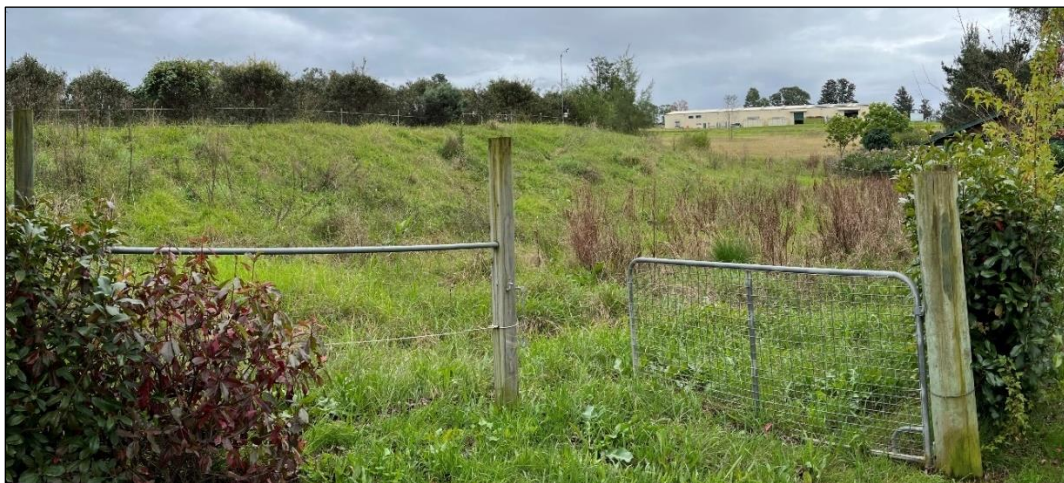
The pond is approximately 40m in length (maximum dimension) and it appears that excavated material has been apparently deposited to the east of the excavation, creating an approximately 2-3m high detention bund with batter slope.

Photograph 31: View of the south side of the pond within Lot 11 DP3007 looking north from near the site access driveway.

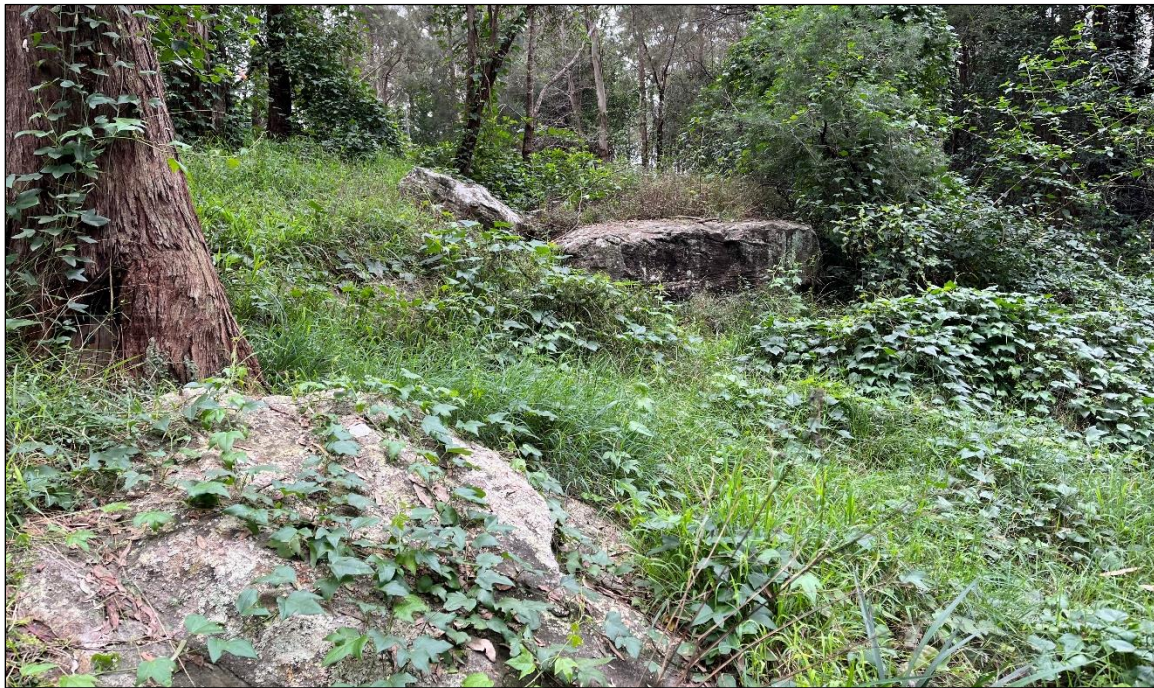
Within the east of the site, a stream is present in which exposed bedrock was observed and the topography increased in steepness. The bedrock comprised low to medium strength sandstone which was also observed outcropping within the adjacent bushland.

Photograph 32: View of bedrock exposures within Lot 11 DP3007 looking east from south of the site residence

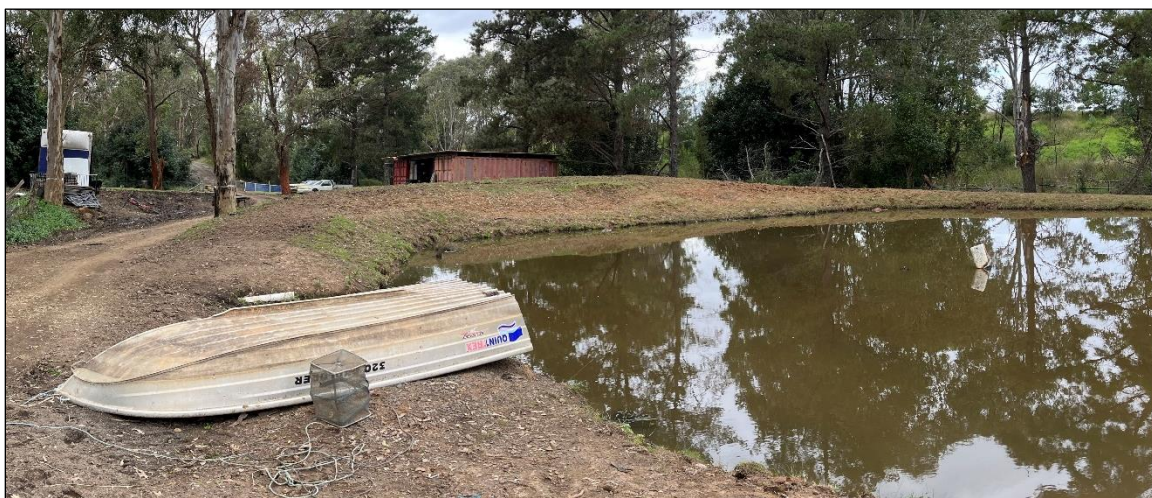
This lot is the largest lot in the study area and can be separated into two areas. It contains two single storey residential dwellings and pond within the west of the lot and overgrown bushland with temporary structures within the east of the lot. The ground surface within the east of the lot sloped to the east and west, either side of a broadly north-south trending ridgeline between approximately RL172m and RL210m. Within the west of the lot the terrain displays a gentle west to east dip between approximately RL218m and RL208m. The ground surface within the west of the lot did not appear significantly altered/filled however some excavated spoil was associated with the pond excavation and construction.

Photograph 34: View of existing pond within Lot 1 DP570466 looking east from south of the site residence

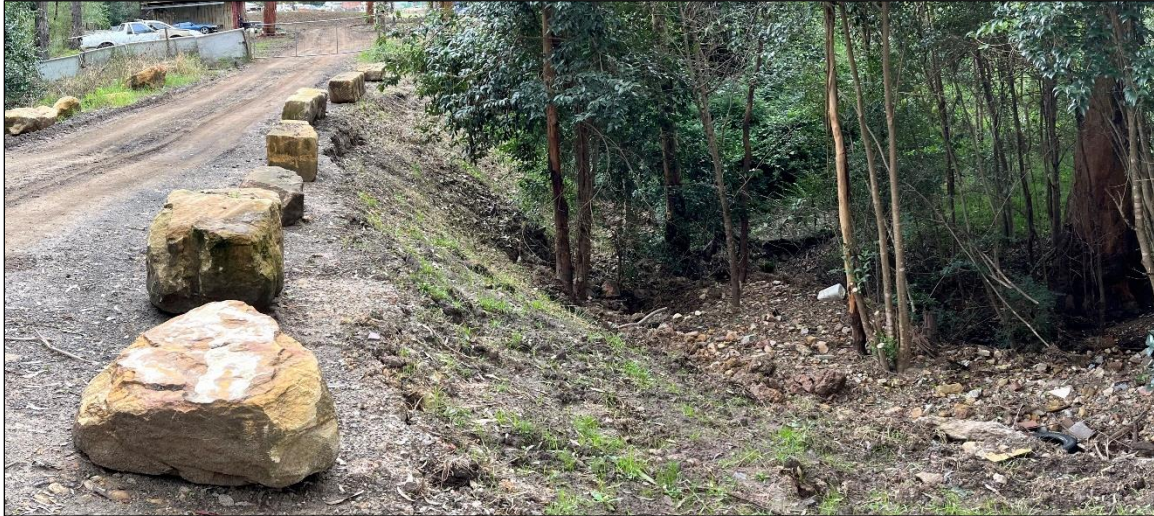
Access to the east portion of the site is provided by an earth fill bridge which traverses a small creek which runs broadly north south through the center of the lot (separating the east and west portions) draining from a large dam in an adjacent property to the south and outside the study area. Some minor slumping of the earth bridge was observed near the crest of the fill.

Photograph 35: View of the earth bridge with Lot 1 DP570466 looking west

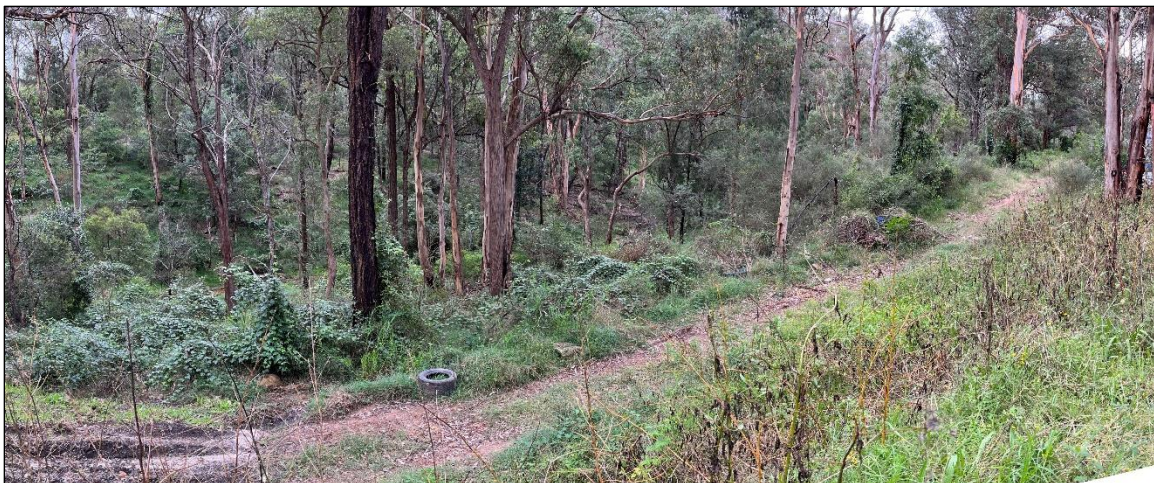
In situ bedrock comprising low to medium strength sandstone was observed within the east of the lot at numerous locations. The surface of the site appeared generally well drained. Standing water or significant soft spots were not observed during the site walkover with the exception of the small creek passing through the center of the lot. Densely vegetated areas of variable steepness up to 15° were located to the east and west of the ridgeline.

Photograph 36: View of a densely vegetated slope towards the west boundary of Lot 1 DP570466 looking west
