ABBOTSFORD

GEOTECHNICAL ASSESSMENT – PICTORIAL

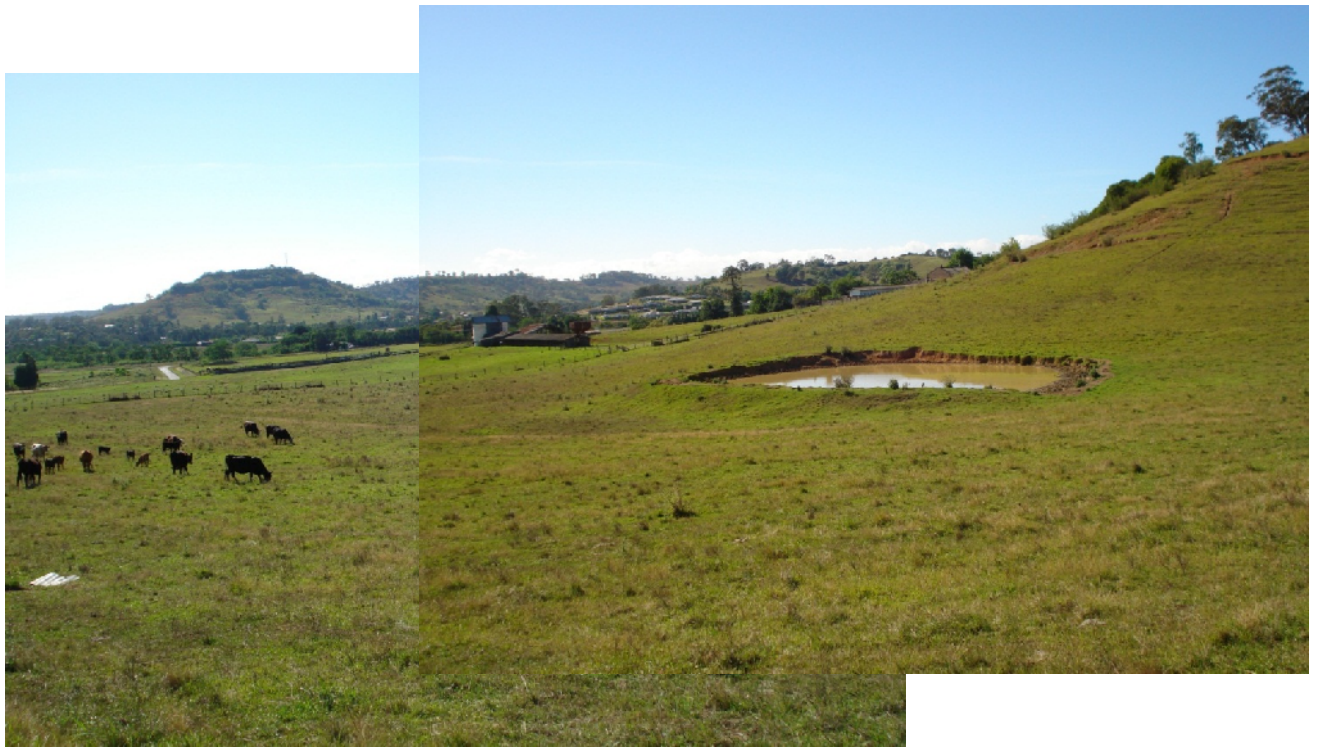
Plate 1: Looking south-easterly at Abbotsford Dairy. Valley floor around dam is suitable for development.

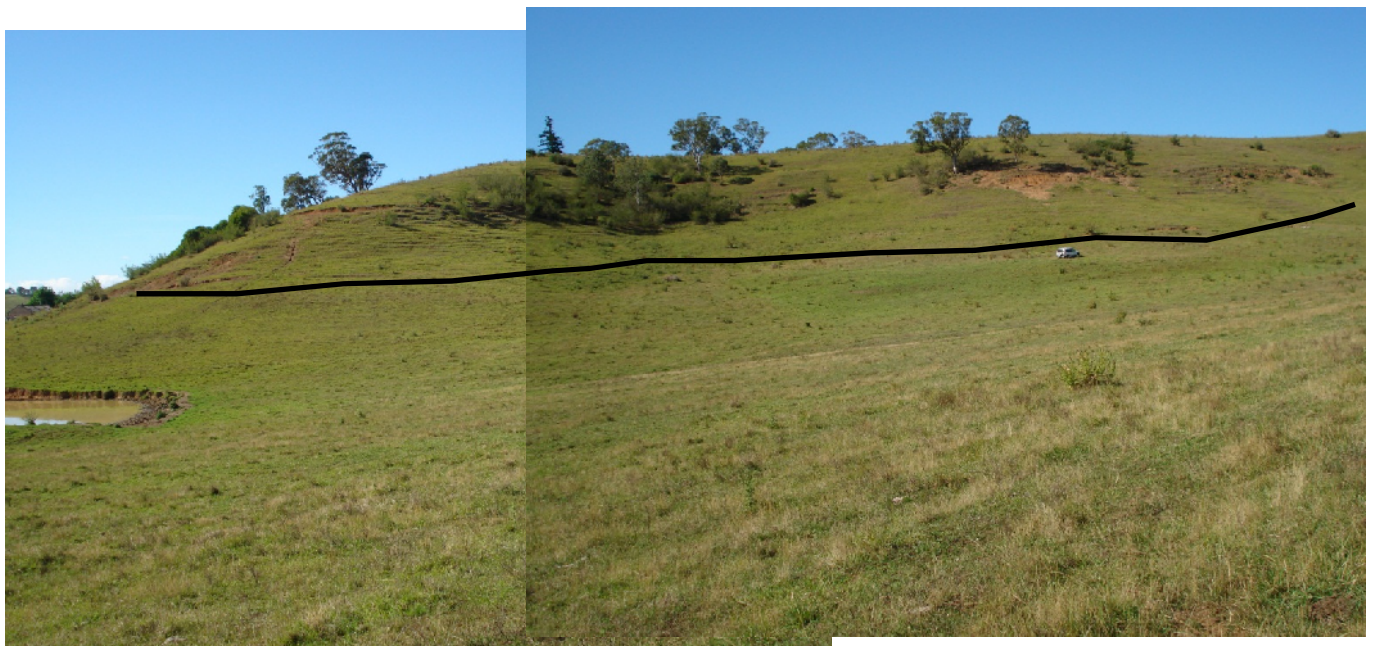
Plate 2: Looking southerly at valley floor and steep (>20%) side slopes. Approximate position of building line indicated.

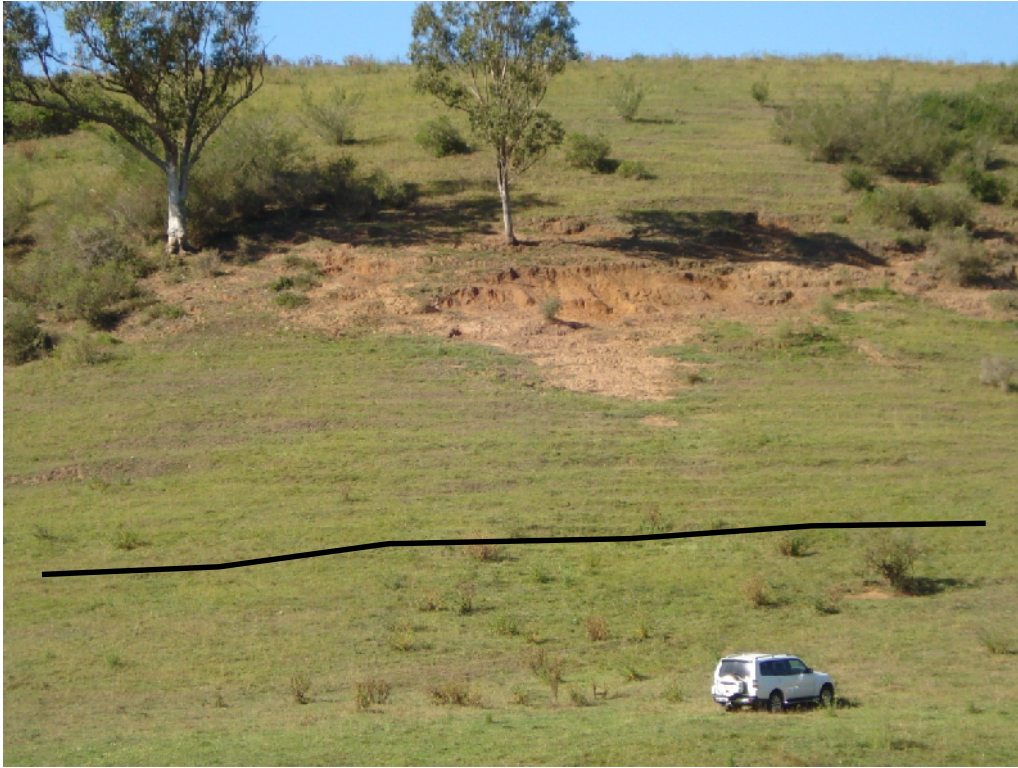
Plate 3: Close up of steep side slopes with typical high levels of erosion and slumping. Slope above line is $>20\%$ and falls within VH Risk of Instability Zone. No development should be allowed on these slopes.

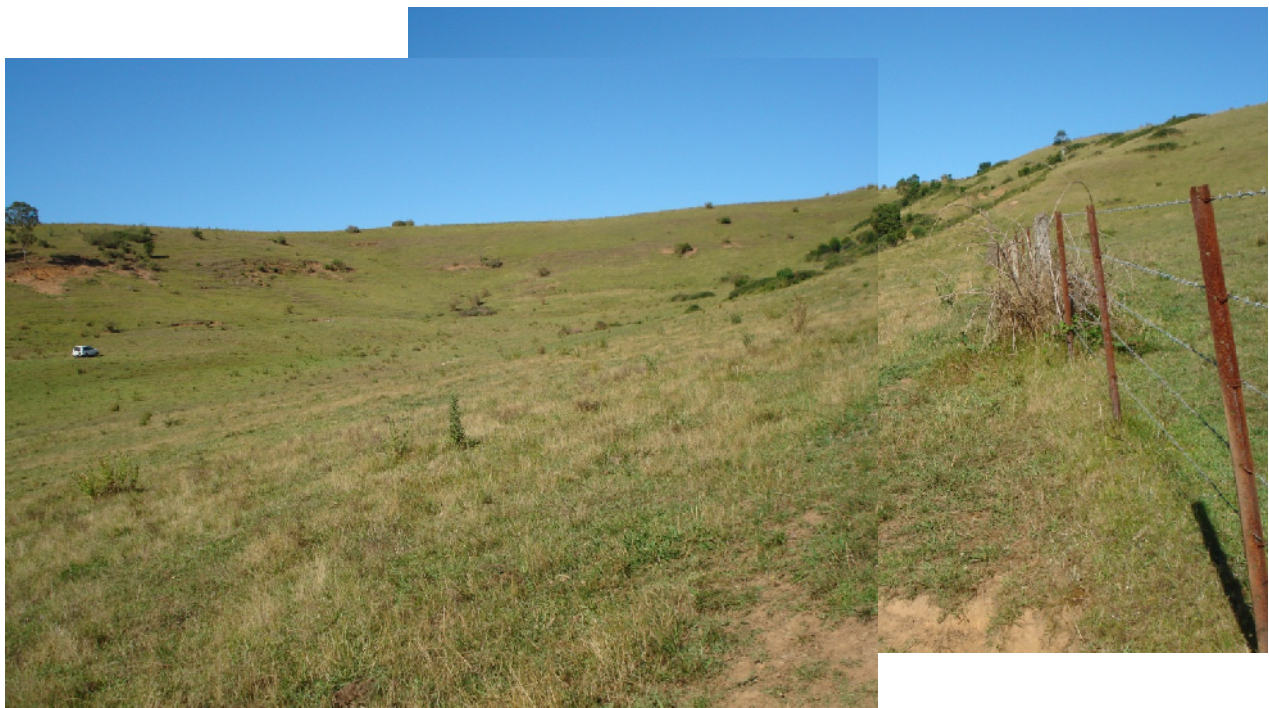
Plate 4: Looking westerly. Fence line is close to building line, with slopes on Left Hand Side being $<20\%$.

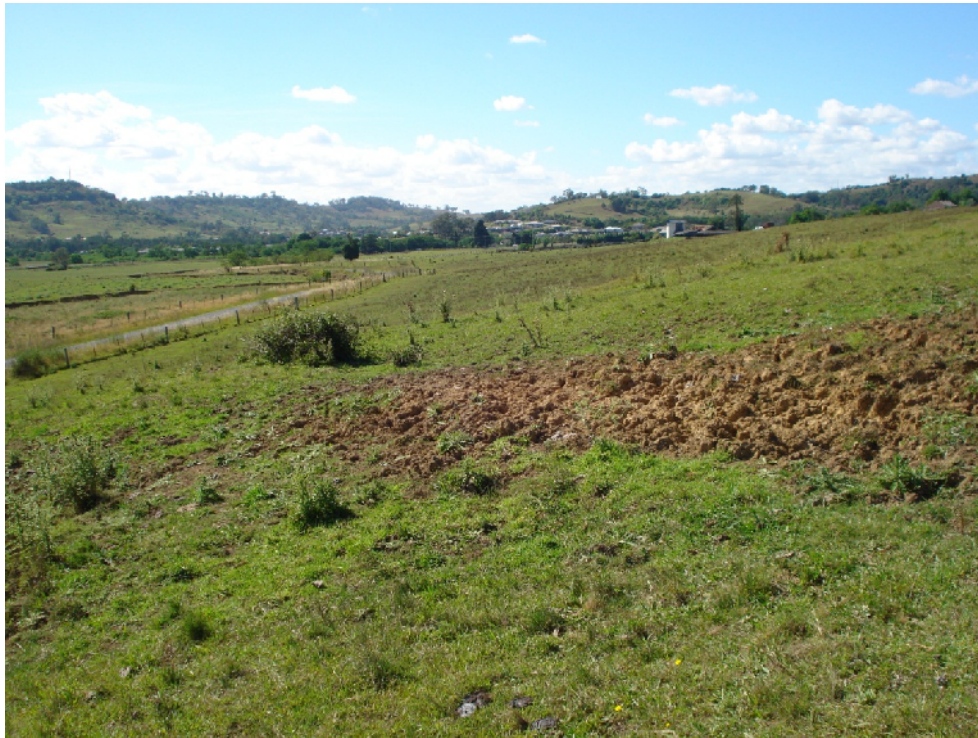
Plate 5: Looking south-easterly towards Picton, showing significant slumping in foreground – probably exacerbated by high moisture levels.

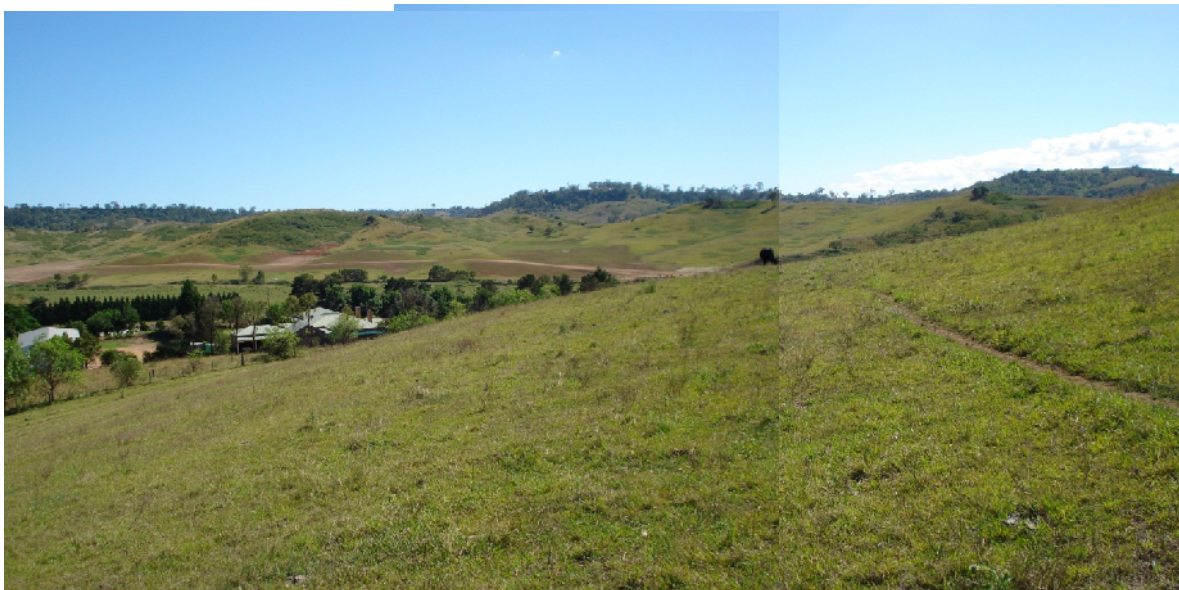
Plate 6: Looking north-easterly at suitable building site – cross fall is approximately 10%.

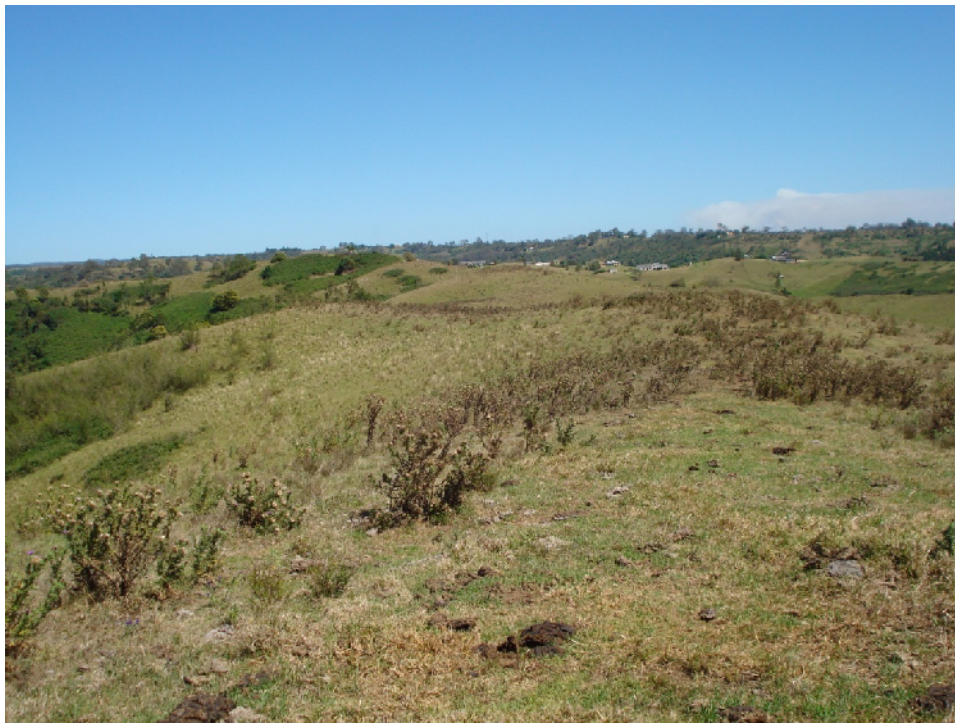
Plate 7: Looking westerly along ridge top. Ridge tops are suitable for access roads, but often too narrow to support building development.

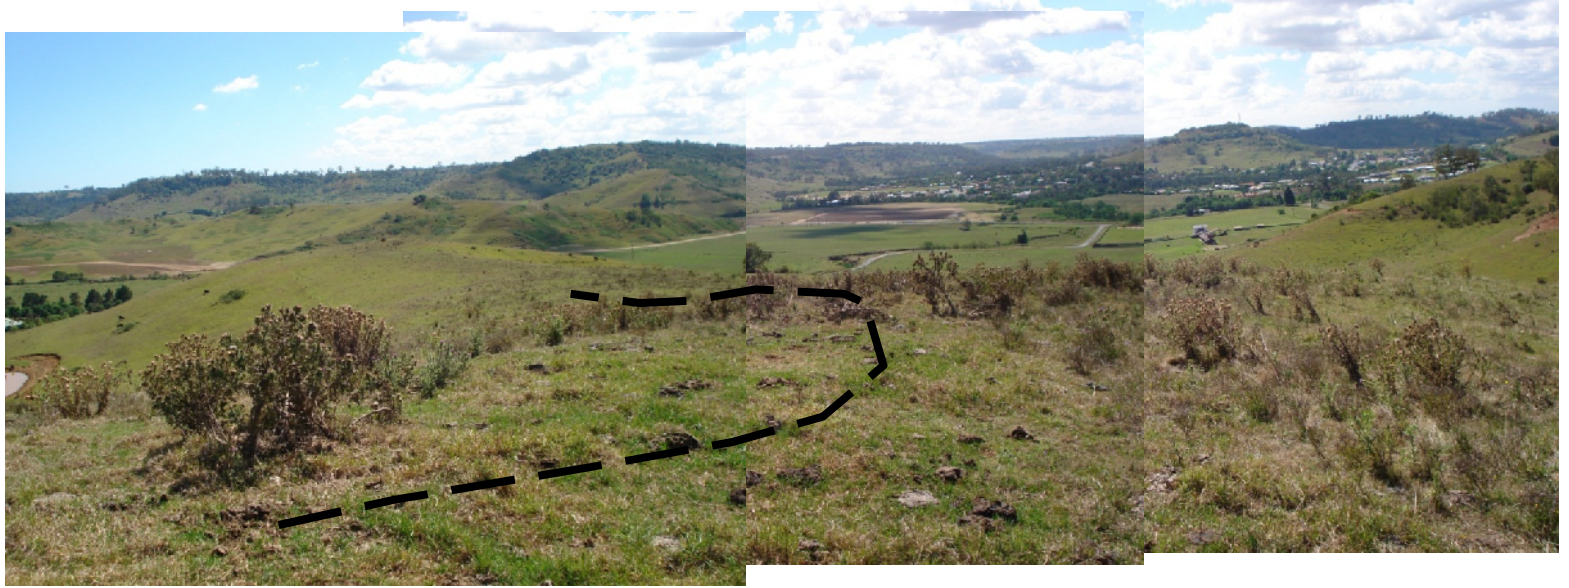
Plate 9: Looking north-easterly along ridge line (see dashed line). Potential for development site is good.

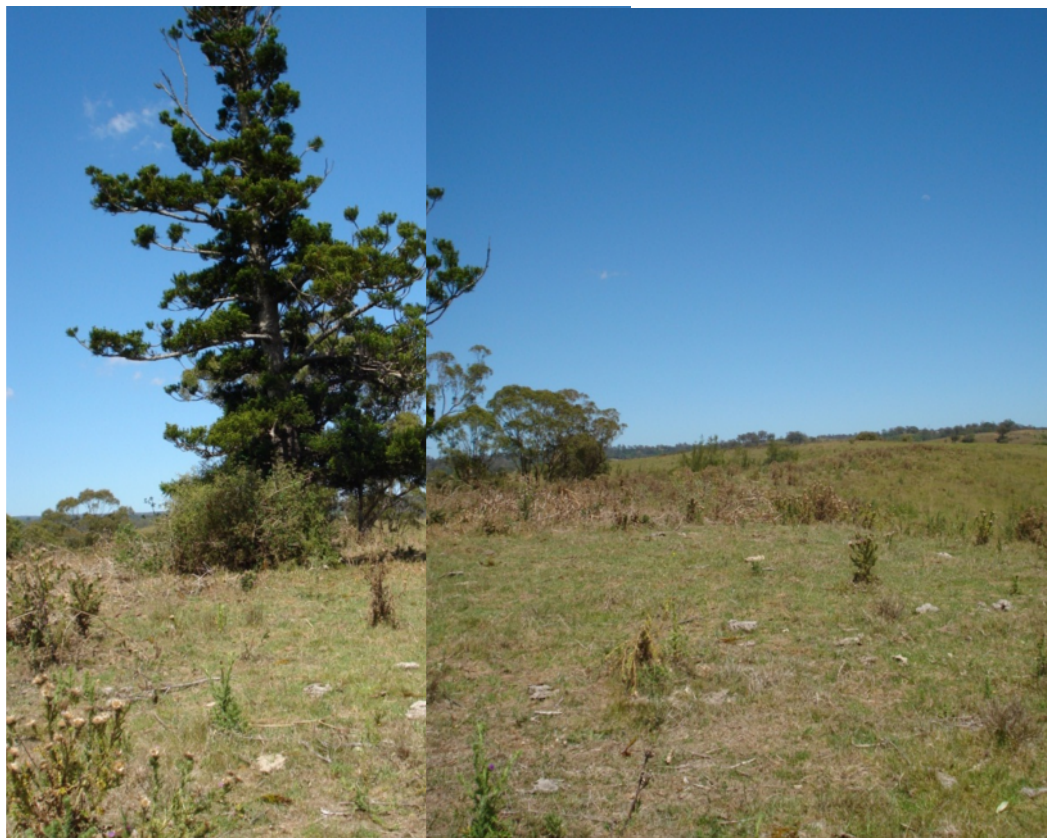
Plate 10: Looking westerly along ridge line. This area has potential for development.
