Moonshine 7

Moonshine 7A

Legacy Well Inspection Card

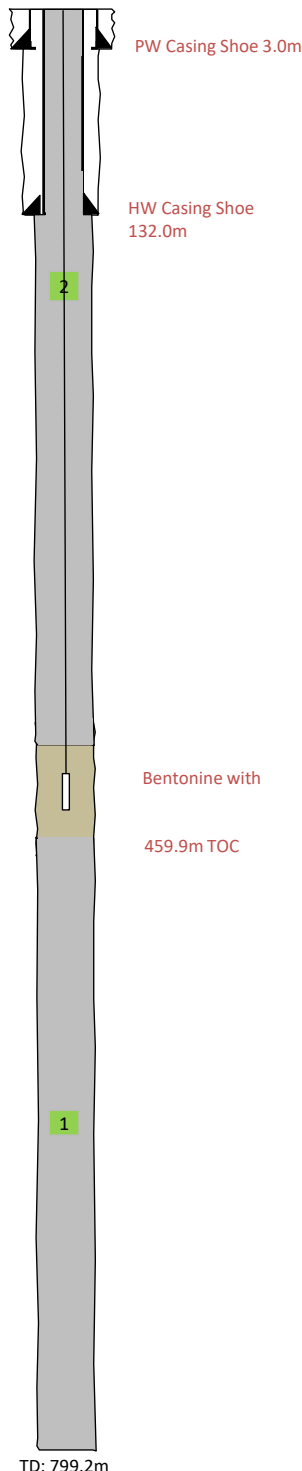
The well was inspected on the 29th of May, 2015. Subsidence visible at cellar location but no evidence of well at surface. Inspection did not locate any remaining well infrastructure (including Piezo cable) at location

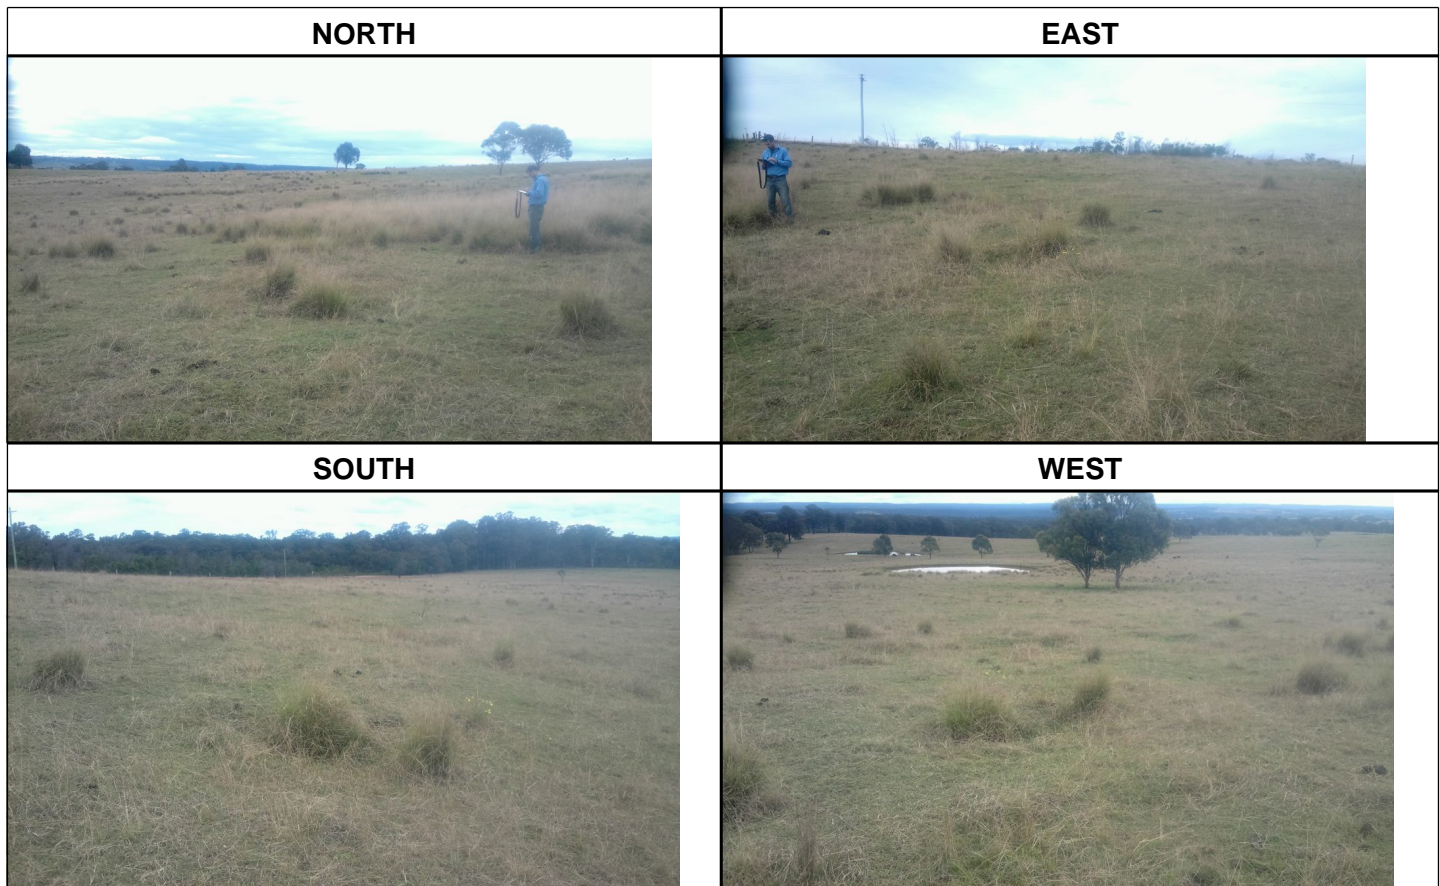
Comments: Subsidence visible at cellar location. P&Ad below ground.
