Job No: 14305/1&2 Our Ref: 14305/1&2-L1 7 November 2018

re: Proposed Stages 1 to 4 Residential Subdivision Part Lots 201 & 202 in DP590247 Station Street, Menangle Progress of Detailed Contamination Assessment

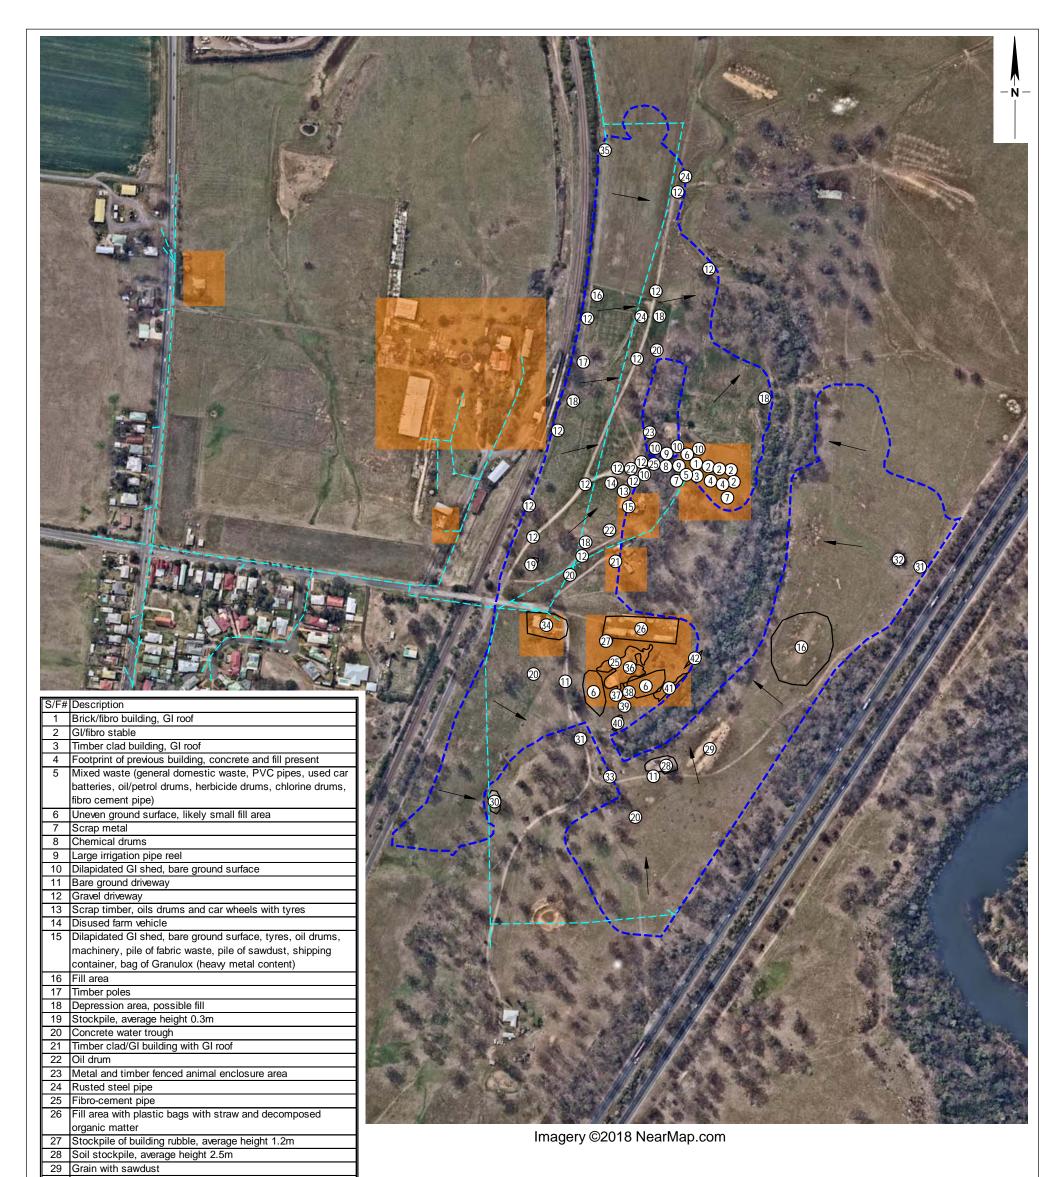
Observed site features in proposed stage proposed Stage 1 Development Area (in part Lot 201 in DP590247) and in proposed Stages 2 to 4 Development Areas (in part Lot 202 in DP590247), are shown on attached Drawing Nos 14305/1-AA1 and 14305/2-AA1 respectively. Areas of environmental concern as identified by EIS are also shown on the drawings.

Judgemental Sampling in the Proposed Stage 1 Development Area					
S/F#	Description	Sampling points	Remarks		
1	Uneven ground surface, likely fill area	7			
2	Scrap metal	2			
3	Gravel driveway	3			
4	Scrap timber, oils drums and car wheels with tyres	1			
5	Fill area	6			
6	Depression area, possible fill	6			
7	Dam	3 in the dam, 6 in dam wall, 10 in dam sediment stockpile	Sampling of dam water (before breaching), dam wall (after breaching) and dam sediment (after breaching and stockpiling the sediment)		
8	Concrete water trough	-			
9	Concrete driveway	2	Post Demolition		
10	Clad/fibro building, GI roof	3	Post Demolition		
11	Dilapidated GI/timber structure with scrap metal and car tyres surrounding	3	Post Demolition		
12	Bitumen road	3			
13	Rusted metal trough	1			
14	Dilapidated GI sheds	4	Post Demolition		
15	GI above ground storage tank	2	Post Demolition		
16	Timber clad building, GI roof	1	Post Demolition

17	Scrap timber	-			
	Power poles	4 per pole	After removing the poles from the ground.
