**GEOTECHNICAL FEASIBILITY STUDY**

**ARINA ROAD, BARGO, NSW**

**Wollondilly Shire Council**

**Project No.: 2022-098**

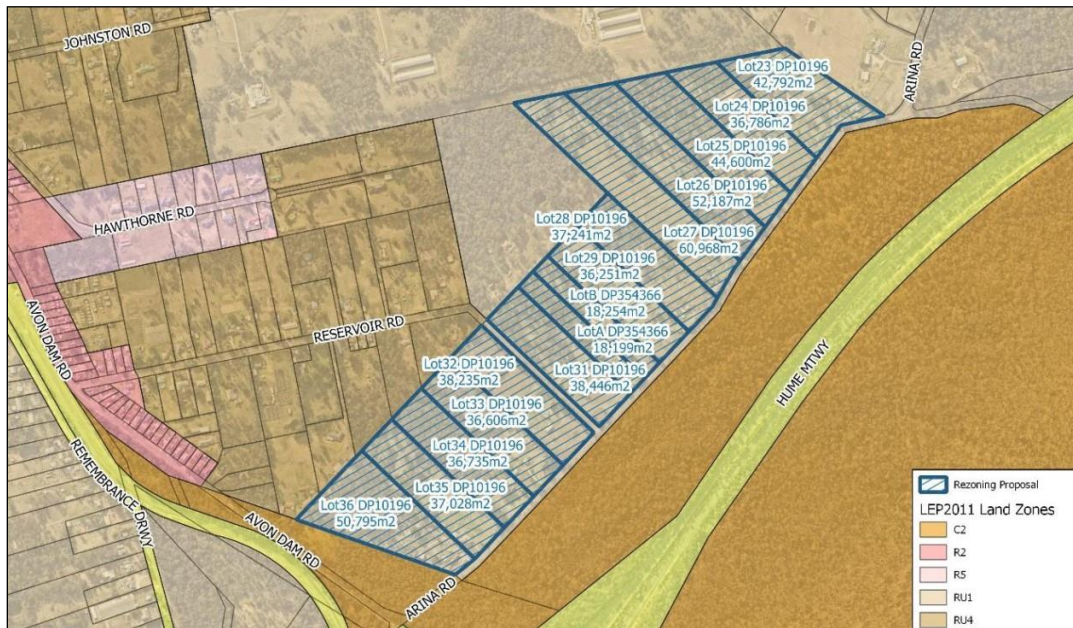
Photograph 1: Aerial view of the study area with lots overlain

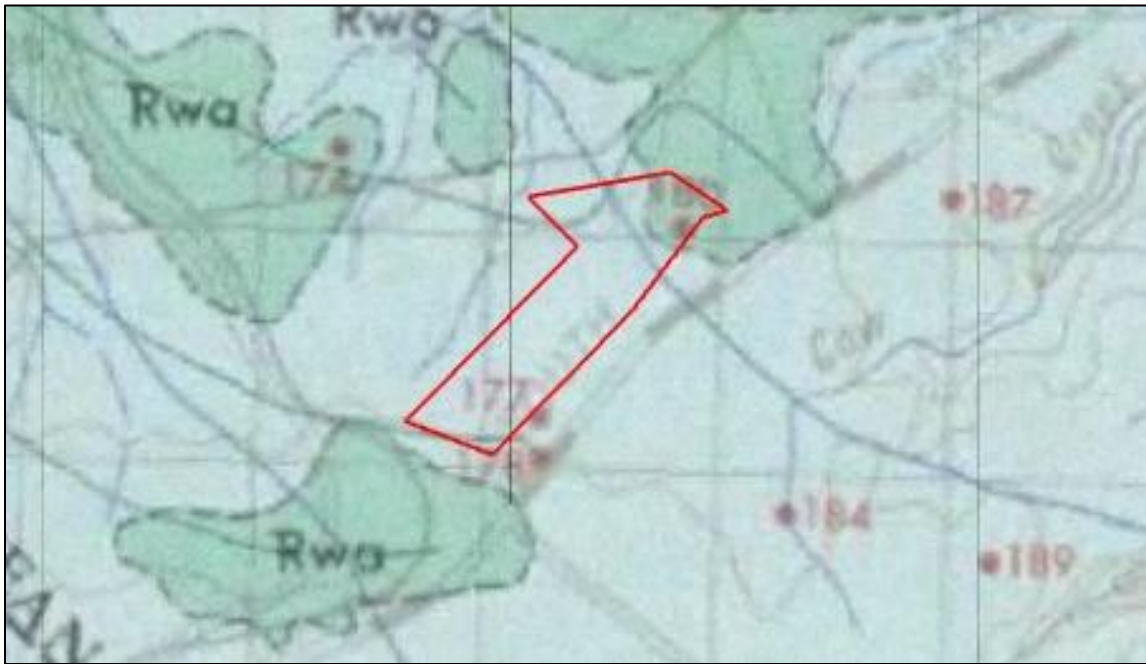
Extract 2: Extract from the Wollongong – Port Hacking Geological Series sheet (9029 - 9129) with site outlined red

Reference to the Wollongong – Port Hacking 1:100,000 Geological Series sheet (9029 - 9129) indicates that the majority of the study area is underlain by the Hawkesbury Sandstone (Rh) with a narrow section of the overlying Ashfield Shale in the extreme north east indicated underlying the study area.

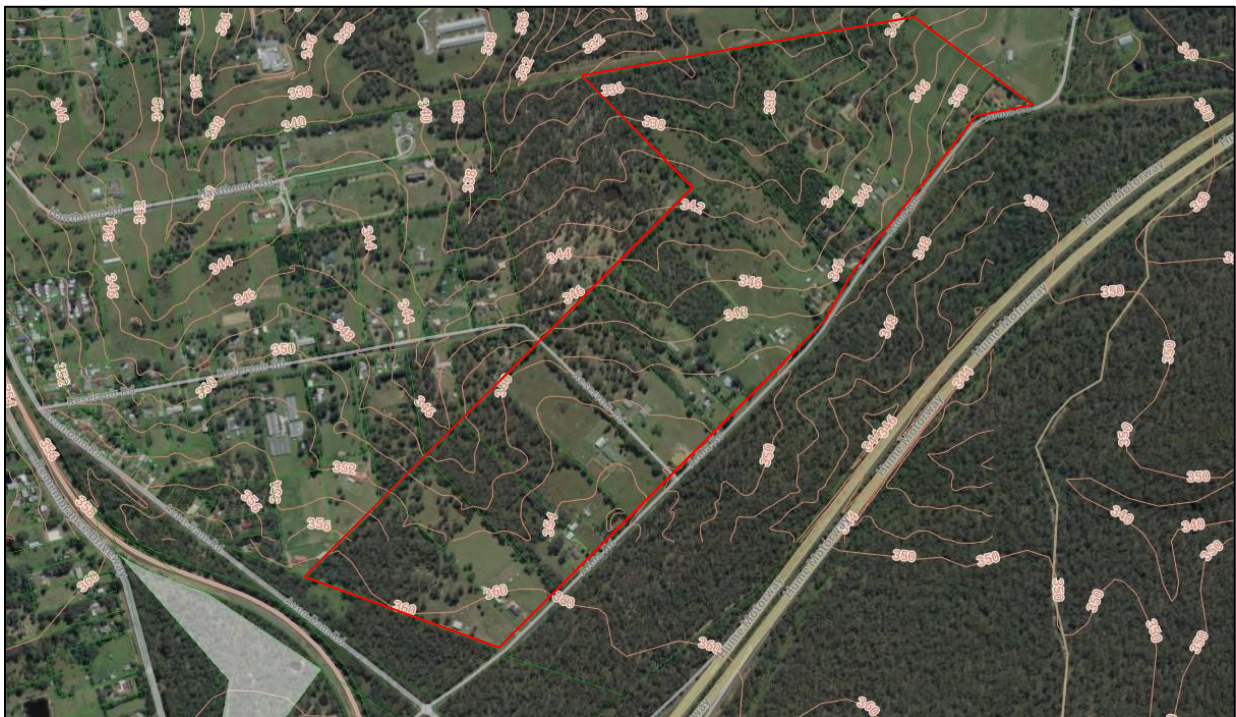
Extract 4: Extract of a contour map of the study area obtained from Mecore Mozaic

The study area lies within gently north sloping topography and varies between a high of RL360m adjacent to the south boundary and a low of RL334m adjacent to the north boundary. An extract of a topographic map of the area is provided as Extract 3 with a contour map provided as Extract 4.

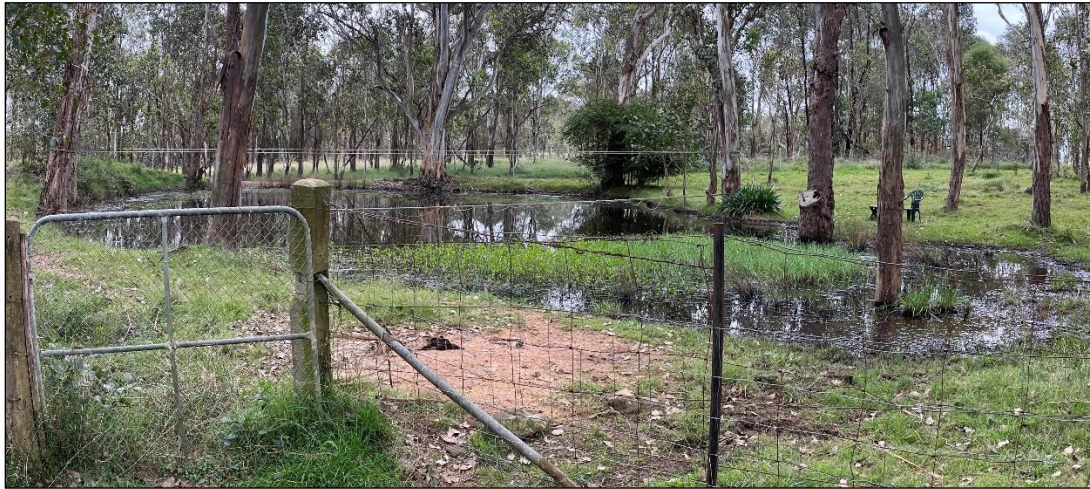
The lots are thin and narrow in shape and are occupied by residential properties with numerous horse compounds scattered throughout the lots. The majority of the areas within each of the lots appear undeveloped and comprise open paddocks or areas of bushland containing mature trees. Significant cut/fill earthworks do not appear to have been undertaken within the lots with the exception of some limited excavation works associated with ponds located within Lots 23, 25 and 26. Minor fill is also anticipated around the existing residences however it is expected to be relatively shallow and localised.

*Photograph 2: View of an existing pond within Lot 23 DP10196*

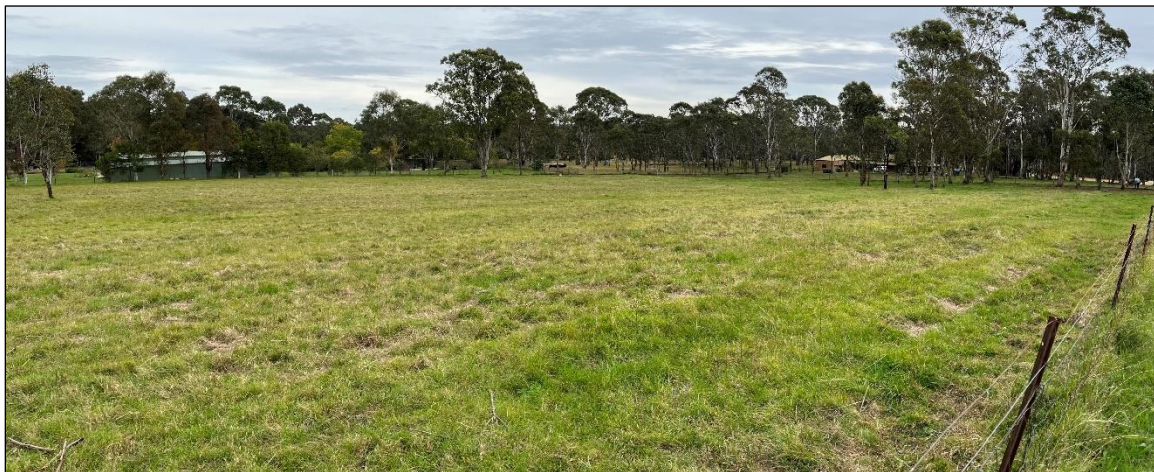
With the exception of the ponds, standing water or boggy areas were not observed during the site walkover. However, it is understood from the occupants of the lots that various portions of the properties are soft underfoot, particularly following rainfall events.

*Photograph 3: View of the front of Lot 24 DP10196 looking broadly northwest*

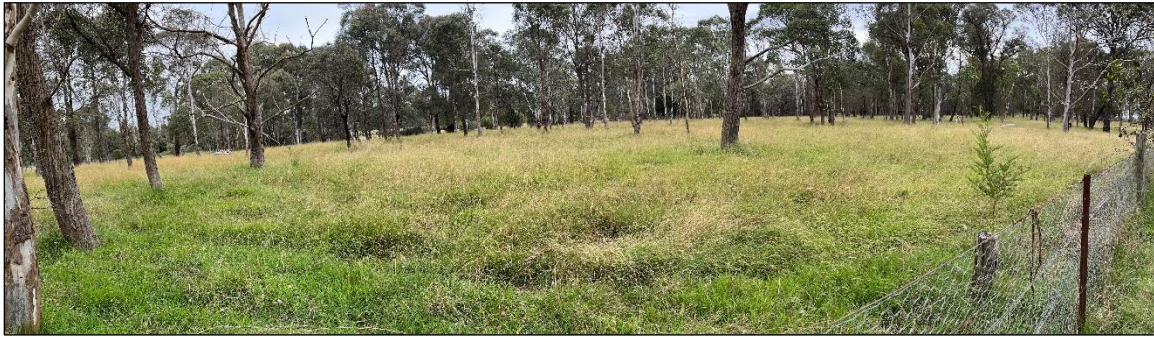
Inspection of the existing structures did not indicate any significant cracks to indicate excessive shrink swell movements of the founding soils. No signs of excessive surface erosion or potential landslip movements were observed. No areas of discoloured grass or vegetation were observed to indicate the presence of potential contaminants or elevated salinity.

*Photograph 4: View of Lot 25 DP10196 looking west*

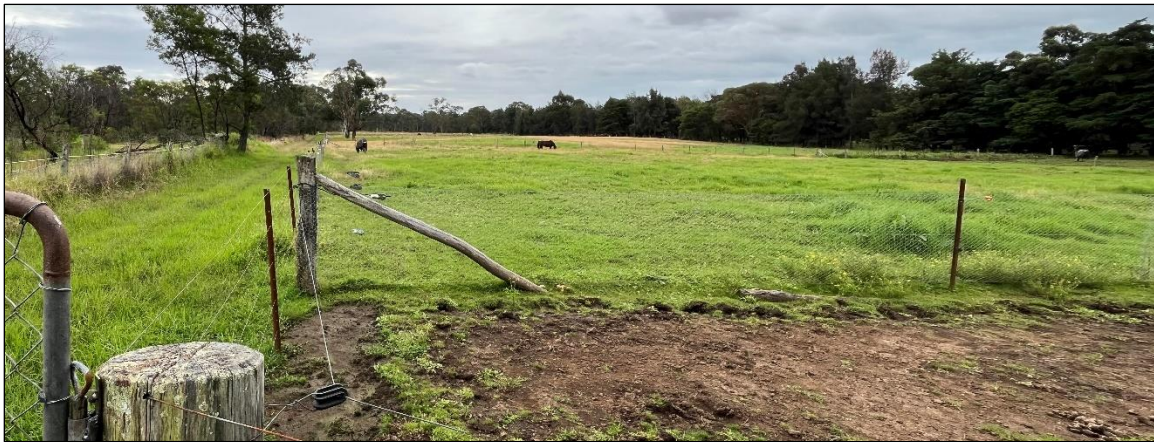
*Photograph 5: View of Lot 27 DP10196 looking broadly north from near the lot residence.*

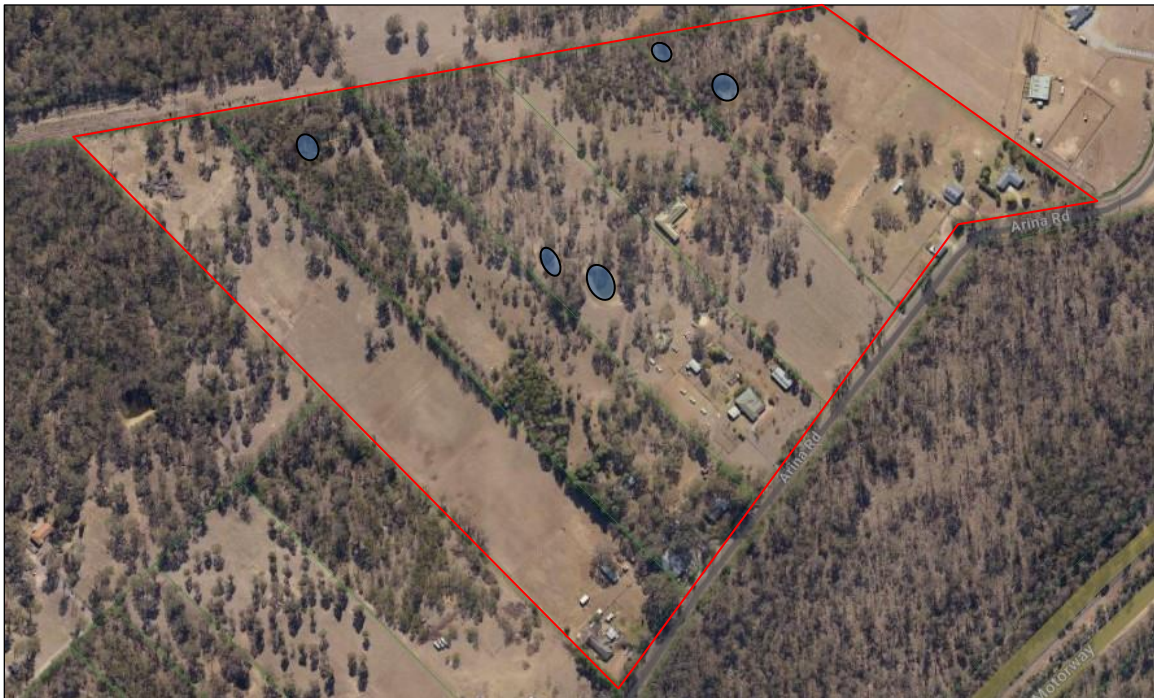
*Photograph 6: Aerial view of Lot 23 DP10196 to Lot 27 DP10196*

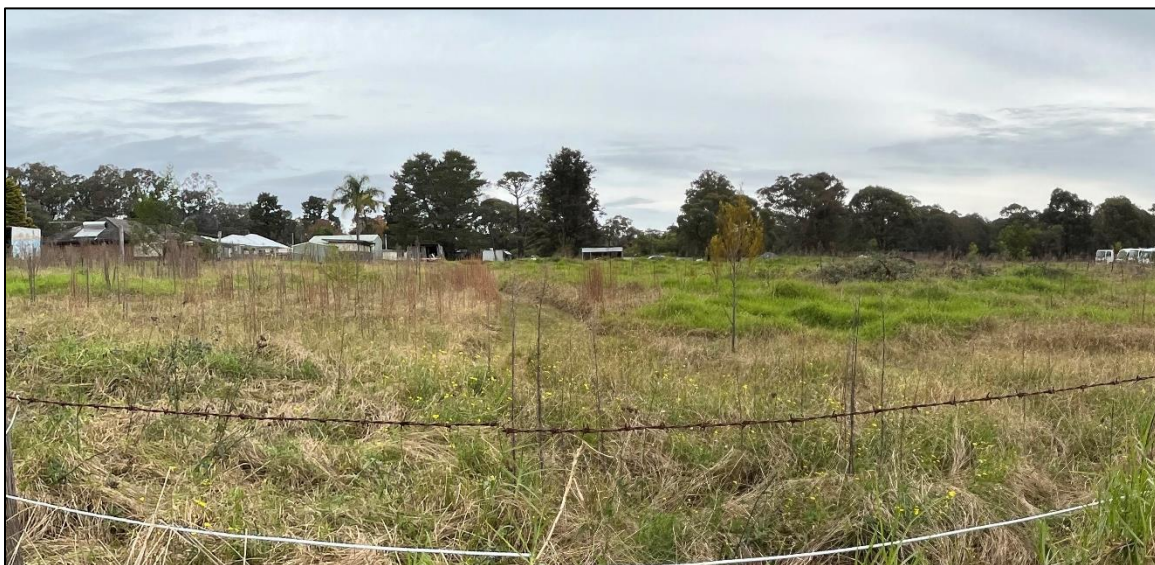
*Photograph 7: View of the rear of Lot 610 DP10196 looking broadly west*

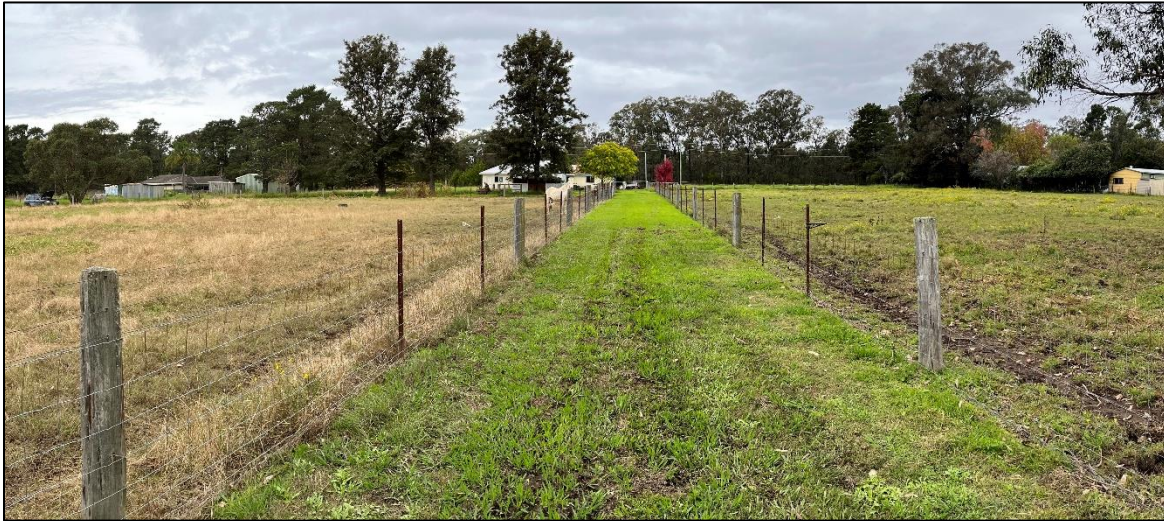
*Photograph 8: View of the center and south of Lot 29 DP10196 looking broadly south*

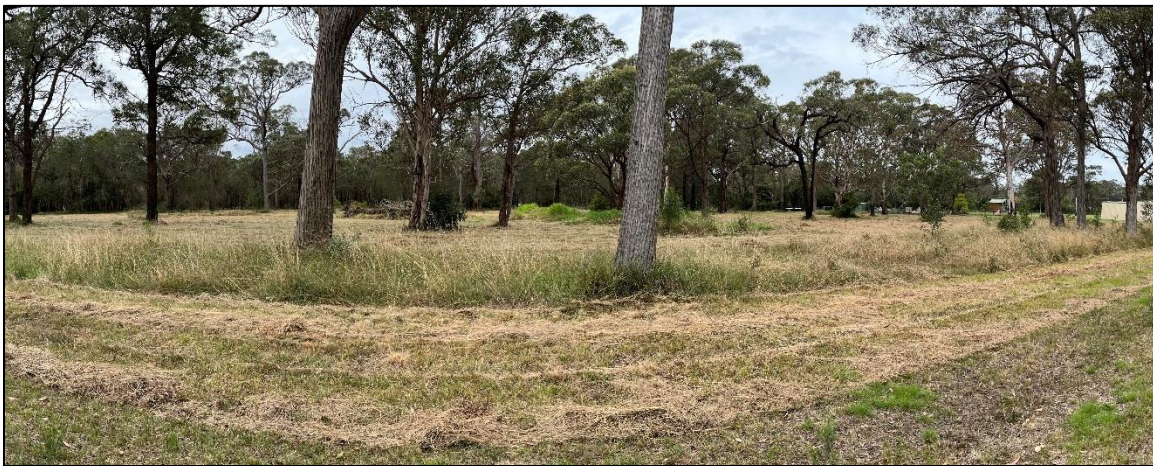
*Photograph 9: View of the center and south of Lot 31 DP10196 looking broadly east*

No obvious signs of erosion (gullying etc.) were observed, although discussions with one of the tenants/owners indicated that areas of soft ground exist within the majority of the lots in the area however this is not confirmed.

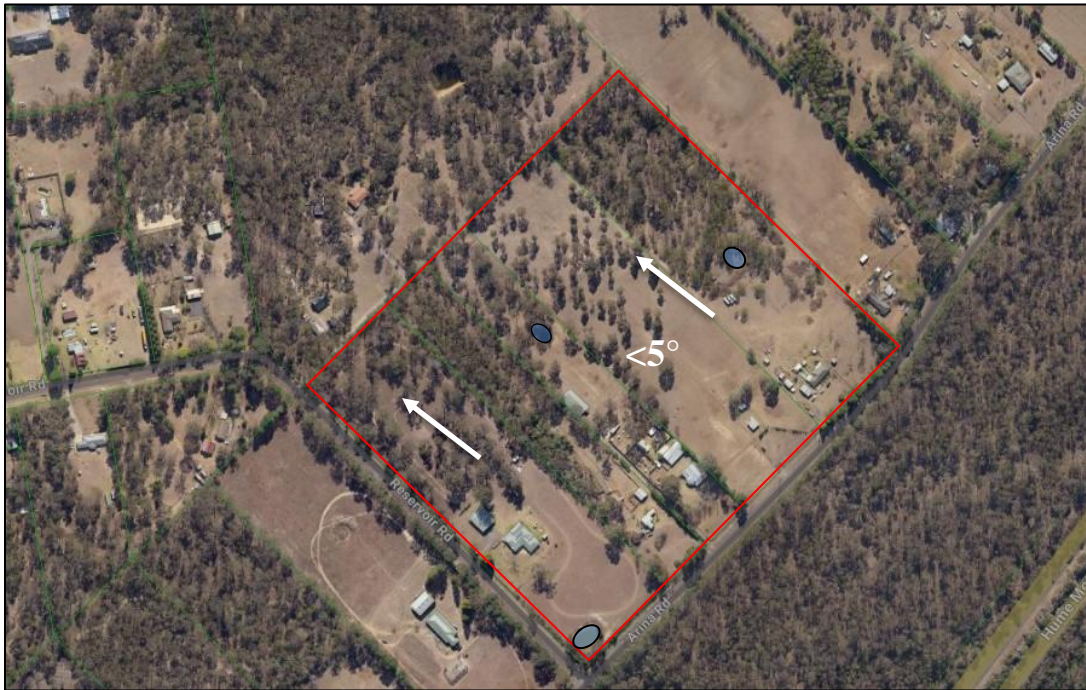
Inspection of the existing structures within the lot did not indicate any significant cracks to indicate excessive shrink swell movements of the founding soils. No areas of discoloured grass or vegetation were observed to indicate the presence of potential contaminants or elevated salinity.

Photograph 10: Aerial view of lots 28 and 29 DP10196, Lot B and A DP354366 and Lot 31 DP10196

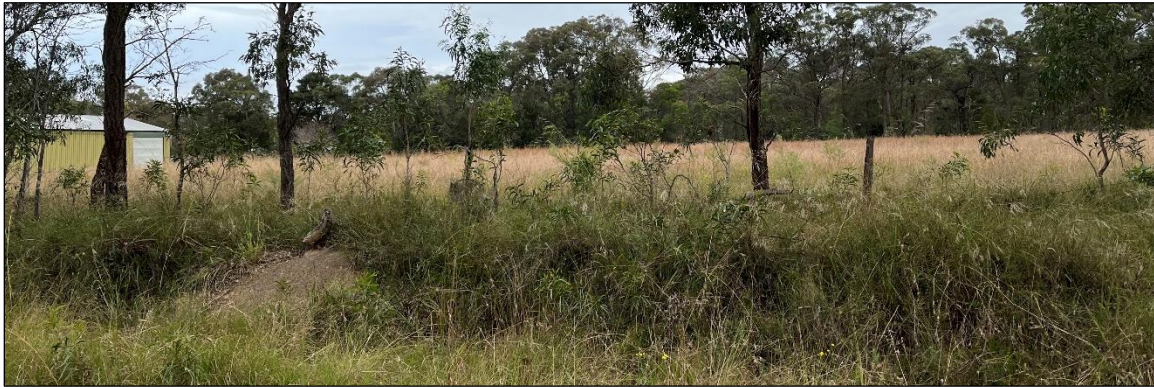
Inspection of the existing structures within the lot did not indicate any significant cracks to indicate excessive shrink swell movements of the founding soils. Signs of surface erosion or potential landslip movements were not observed. No areas of discoloured grass or vegetation were observed to indicate the presence of potential contaminants or elevated salinity.

*Photograph 11: Lot 32 DP10196 looking broadly west from Reservoir Road*

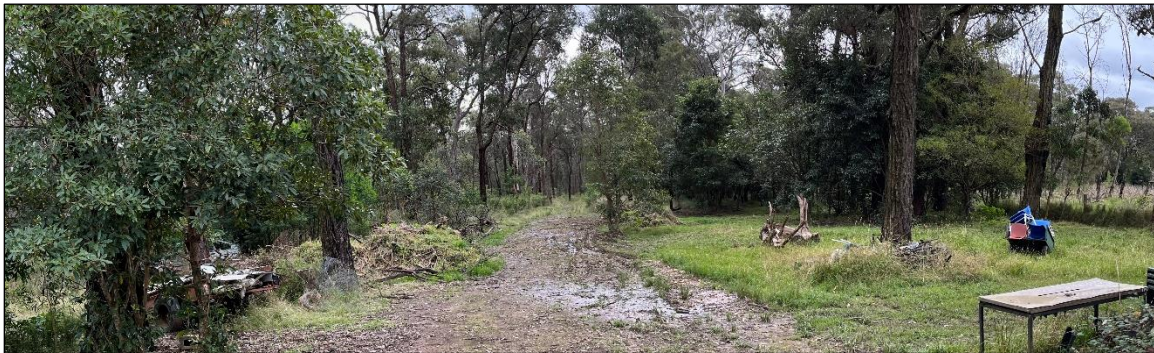
*Photograph 12: View of the north of Lot 34 DP10196 looking broadly south*

The surface of the area appeared generally well drained with no uncontrolled water/erosion observed however it is understood from field discussions that one of the owners has imported granular fill to surface the driveway so that vehicle use could be maintained following rainfall.

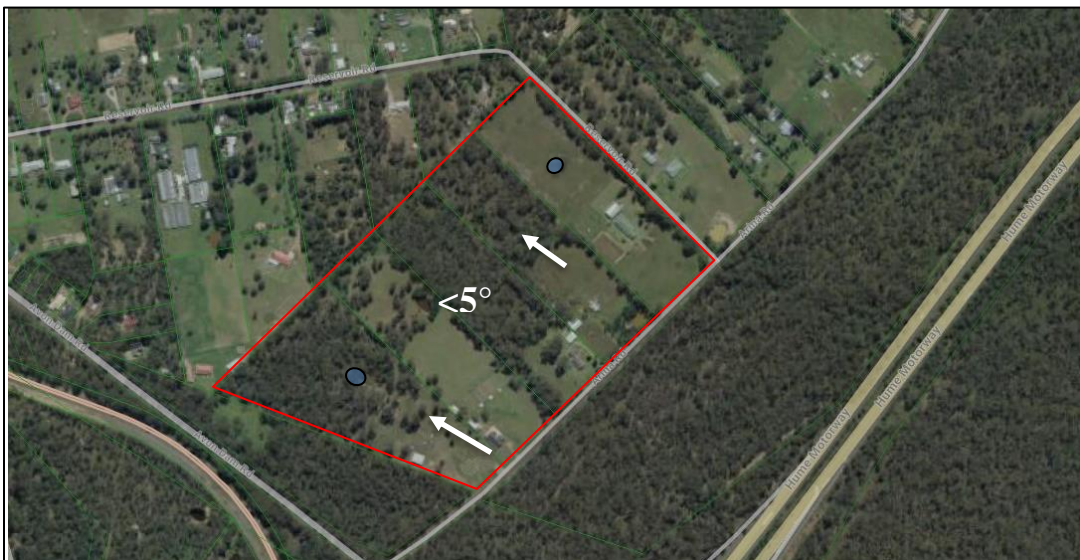
*Photograph 13: Aerial view of Lot 32 DP10196 to Lot 36 DP10196*
