## GEOTECHNICAL STUDY

Proposed Rezoning of Land

1 Abbotsford Road, PICTON

Job Reference: 201368\_Geotech  
23 January 2013

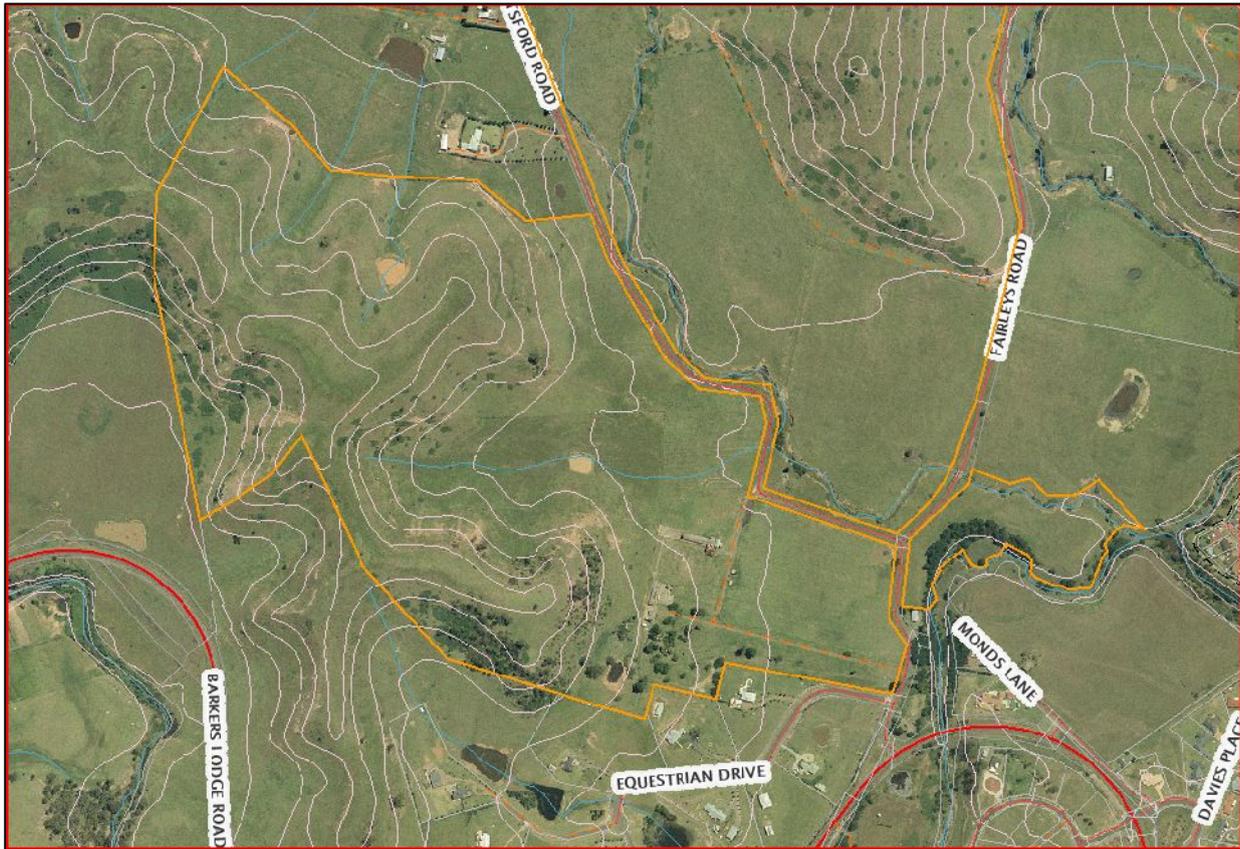
Figure 4: Topographic, vegetation and drainage features in and around the Abbotsford property

The slope and topography of the Property is dominated by a northwest-southeast trending ridge line with a centrally located and northerly trending sub-ridge line. The maximum vertical relief across the property is approximately 60 metres.

Slopes range from 0-5% around the lower lying (drainage) areas to between 15 and 40% for the side slopes. The ridge tops are characterized by narrow (generally less than 15-20 metre) flat areas breaking quickly into very steep slopes. These features are illustrated in Figure 4.

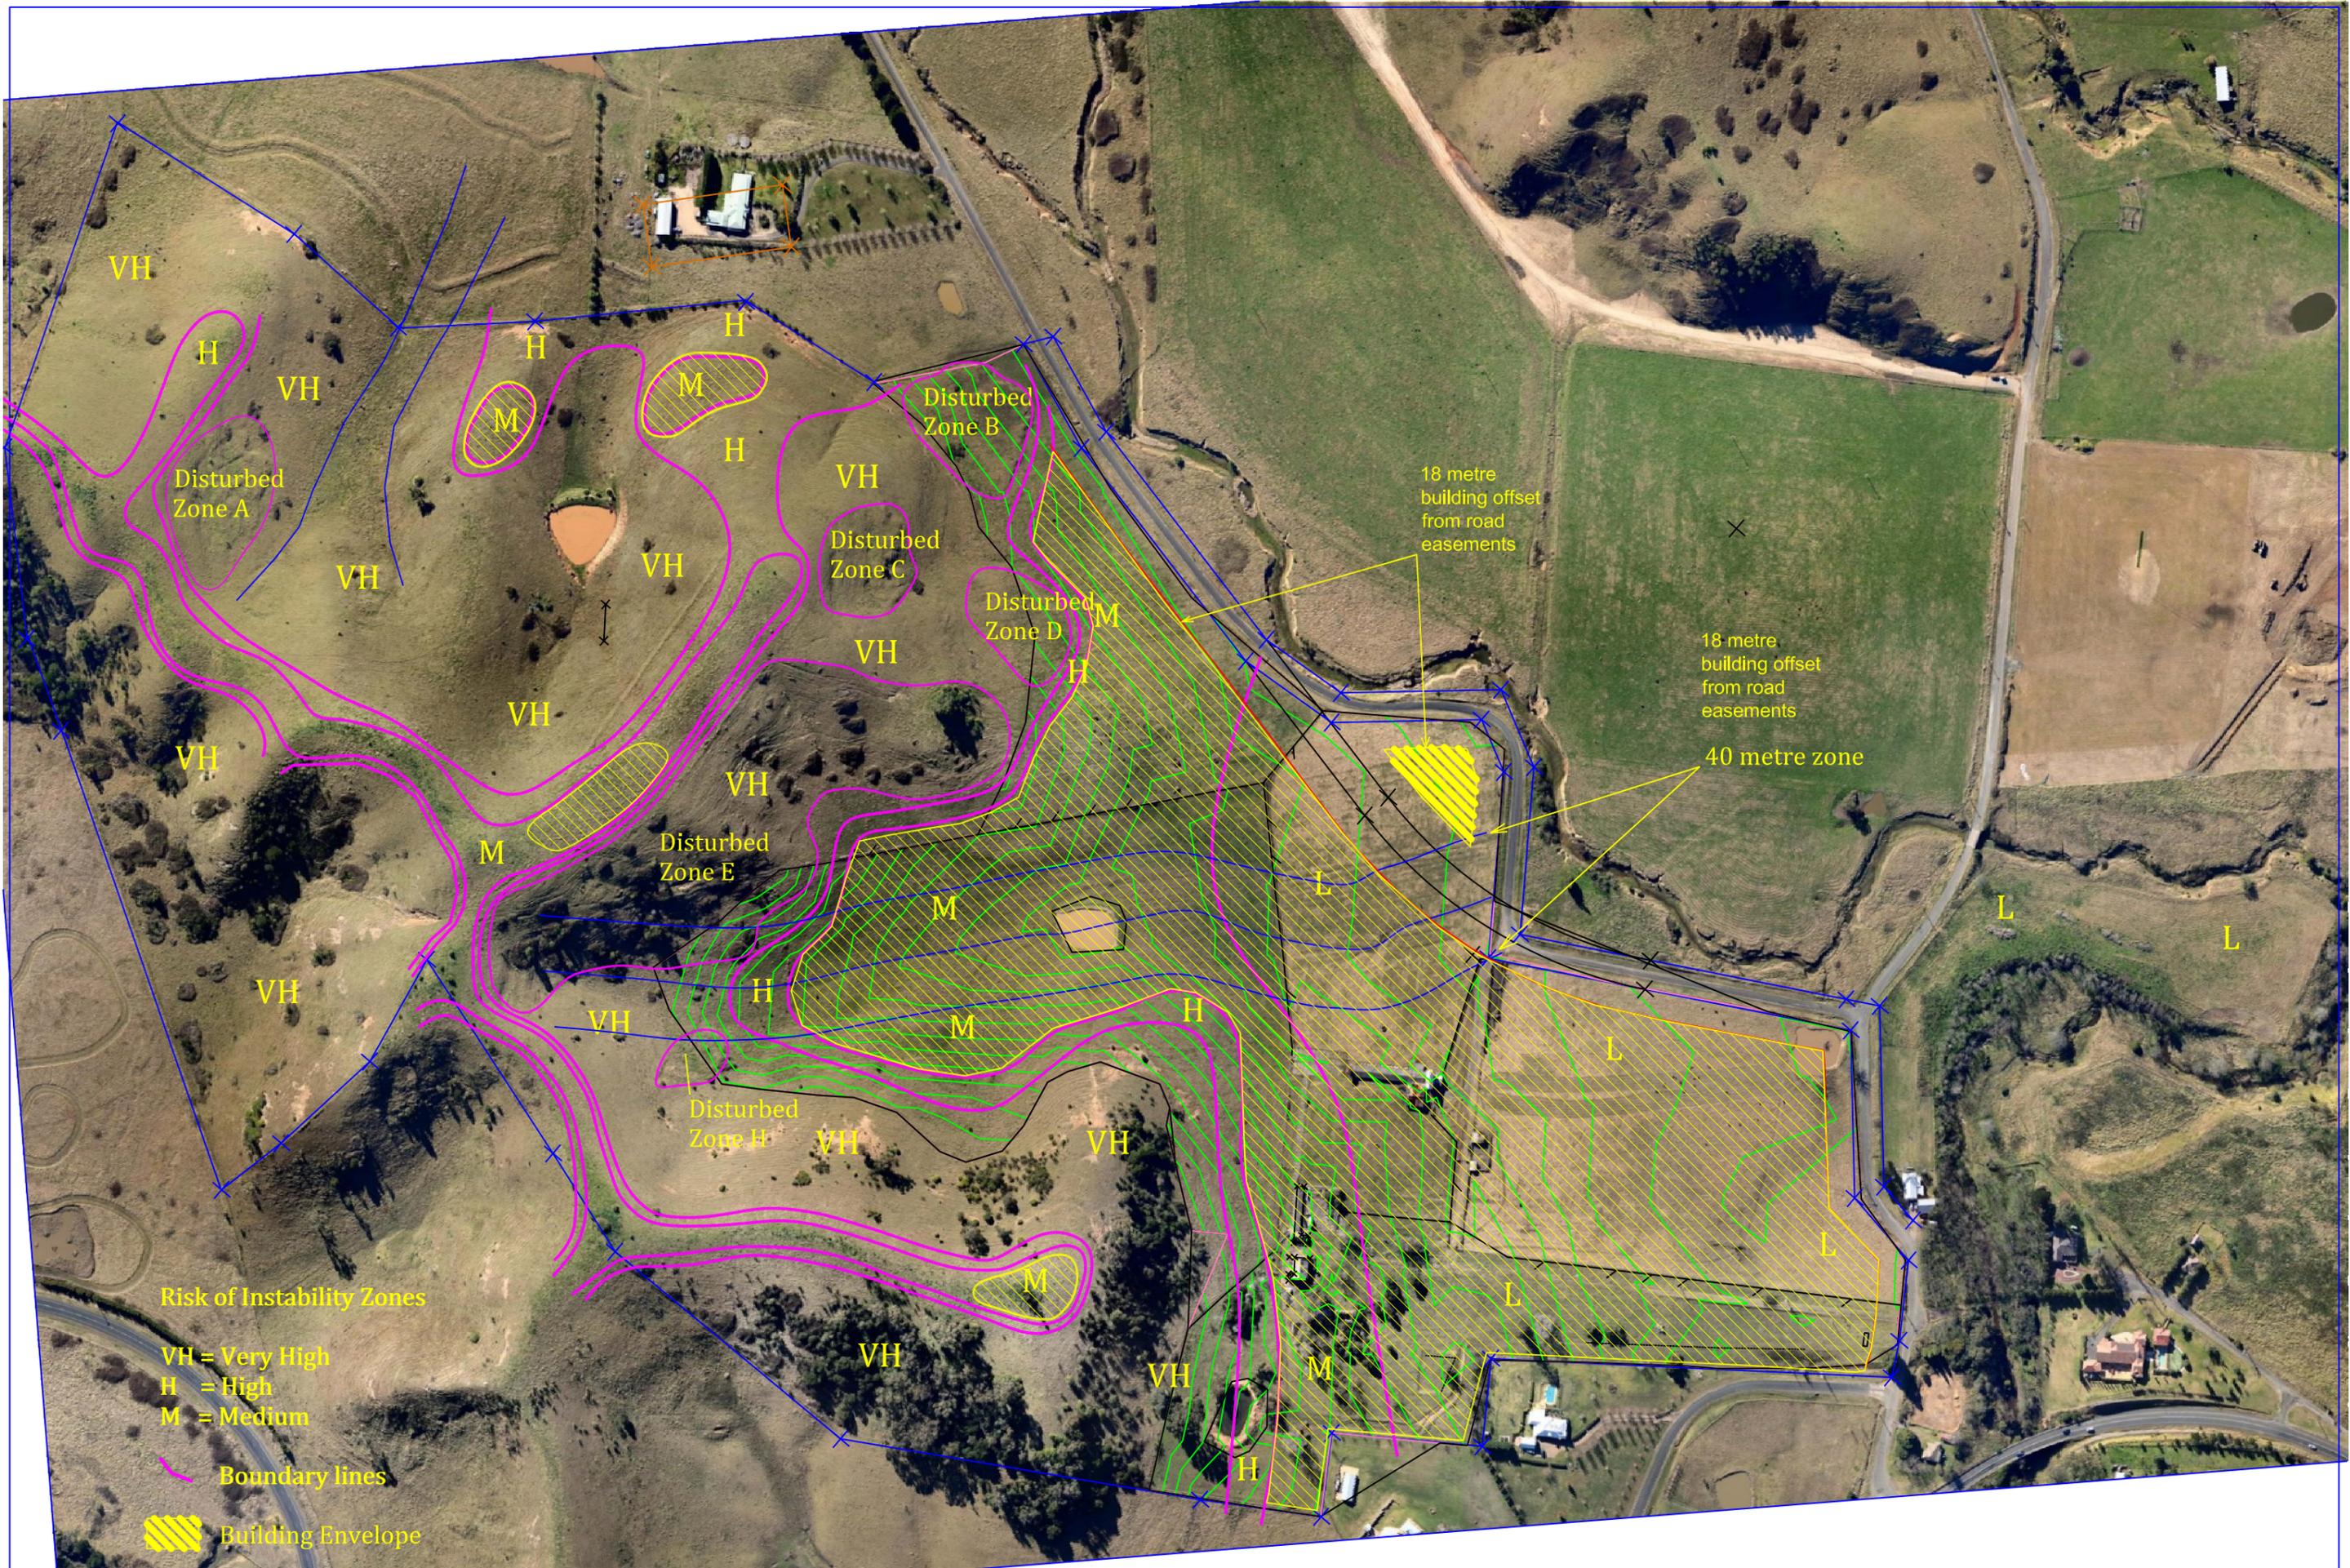
Figure 6

Based on the criteria outlined in Section 5, a number of building envelopes have been outlined within the Property. These building envelopes are illustrated in Figure 6. The assessment of these building envelopes takes into consideration the stability of the site as well as a number of other physical constraints. It should be noted that construction of residential and associated improvements is considered possible anywhere within the building envelopes subject to the acceptance of some geotechnical risk. Construction within these building envelopes should therefore reflect the degree of risk.

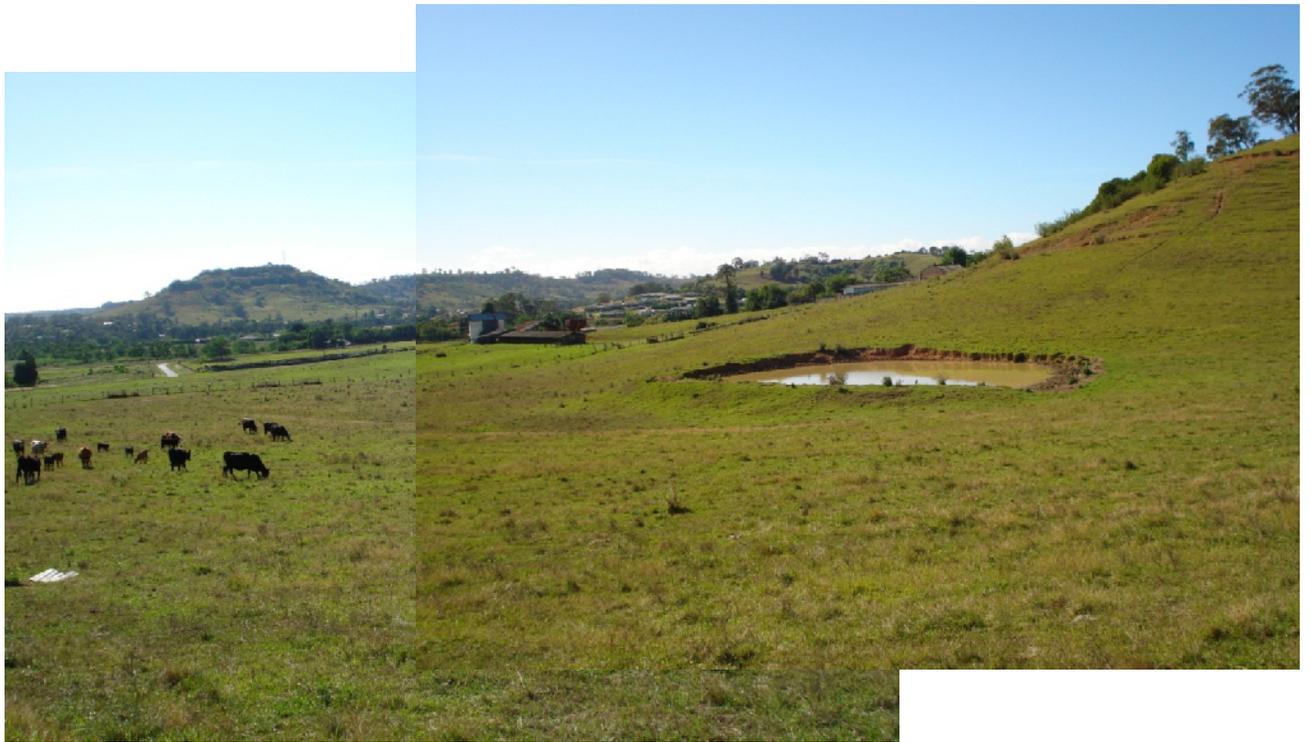
Plate 1: Looking south-easterly at Abbotsford Dairy. Valley floor around dam is suitable for development.

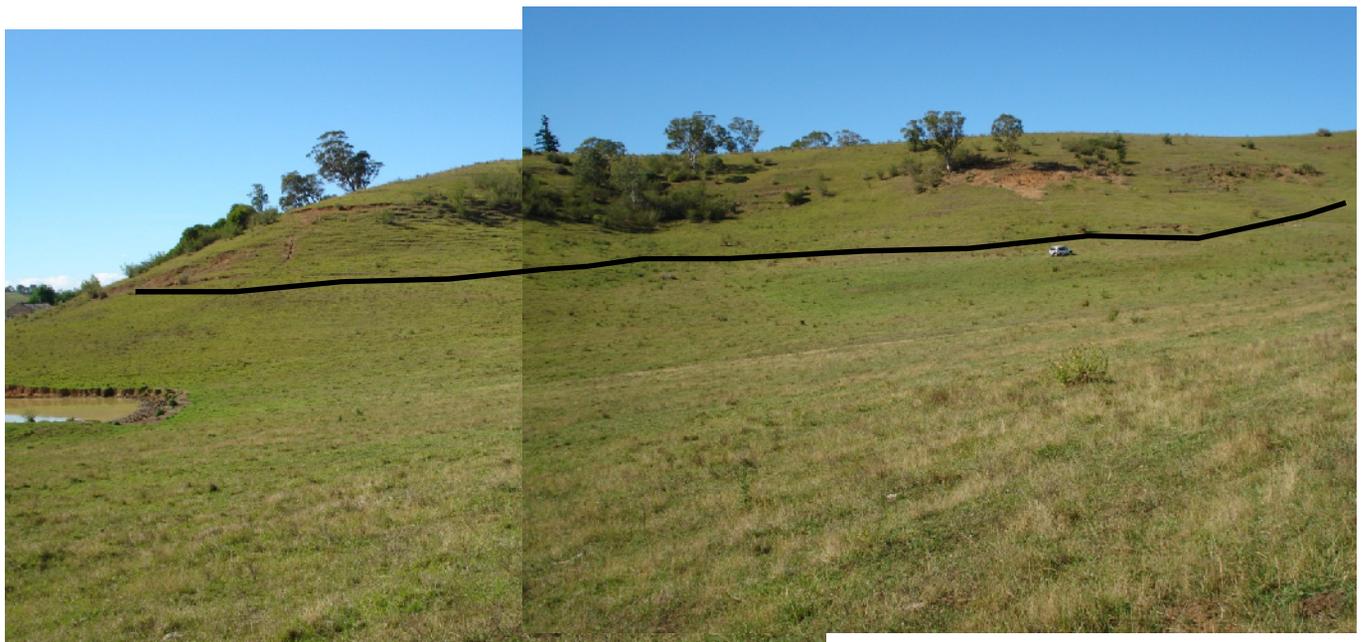
Plate 2: Looking southerly at valley floor and steep (>20%) side slopes. Approximate position of building line indicated.

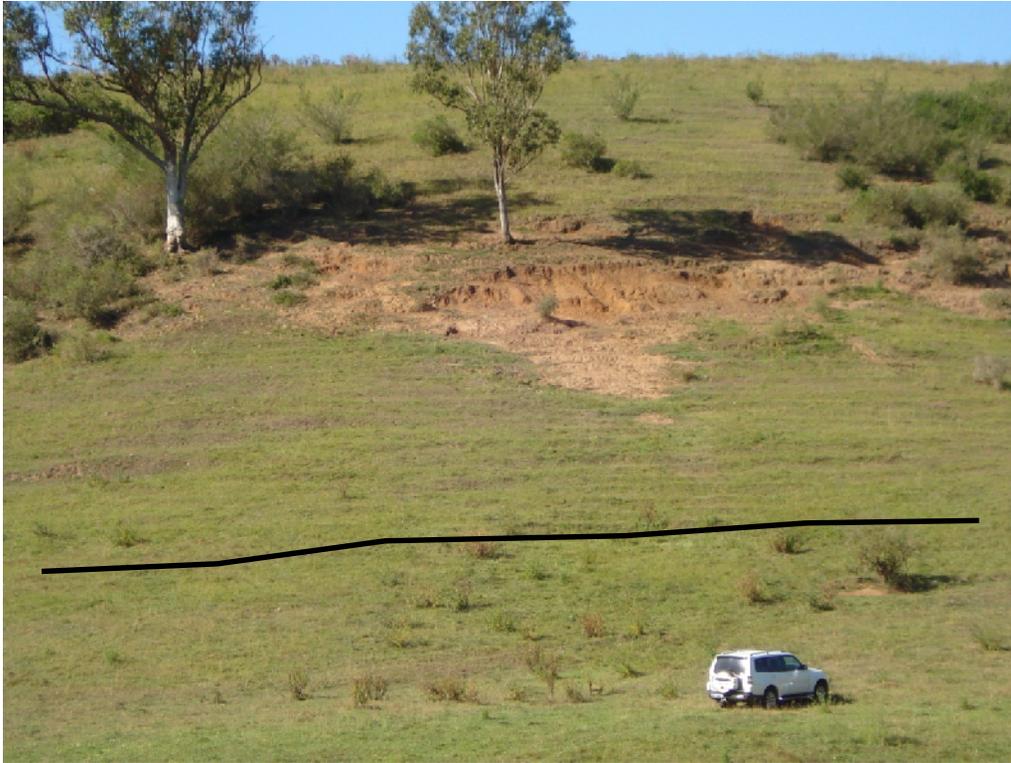
Plate 3: Close up of steep side slopes with typical high levels of erosion and slumping. Slope above line is >20% and falls within VH Risk of Instability Zone. No development should be allowed on these slopes.

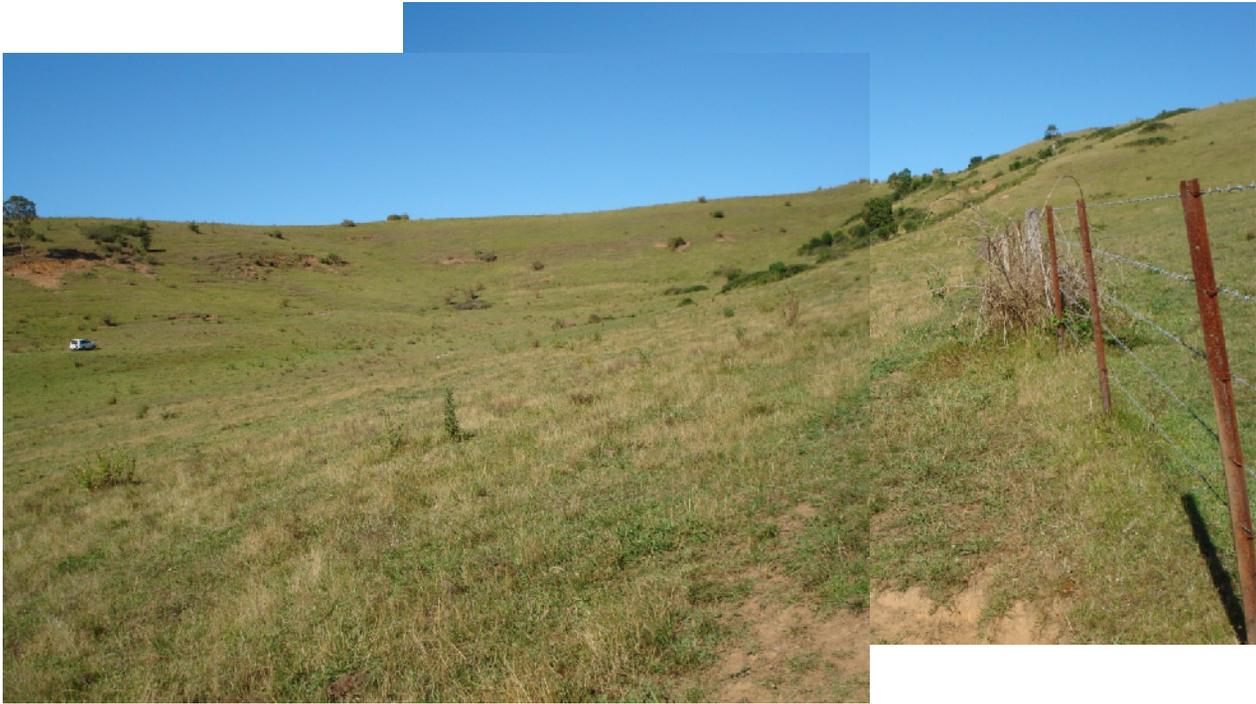
Plate 4: Looking westerly. Fence line is close to building line, with slopes on Left Hand Side being <20%.

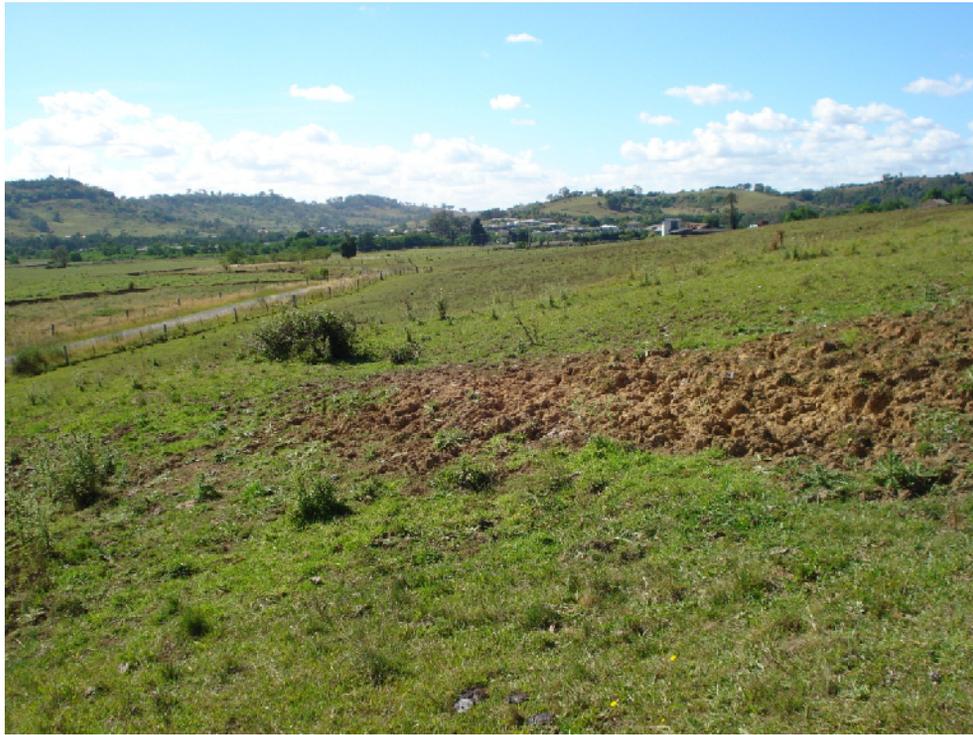
Plate 5: Looking south-easterly towards Picton, showing significant slumping in foreground – probably exacerbated by high moisture levels.

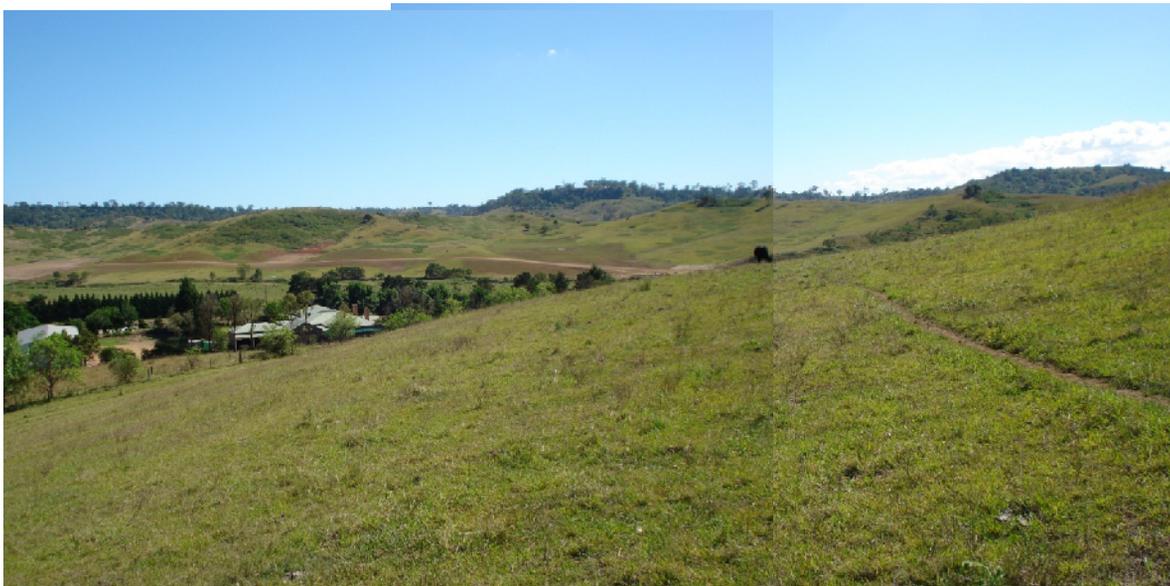
Plate 6: Looking north-easterly at suitable building site – cross fall is approximately 10%.

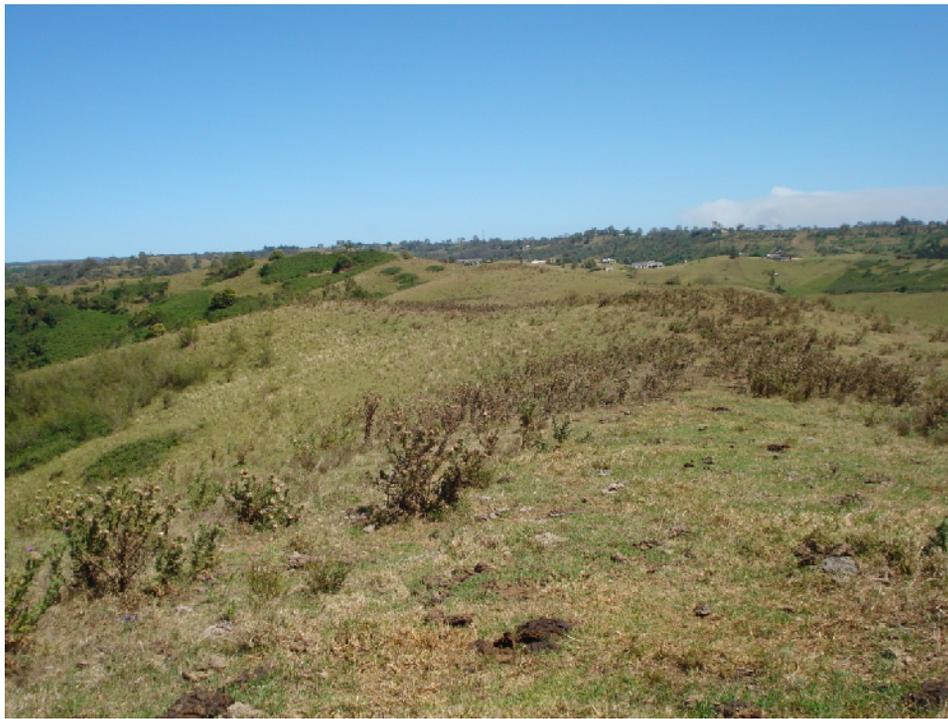
Plate 7: Looking westerly along ridge top. Ridge tops are suitable for access roads, but often too narrow to support building development.

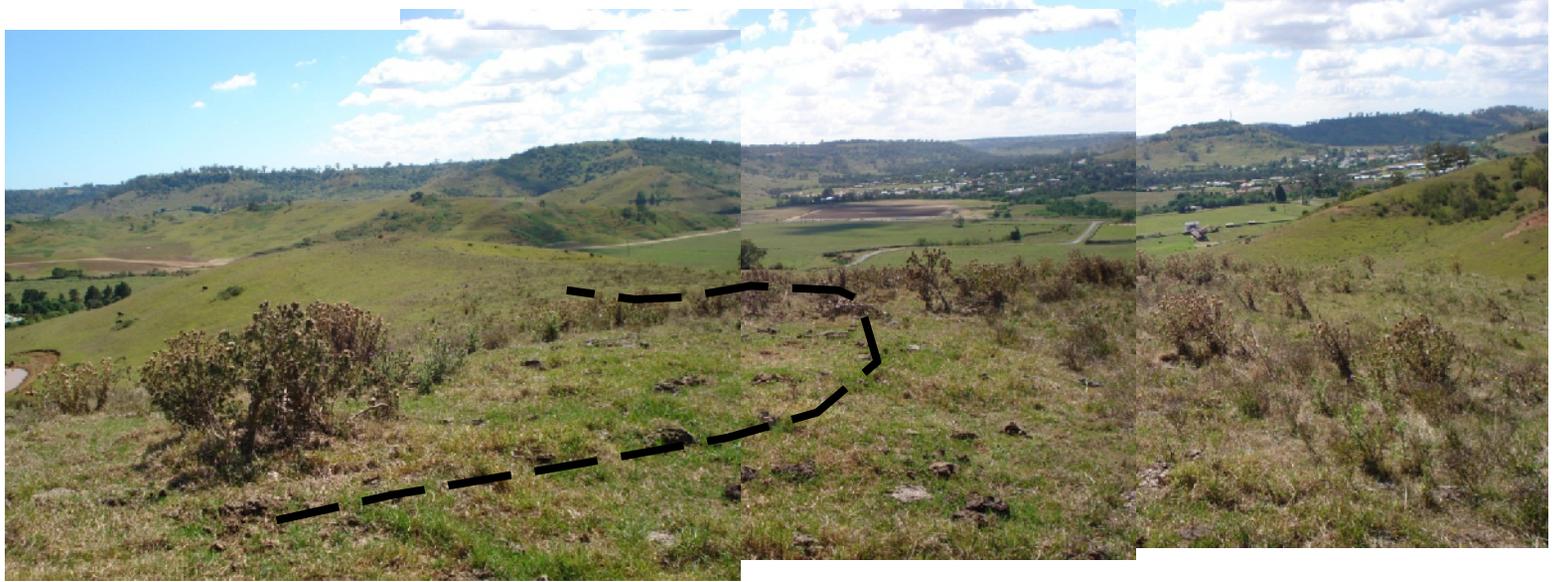
Plate 9: Looking north-easterly along ridge line (see dashed line). Potential for development site is good.

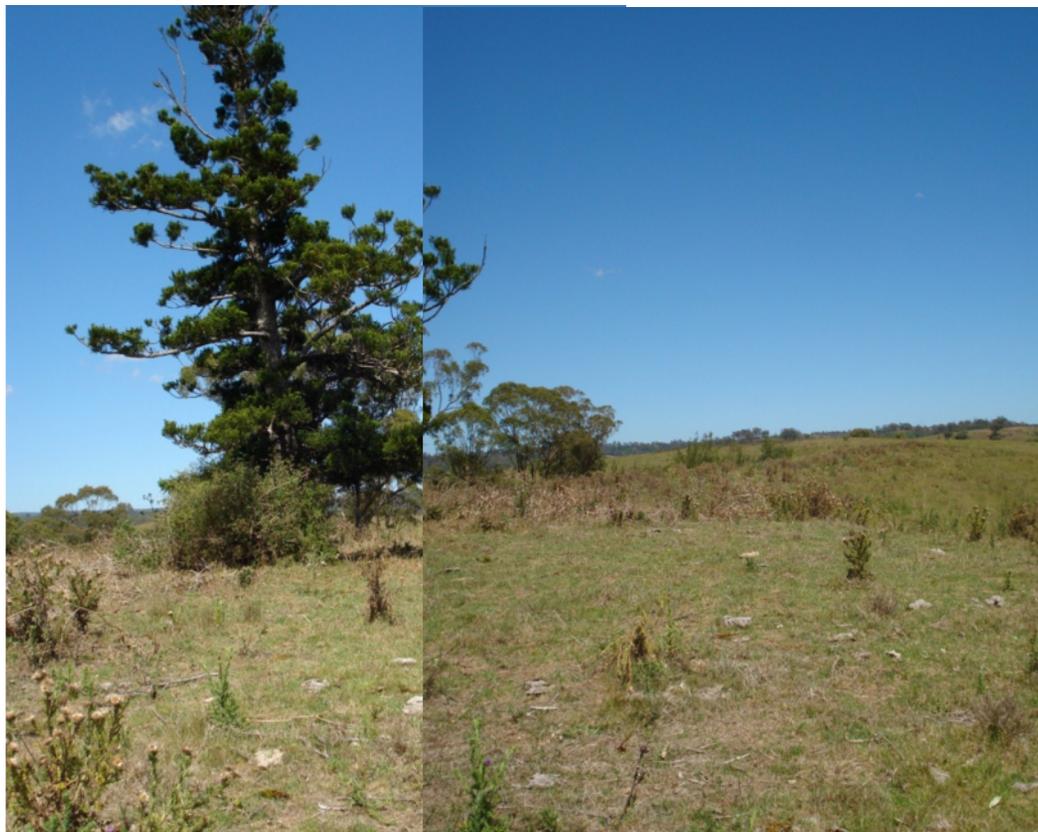
Plate 10: Looking westerly along ridge line. This area has potential for development.
