**Preliminary Site Investigation**

Proposed Residential Subdivision Reeves Creek, Picton

> Prepared for Dartanyan Pty Ltd

Project 76579.03 February 2014

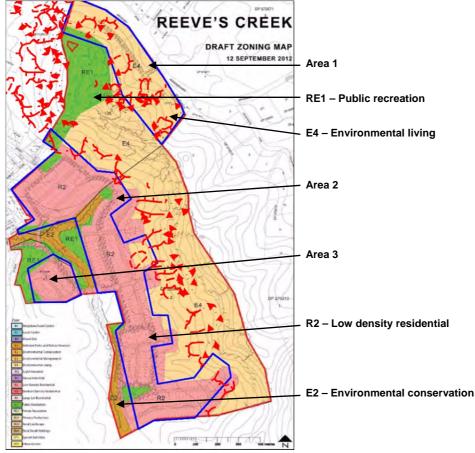
Figure 1: Reeves Creek Master Plan with overlay of landslide features

The Draft Reeves Creek Master Plan (refer Figure 1, below) dated 12 September 2012, includes within the current site boundaries proposed residential lots of varying sizes, access roads with a connection from Area 1 to the adjacent Vault Hill site, areas for public recreation and environmental conservation. Access will be developed from Remembrance Drive, Margaret Street and Menangle Street.

The proposed site layout is overlain in Figure 1 by the nominated investigation areas and the identified, probably historical slump-flow landslide affected areas (refer Drawings 2 to 5 in DP (2013) for details).

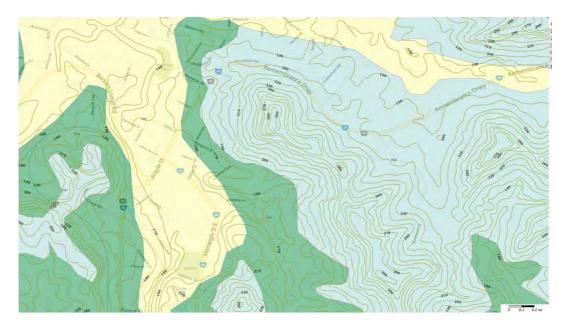
Figure 2: Reeves Creek regional geology

The Wollongong – Port Hacking 1:100 000 Geological Series Sheet indicates that the site is underlain by rocks of the Wianamatta Group of Triassic age. All of Area 1 and the mid-slope areas of Area 2 are underlain by Bringelly Shale which typically comprises thinly bedded shale, siltstone, carbonaceous claystone, fine grained sandstone, laminite and some minor coaly bands. These rocks weather to form clays of high plasticity. Vault Hill and its associated south easterly trending ridgeline are capped by a thick, unnamed sandstone bed within the Bringelly Shale.

Most of the footslope areas are mapped as being underlain by Ashfield Shale, which comprises predominantly laminite and claystone. The boundary between Bringelly Shale and Ashfield Shale is typically marked by the Minchinbury Sandstone which ranges from approximately 1.5 m to 3.5 m thick. The field mapping indicated a fine grained sandstone band, somewhat inconsistent with the typical Ashfield Shale strata, in the base of Reeves Creek. This indicates that the mapped boundary may be inaccurate.

The Ashfield Shale (Rwa) and Bringelly Shale (Rwb) are shown on Figure 2, below.

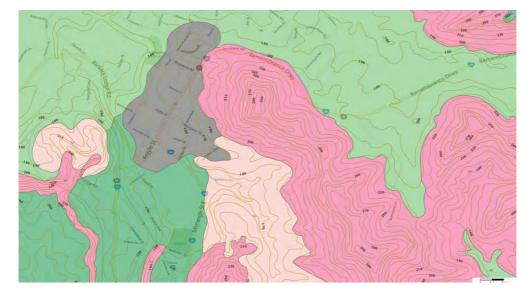
Figure 3: Reeves Creek regional geology

The Soil Landscapes of the Wollongong – Port Hacking 1:100 000 Sheet indicates that the Picton soil landscape is mapped over all of the northern and eastern portions of the site. The remainder of the site, with the exception of a small section of disturbed terrain (located at an isolated area located approximately midway along the western boundary), are within the Luddenham soil landscape.

The Picton soil landscape is a colluvial landscape, developed on the Wianamatta Group rocks and derived colluvial materials. It is characterised by steep to very steep side slopes (slope gradients of 20% [11°] to 80% [39°]) with local relief of 90 m to 300 m and indications of widespread mass movements, predominantly soil creep and slumping.

The Luddenham soil landscape (soil mapping unit lu) is an erosional landscape which is also developed on the Wianamatta Group rocks. It is characterised by rolling to steep low hills (slope gradients of 5% [3°] to 20% [11°]; dominantly 10% [6°] to 15% [9°]) with local relief of 50 m to 80 m.

The disturbed terrain (xx), Picton colluvium (pn) and Luddenham erosional (lu) are shown on Figure 3, below.

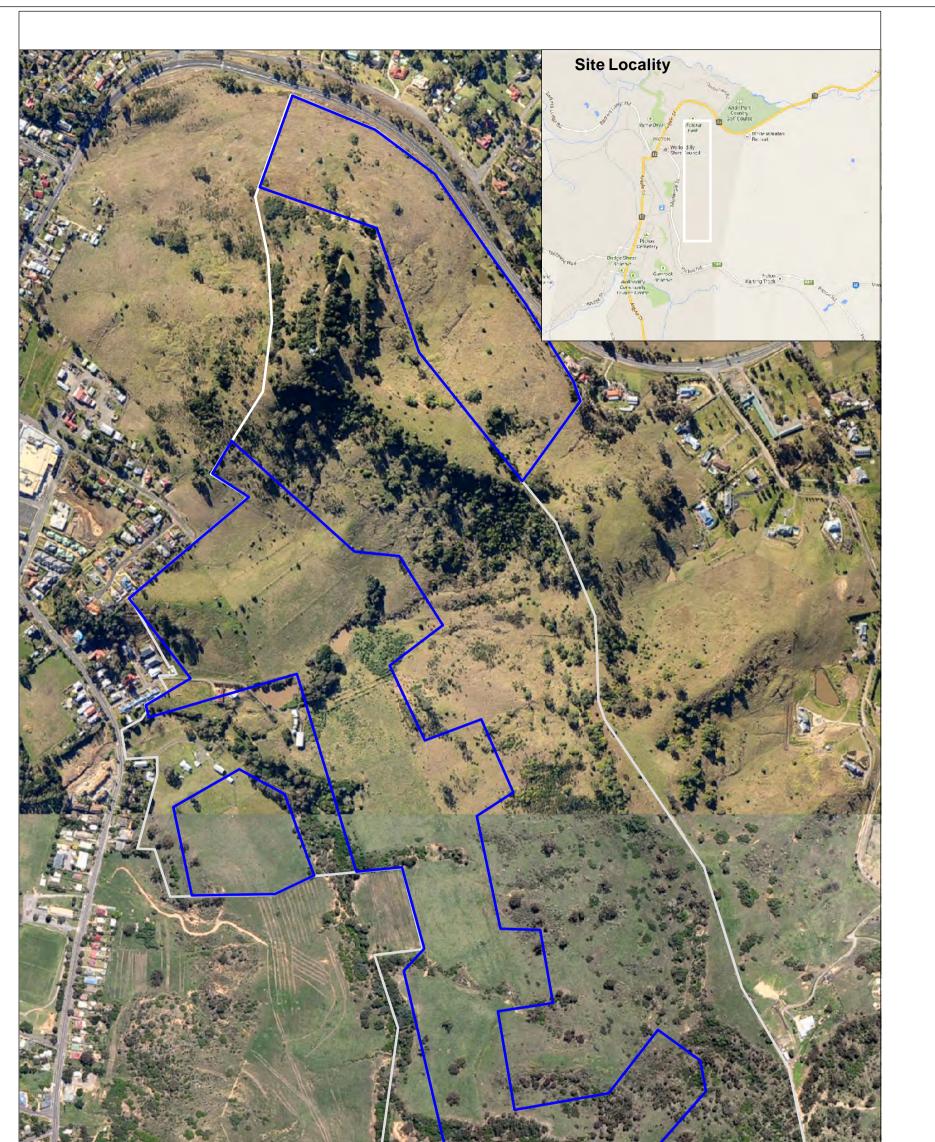
A site plan (aerial photograph, 2012) and locality map are shown on Drawing 1, Appendix A.

Legend Reeves Creek Boundary Site Boundary				meters	<u>30</u> 0.0
	Site Locality				OFFICE: Macarthur
<b>Douglas Partners</b> Geotechnics   Environment   Groundwater	Preliminary Contamination Assessment				DRAWN BY: MJC
	Reeves Creek, PICTON				DATE: 08.01.14
CLIENT: Dartanyan Pty Ltd	PROJECT No: 76579.03	DRAWING No: 1	REVISION:	-	SCALE: As shown

**2012 (Drawing 1):** The site appeared relatively unchanged from the previous aerial photograph, with the exception of increasing vegetation cover in the central portion of the site. There appears to be an increase in the density of residential development surrounding the site.
