EUROPEAN HERITAGE ASSESSMENT PTTAG STUDY AREA

THIRLMERE AND TAHMOOR

PTTAG STUDY AREA

REIN, WARRY & CO

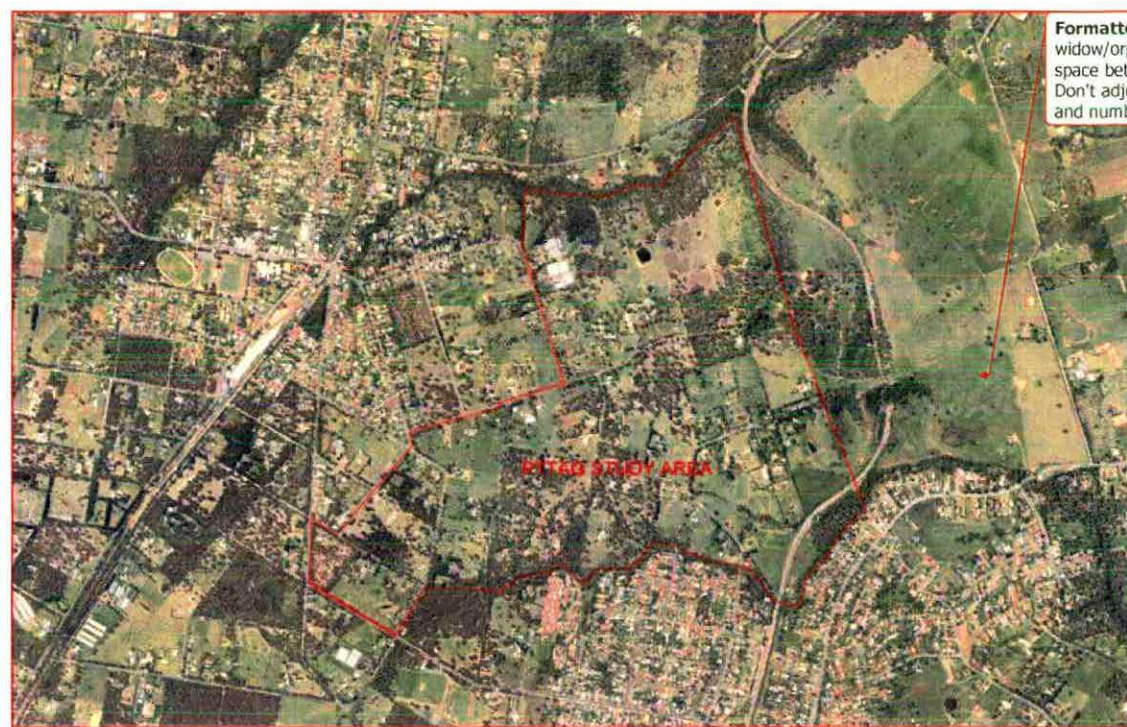
Figure 1 : Aerial Figure with PTAG Study Area edged red (Nearmap 2011)

The Study Area comprises eighty seven (87) allotments of land, with a combined land area of approximately 232 hectares and is shown in the aerial Figure 1. It is located between the townships of Tahmoor and Thirlmere and is generally bounded by Redbank Creek, Myrtle Creek and the Main Southern Rail Line.

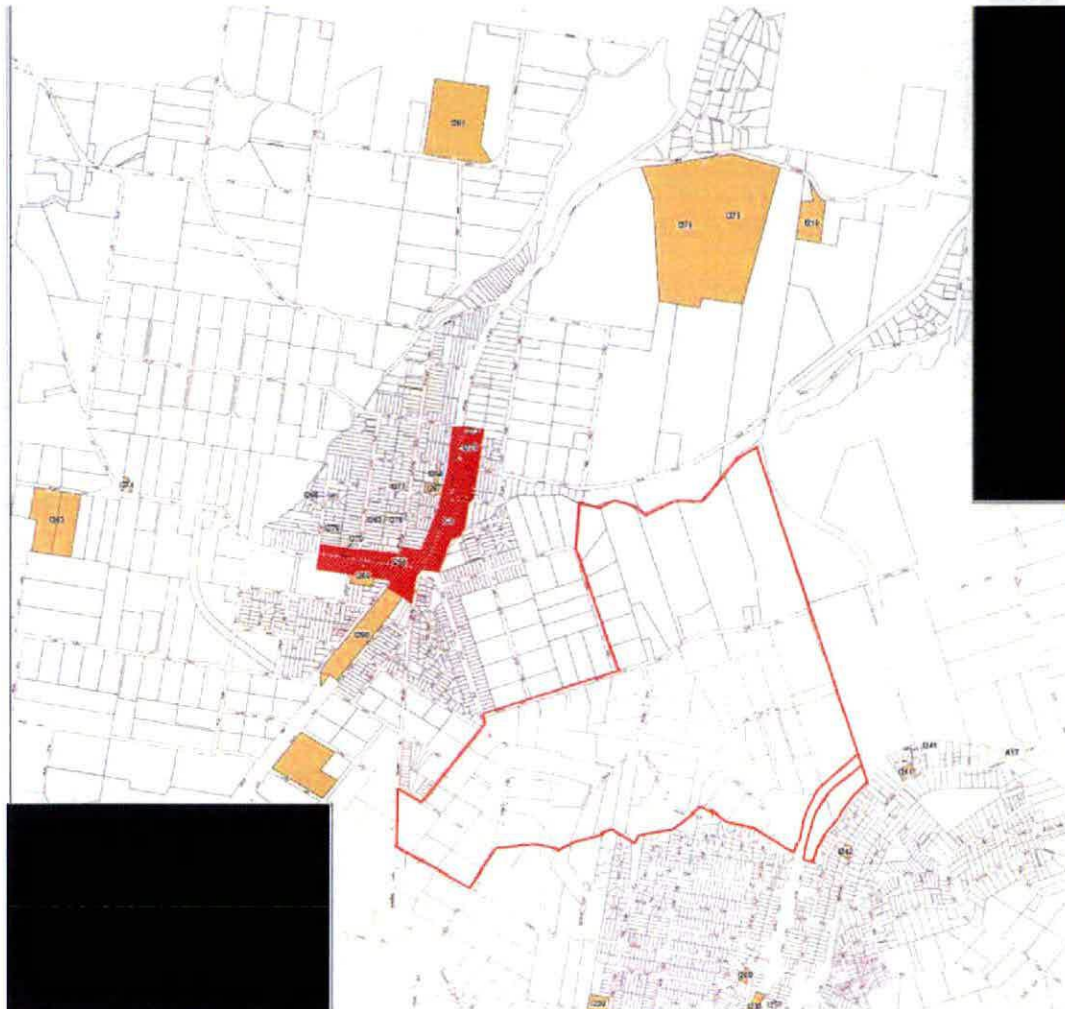
These two previous reports have not identified any European Heritage that specifically relates to the Study Area. An extract of that map pertaining to Thirlmere/Tahmoor is shown below in Figure 2 below.

Figure 2: Extract of Thirlmere and Tahmoor Heritage Maps for WLEP 2011. The Study Area for the PTTAG is shown edged red. The heritage items and precincts are coloured red and tan respectively. There are no listed items within, or near the Study Area. (Source WSC 2012 edited by D Warry)

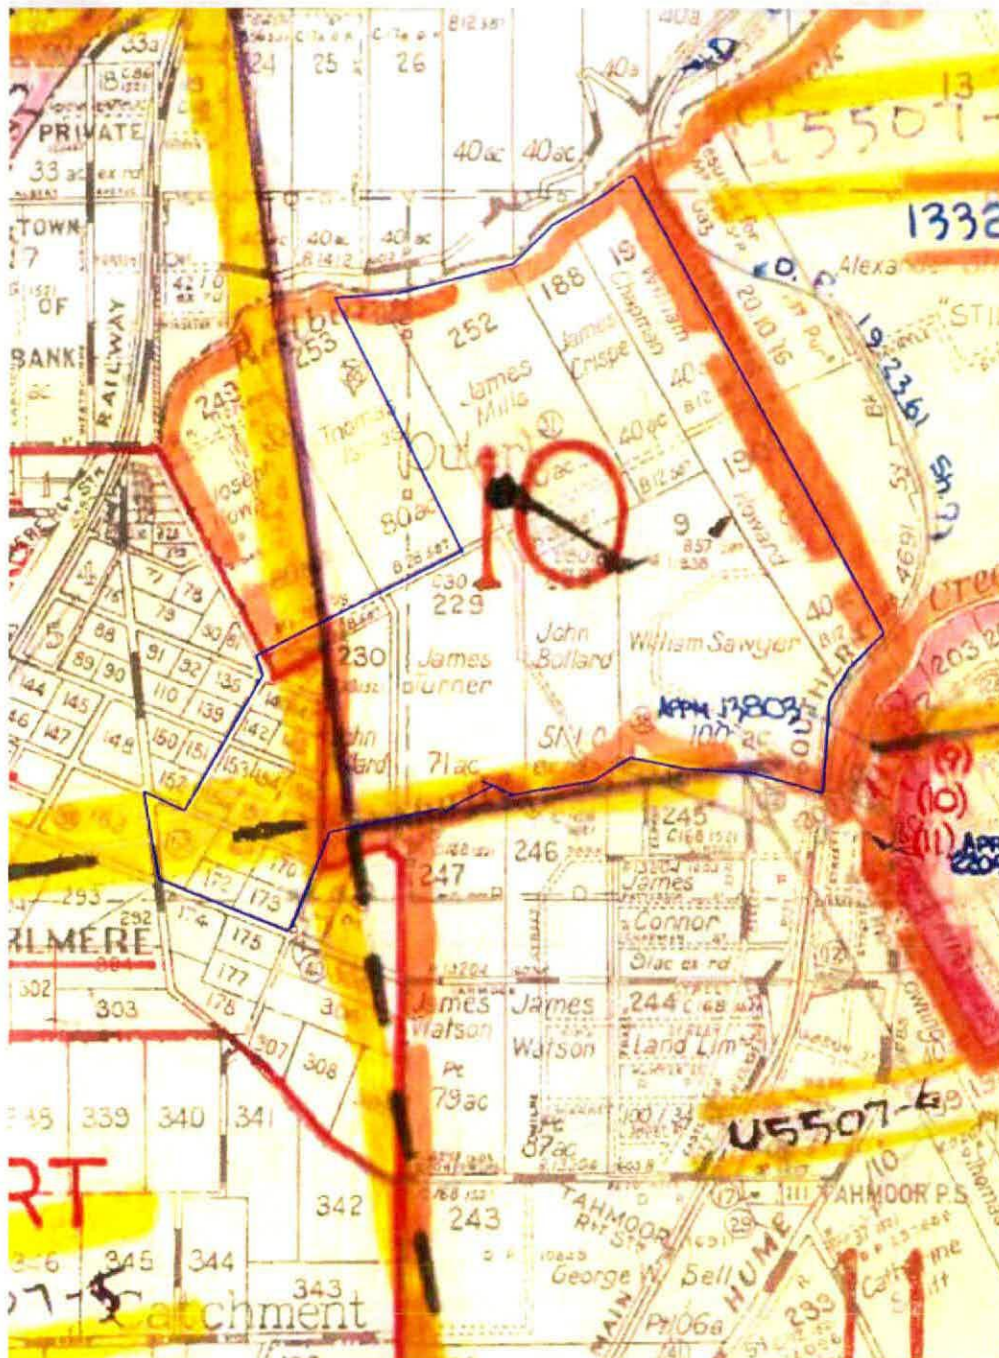
Figure 3 shows an extract of the original Parish Map as it pertains to the PTTAG Study Area, which has been edged in blue.

Figure 3 .Extract of the Parish Map for Couridjah LPMA 2012). There are numerous text lines on the extract which are present on the original. A fine blue line has been placed around the Study Area.

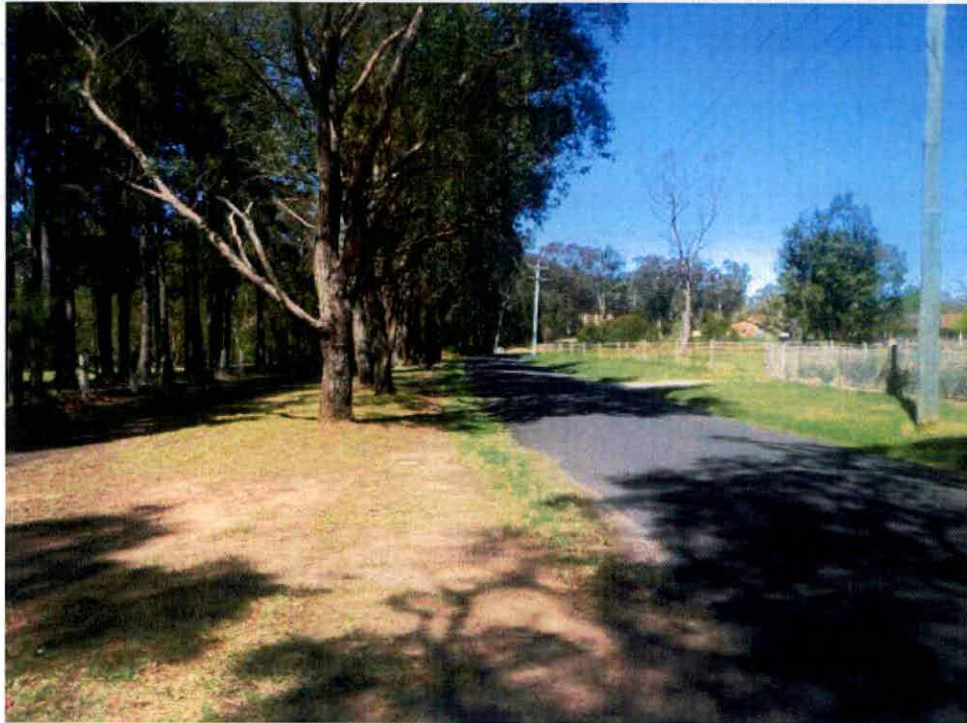
There are no particular or unique characteristics about these streetscapes other than Denmead Street. This street contains a cycleway constructed by Wollondilly Shire Council. This cycleway is integrated into the streetscape and is separated from the bitumen roadway by a significant line of trees as shown on Figure 4 below.

Figure 4. View south along Denmead Street showing the road pavement, a line of native trees and the cycleway. The road pavement is offset to the western side of the centre of the road reserve. (DWarry 2012)

Recommendation 3: The existing bitumen surface alignment of the roads should be retained and that road pavements remain offset where this situation currently exists such as Denmead Street to retain as much of the native vegetation in the road reserve as possible.;

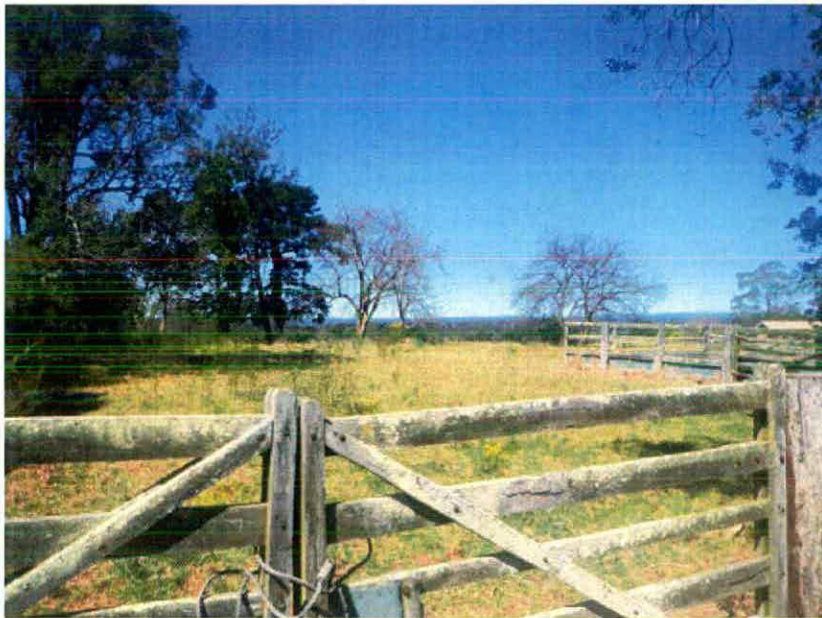
Figure 5. View of distant glimpse to the south from the ridge on Brundah Road (DWarry 2012)

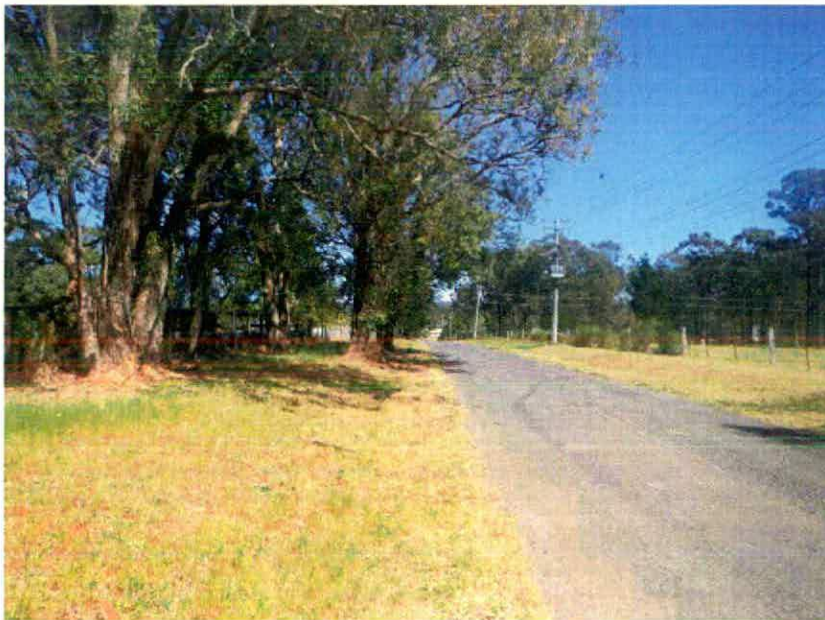
Figure 6. View west along Brundah Road towards Turner Street. Note that the native trees remain on the southern side with trees removed for the electricity service on the northern side. (DWarry 2012)

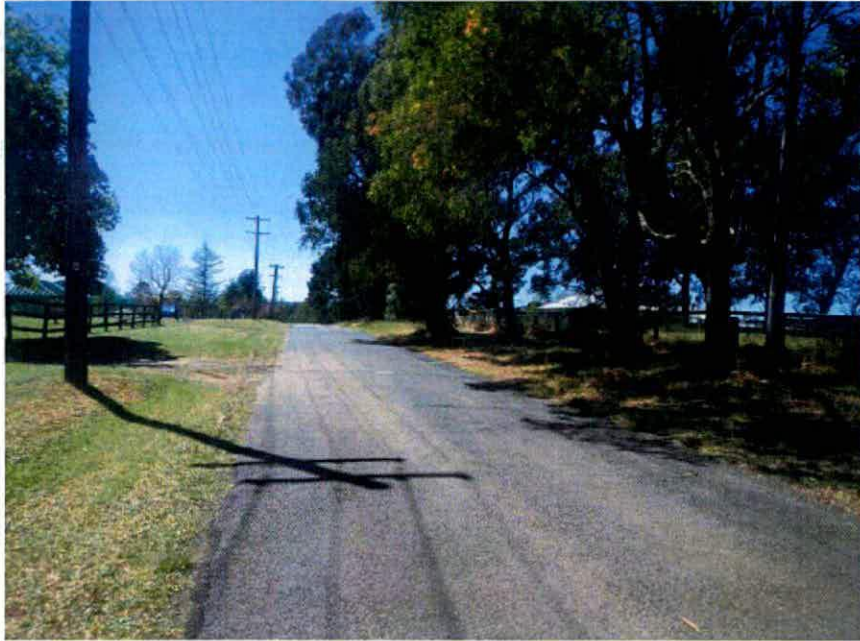
Figure 7. View east along Brundah Road showing significant remaining native trees. (DWarry 2012)

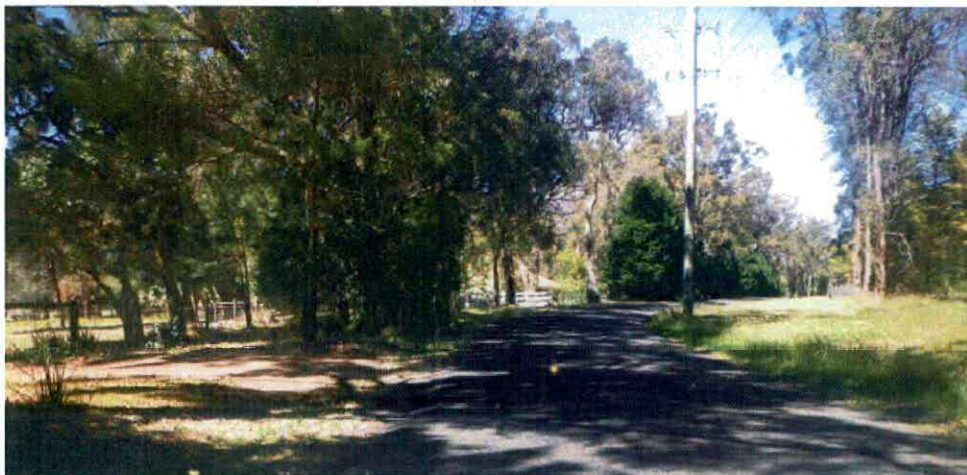
Figure 8. View east along Brundah Road towards Glenanne Place showing significant remaining native trees and exotic tree planting (Cypress). (DWarry 2012)

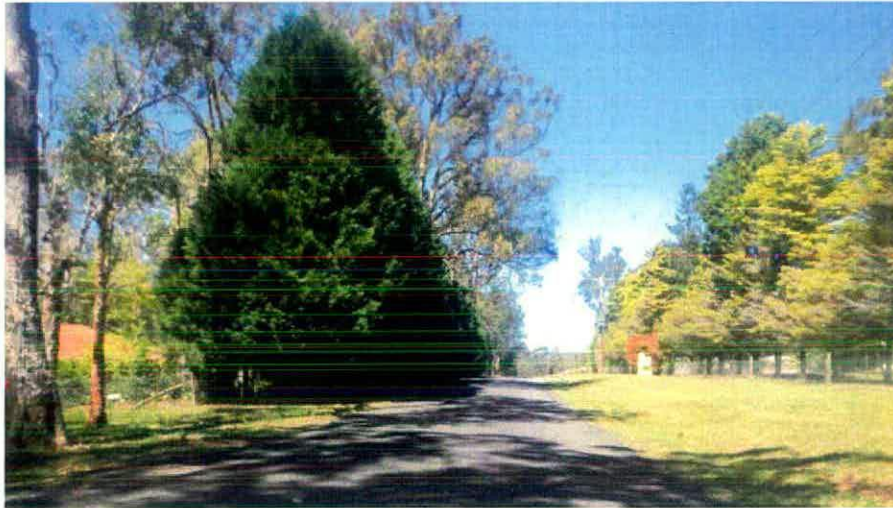
Figure 9. View east along Brundah Road towards Glenanne Place showing significant exotic tree planting (Cypress). (DWarry 2012)

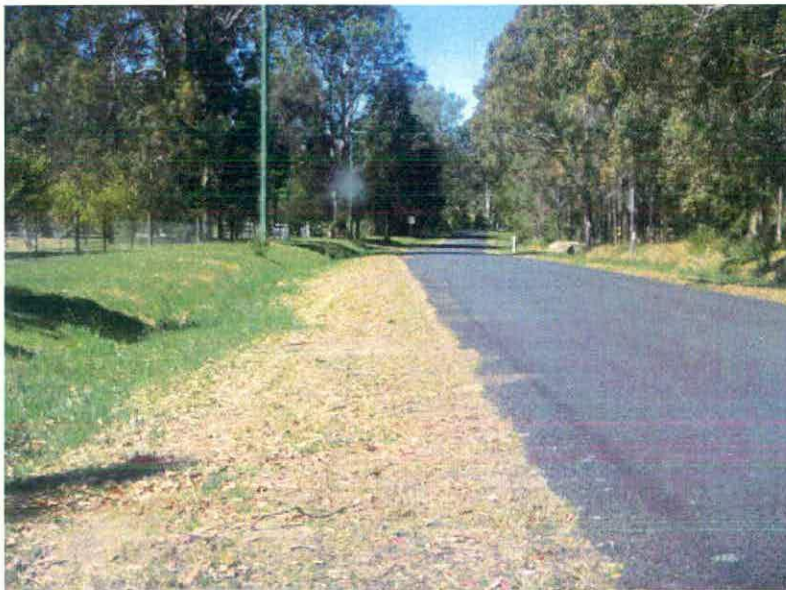
Figure 10. View east along Brundah Road between Glenanne Place and Myrtle Creek showing significant remaining native trees. (DWarry 2012)

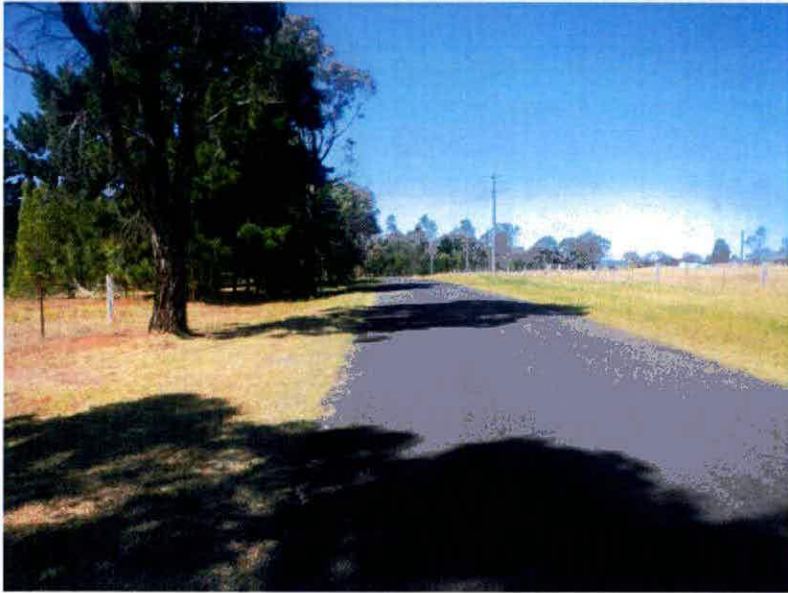
Figure 11. View south along Tickle Drive towards intersection with Brundah Road showing remaining trees and a cleared side for services (DWarry 2012)

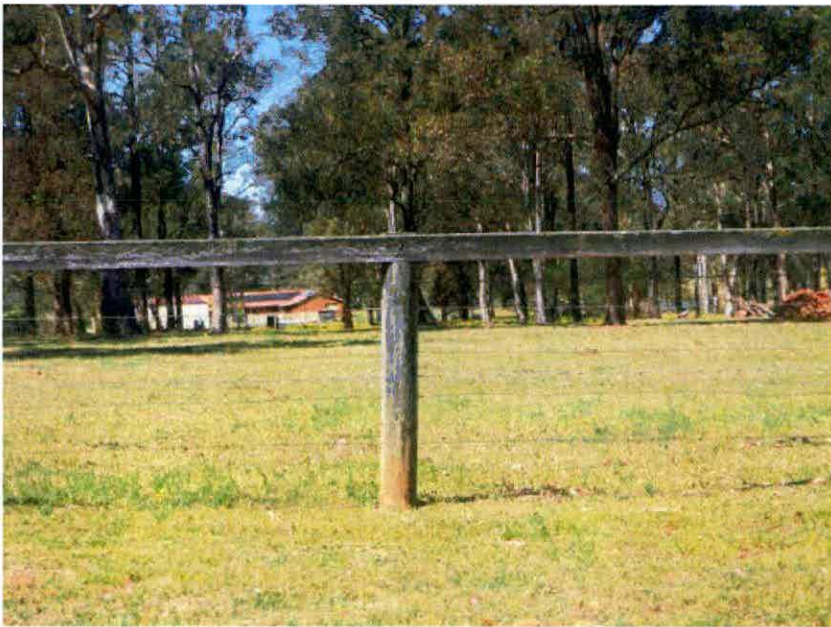
Figure 12. View east from Tickle Drive showing glimpses of distant views (DWarry 2012)

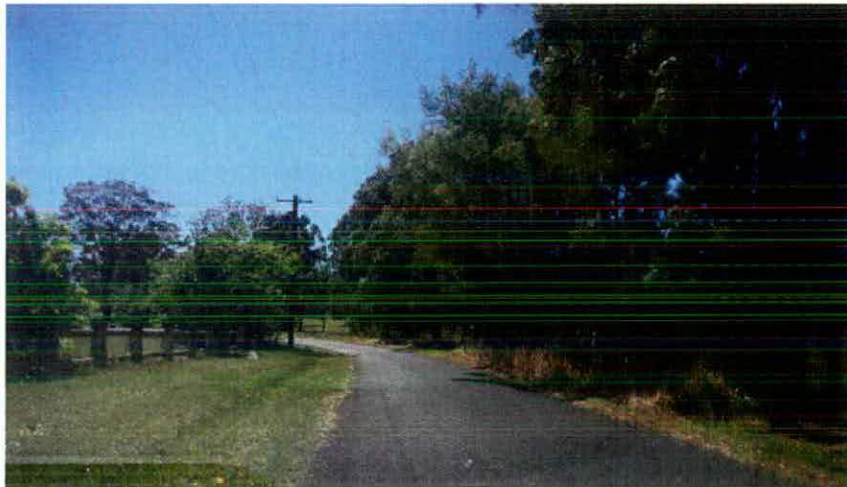
The horizontal geometry of the roads retain the alignment put in place prior to any thought of motor vehicles. Each road has sharp turns with little in the way of sight distance;

Figure 13 . View north along Tickle Drive showing limited sight distance due to remaining native trees and sharp road angles (DWarry 2012);

Recommendation 4: That only minor road widenings be carried out to improve sight stopping distances;

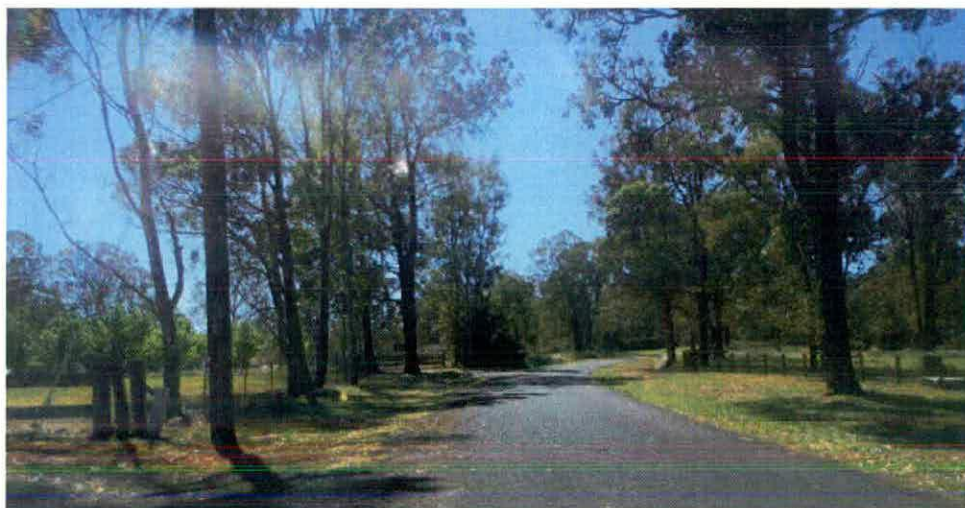
Figure 14 . View north along Tickle Drive showing limited sight distance due to remaining native trees and sharp road angles (DWarry 2012);

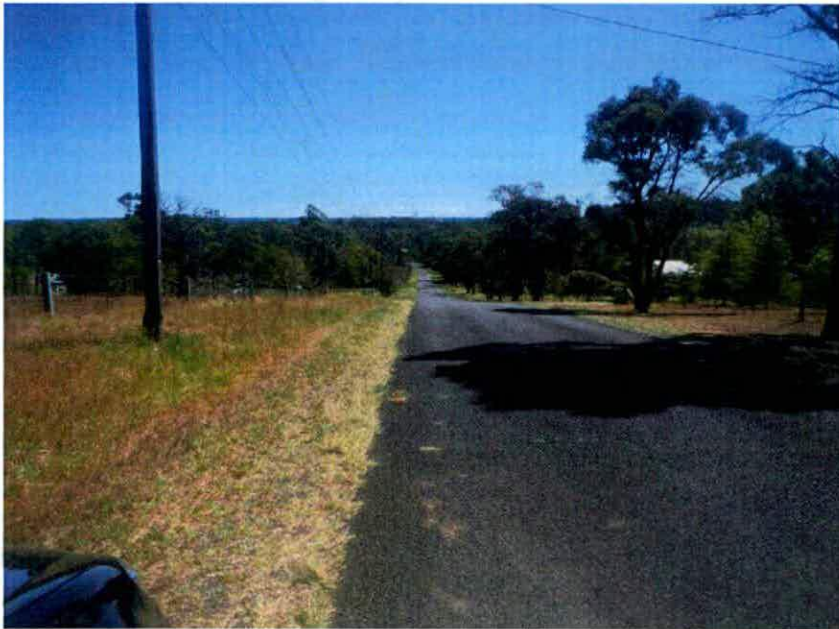
It has extensive tree planting to one side and the utility services, especially overhead electricity has been located on a cleared side. It also has, from the highest point, distant glimpse views.

Figure 15. View north west along Rita Street showing distant views and the tree line along one side only with the electricity along the opposite side (DWarry 2012)

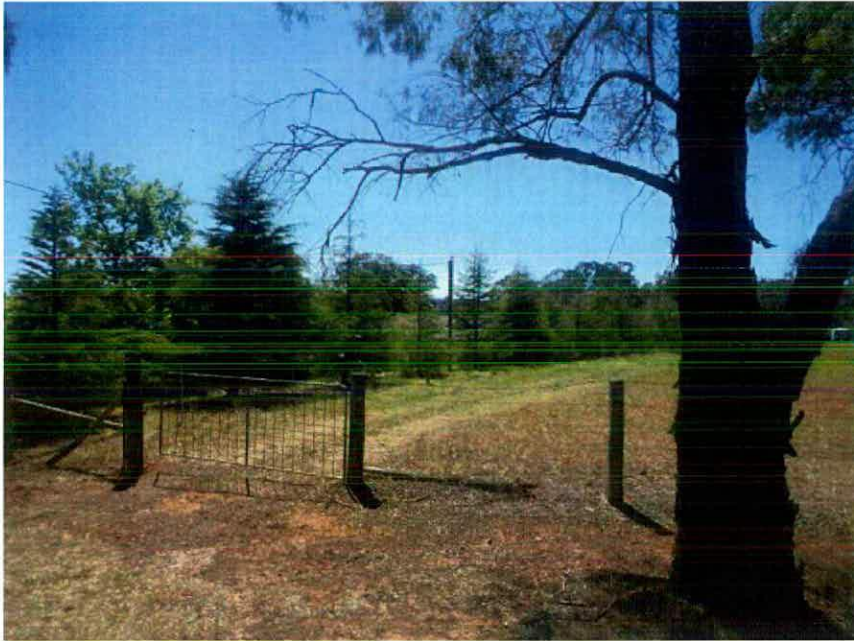
Figure 16. View north from Rita Street showing distant views although obscured partly by trees.
(DWarry2012)

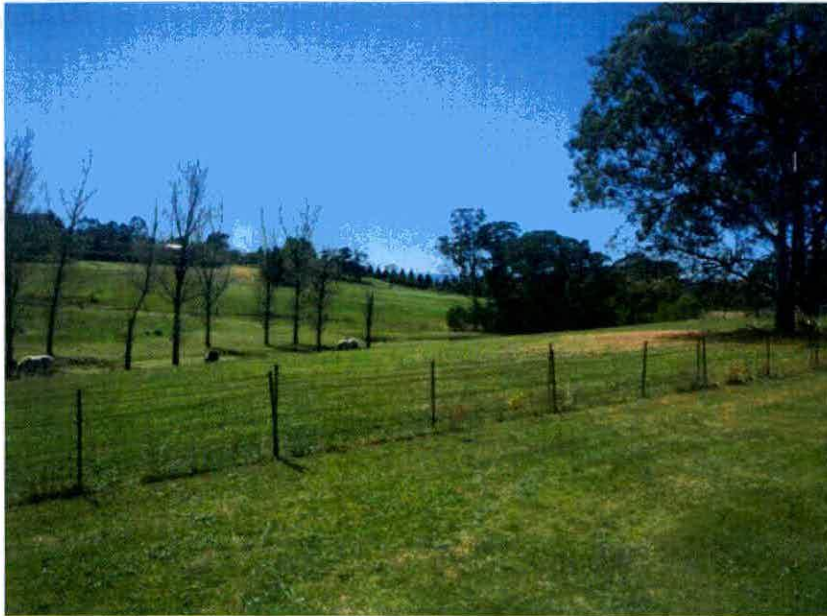
Figure 17. View north east from Hilton Park Road showing distant views although obscured partly by trees. (DWarry2012).

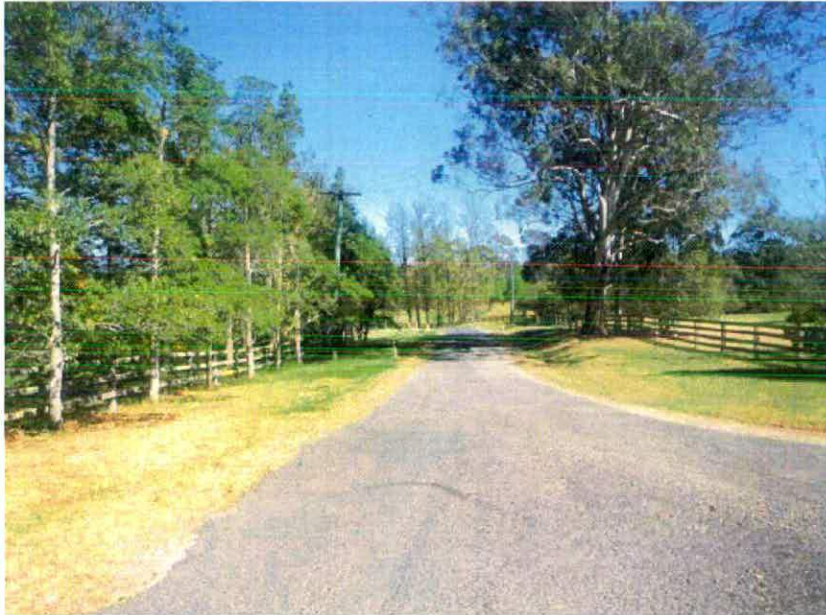
This road came into existence in 1922 with the registration of DP 11938. Its form and shape has remained the same since that time despite several small subdivisions in more contemporary times. For the majority of this road there is a distinctive streetscape of street planting of tall poplar trees which date back to the original subdivider. Other sections have pine tree plantings within the road reserve. From a number of locations along Hilton Park Road there are glimpses of distant views. This road also was designed at a time when cars were not considered and it has a number of sharp bends with limited sight stopping distance.

Figure 19. View south west along Hilton Park Road showing extensive tree plantings in the road reserve. Note that the electricity line is not confined to one side of the road only. (DWarry2012).

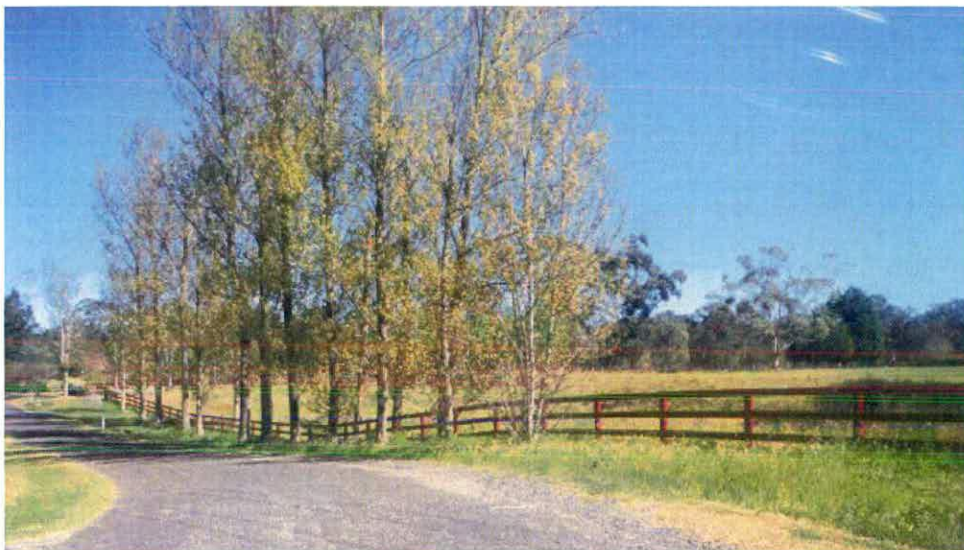
Figure 20. View south west along Hilton Park Road showing line of Poplar trees that exist along the majority of this road. (DWarry2012).

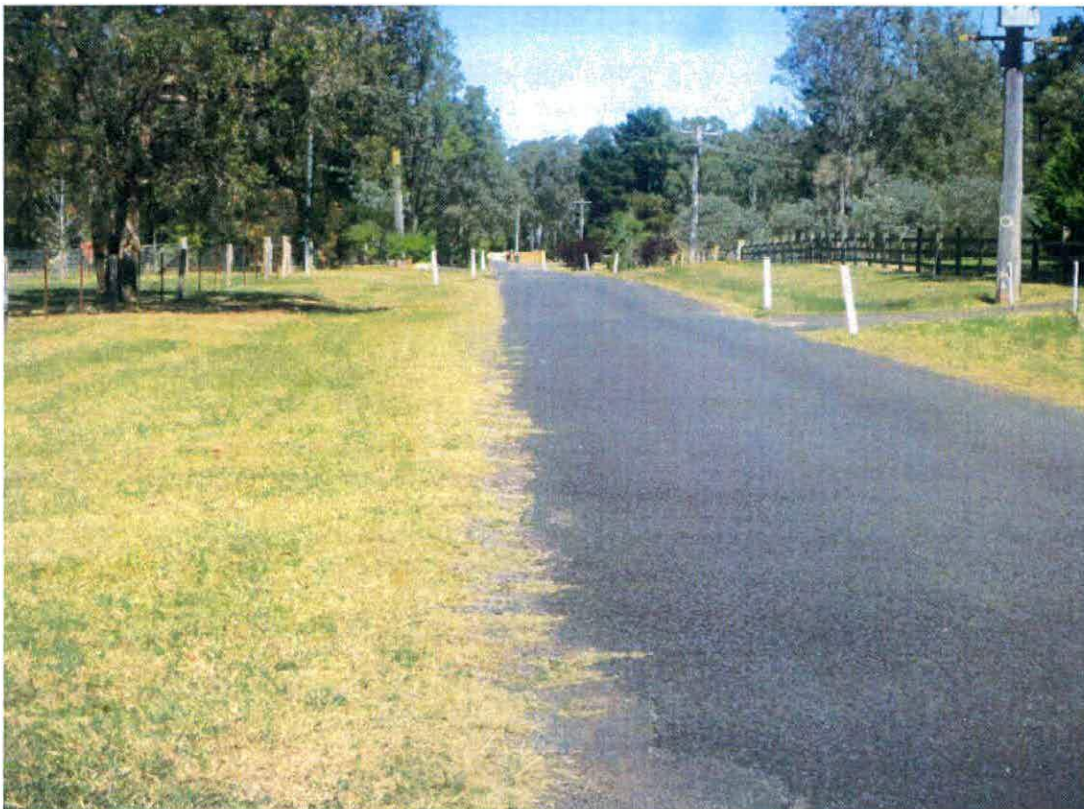
Figure 21. View south west along Glenanne Place showing the lack of native vegetation in the road reserve (DWarry 2012).

This road came into existence in 1973 with the registration of DP 245495. Its form and shape has remained the same since that time and each of the eight lots created have remained intact without subdivision. Unlike the "Portion Roads" no native vegetation was left in the road reserve. Some street planting exists but is not remnant vegetation. Overhead electricity services each allotment.

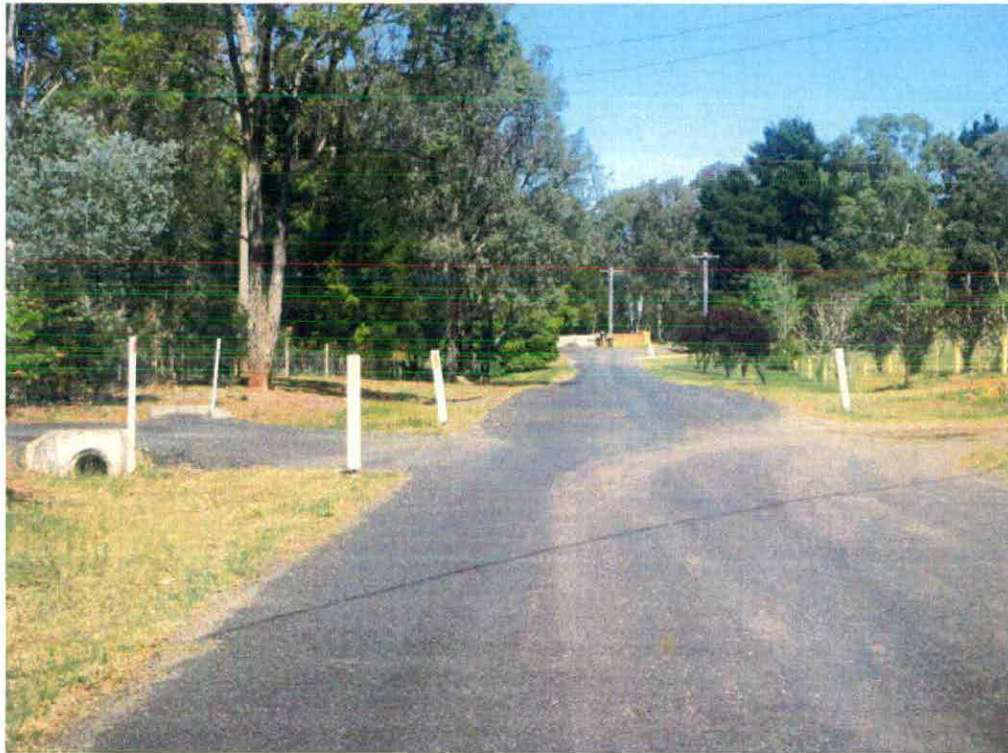
Figure 22. View south west along Glenanne Place showing the lack of native vegetation in the road reserve (DWarry 2012).

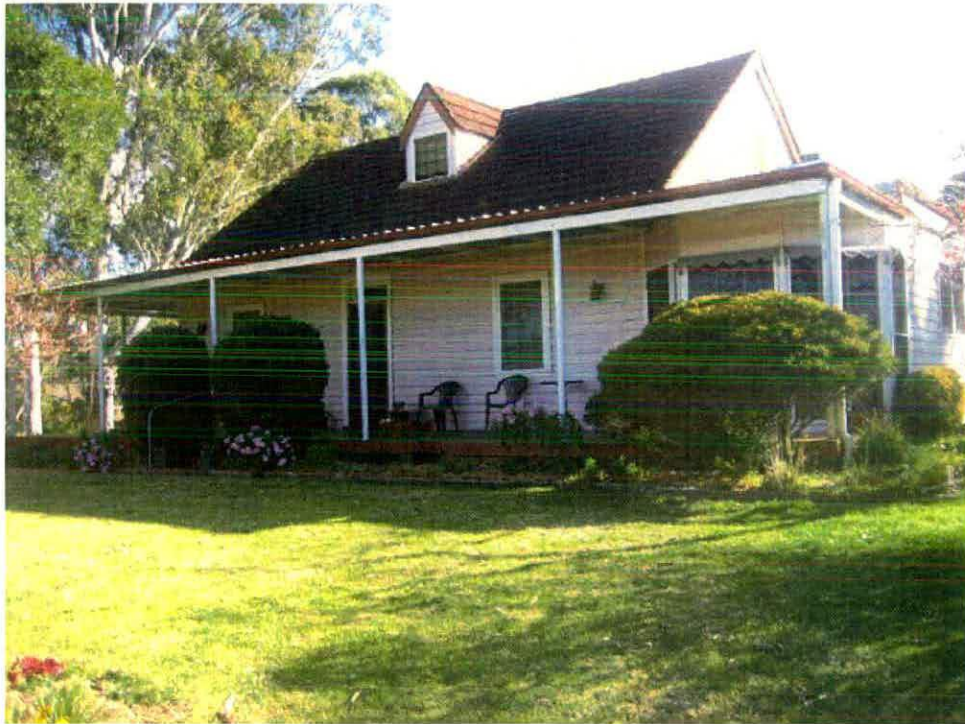
- 1945 tongued and grooved flooring replaced the slabs.
- 1956 Change of ownership to John C Bowden
- 1956 Roof replaced with Marley tiles
- 1965 Interior walls replastered, house rewired, exterior painted, Kitchen and bathroom renovated.
- 1981 Change of ownership to the current Owner -Yvonne Bowden
- 1982 back verandah glassed in
- 1983 Annexe rebuilt retaining the integrity of the original building.

Example of early rural settlement of Thirlmere/ Tahmoor

Figure 23: No. 10 Hilton Park Road north eastern elevation of dwelling in 2012 (M Cronin 2012)

Recommendation 1: For each of the identified four (4) items, at the development application stage a more detailed curtilage assessment should be carried out. This assessment should identify an appropriate curtilage that will contain the heritage item and any landscaping and setting features.

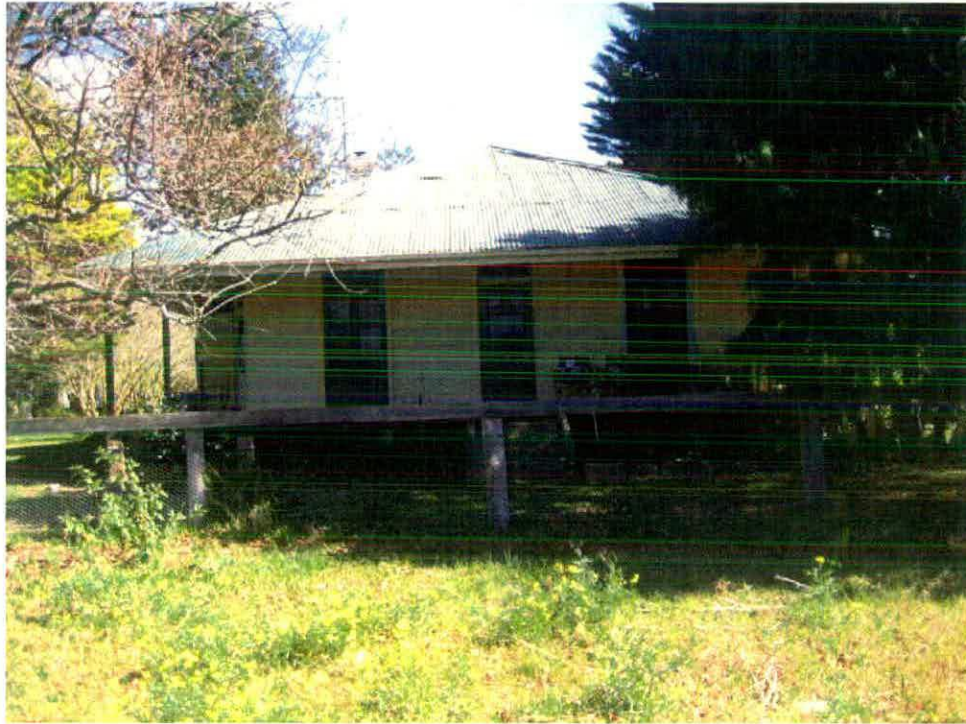
Condition of House at 2001: Aged but partially (poorly) renovated. The tin roof was aged, leaking and in need of replacement. The timber floor was in need of replacement in some areas with boards showing visible borer damage. Timber windows were in poor condition with some painted shut.

Side verandahs have been reopened. Interior and exterior asbestos sheeting has been professionally removed. Exterior walls have been replaced with fibre cement cladding and interior walls now plasterboard / timber lining boards. Part of the lounge room area has been separated and altered to form a 3rd bedroom and ensuite. The kitchen has been removed and transformed into a dining area. The family room has been converted into a new kitchen / family room with the timber floor replaced. The laundry has been replaced and tiled. Bathroom area replaced and tiled. Aluminium doors and windows have been removed and replaced with timber. House fully rewired. A two car colorbond garage has been built. Previous shedding has been removed.

The dwelling is located in a Mine Subsidence District. There has been a number of dwellings in the area affected by Mine Subsidence. The dwelling is on piers so there is a possibility of mining subsidence damage. Wollondilly Shire Council has approved plans for a 2 bedroom extension with ensuite and entertainment area that will be constructed on the southern side of the house.

Figure 24: "Brundah" homestead No.49 Hilton Park Road Tahmoor (M Cronin 2012)

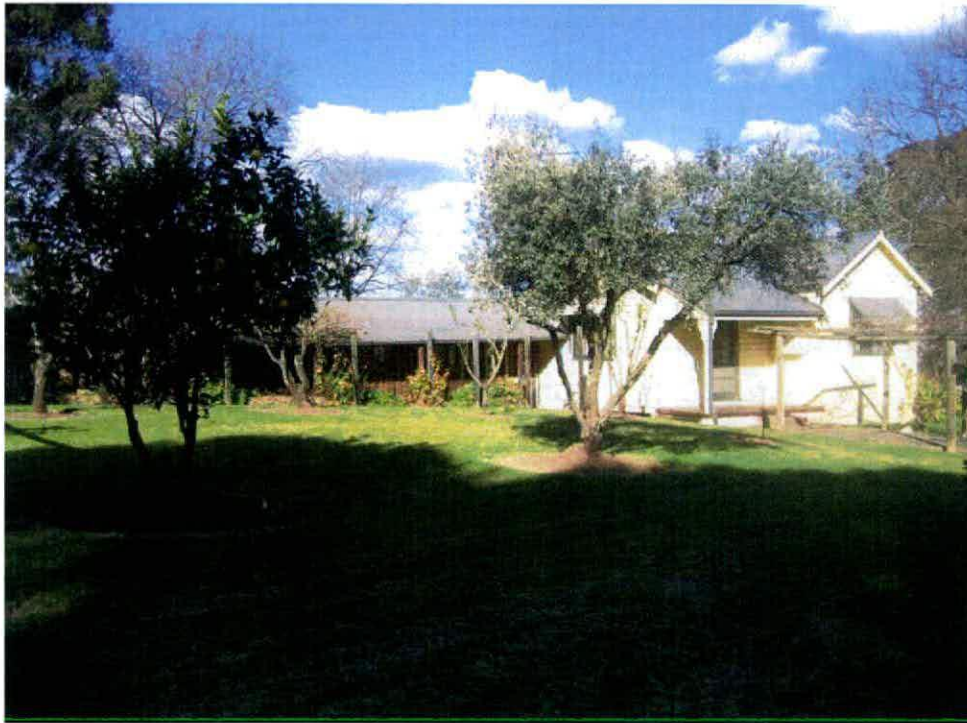
- Anecdotally the house was built in circa 1925 and occupied until circa 1960's by the Tickle family who moved from 10 Hilton Park Road referred to above. It was later purchased by the Murray-Lesley family who sold it to Helmet Schneckar of the Burning Log Company. Marhold Pty Ltd, a McPhee family company, purchased it in 1987. The Murray-Leslie family had extended and renovated in the 70's and a further extension was added in the 80's.

Figure 25: No 100 Hilton Park Road (M Cronin 2012)

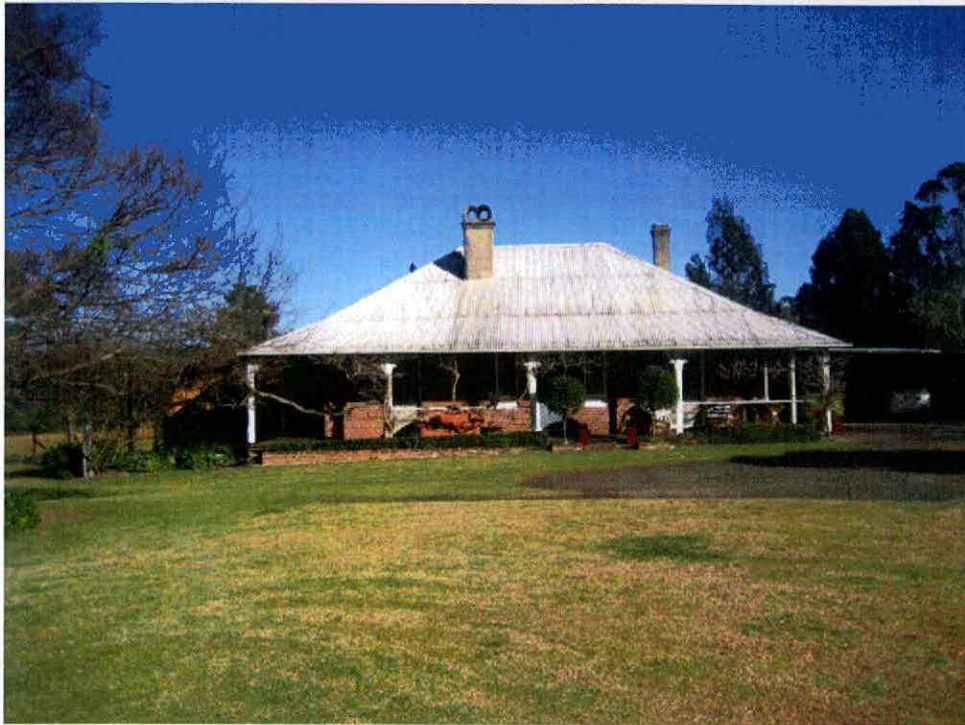
Small residence comprising 3 rooms wide and 2 rooms deep (total 8 rooms – 2 x 4m x 3.3m with back to back fireplaces, 2 x 3.0m x 3.3m (now 1 dining, 1 bed), 1 x 3.5m x 3m (kitchen), 1 x 1.3m x 2.1m (bath), 1 x 1.3m x 1.1m (pantry) and a meat safe/cool room 1.9m x 3.2m – all dimensions approximate), pitched iron roof, brick walls, stone foundations, generally timber floors but 3 concrete, plastered walls and ceilings, timber verandah all round, open 2.5 sides and enclosed 1.5 sides. Timber windows and doors.

Condition of house – Aged. Walls and plaster badly cracked due to shallow foundations, ground water flow and droughts. Ceilings badly cracked. Borers in internal floors. Verandah floor in need of replacement.

Kitchen had 5 doors – 2 doorways bricked up. Bathroom and pantry joined to make 1 x 1.3m x 3.3m pantry. Window enlarged to form a doorway from verandah to (now) dining room. Two timber floors replaced. Pantry floor tiled. Four ceilings replaced. Verandah floor replaced. Rear verandah enclosed and provided with a pair of glazed entry door (not matching original cedar doors) plus fly screens. Fly screens added to the 3 original front entry doors. House fully rewired. Running hot and cold water and waste drainage provided to kitchen. House invaded by termites over many years until effective treatment annihilated them. Significant damage to ceiling joists, some rafters and adjoining timber work.

Discussions have taken place with Xstrata and the Mine Subsidence Board about the risk of serious damage occurring when the house is undermined. The owner expects that the house may suffer irreparable damage but the MSB is more optimistic.

Figure 26: No 70 Tickle Drive Thirlmere (M Cronin 2012)

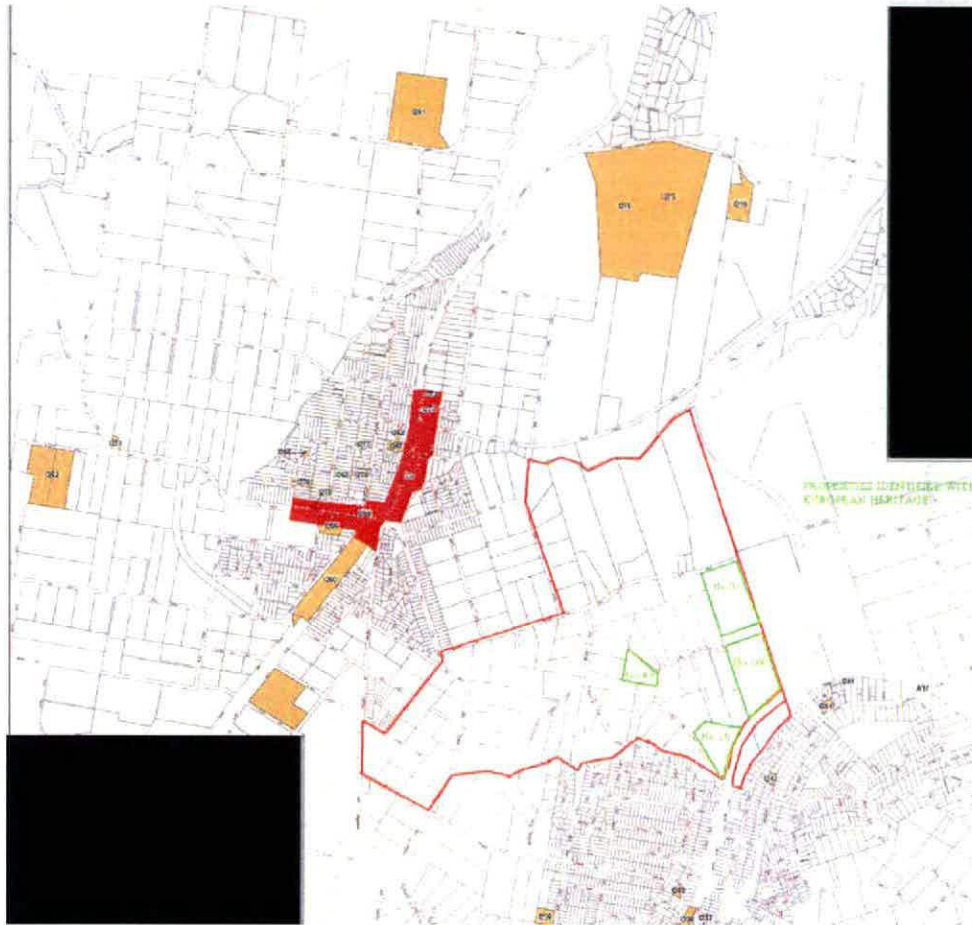
Comment: This Heritage Assessment has identified the four (4) heritage items that are located within the Study Area on relatively large parcels of land. Figure 25 below indicates the location of these properties.

Figure 27. The properties that contain the identified heritage items are shown edged in lime green on this image (WSC 2011 edited by DWarry 2012)

Recommendation 6: Wollondilly Council's Heritage Map be updated with the information shown on Figure 25
