POST ACTIVITY REPORT

UNEXPLODED ORDNANCE FIELD VALIDATION SURVEY BINGARA GORGE, WILTON NSW

Project Ref: 18102ELCO

Prepared For: Elton Consulting

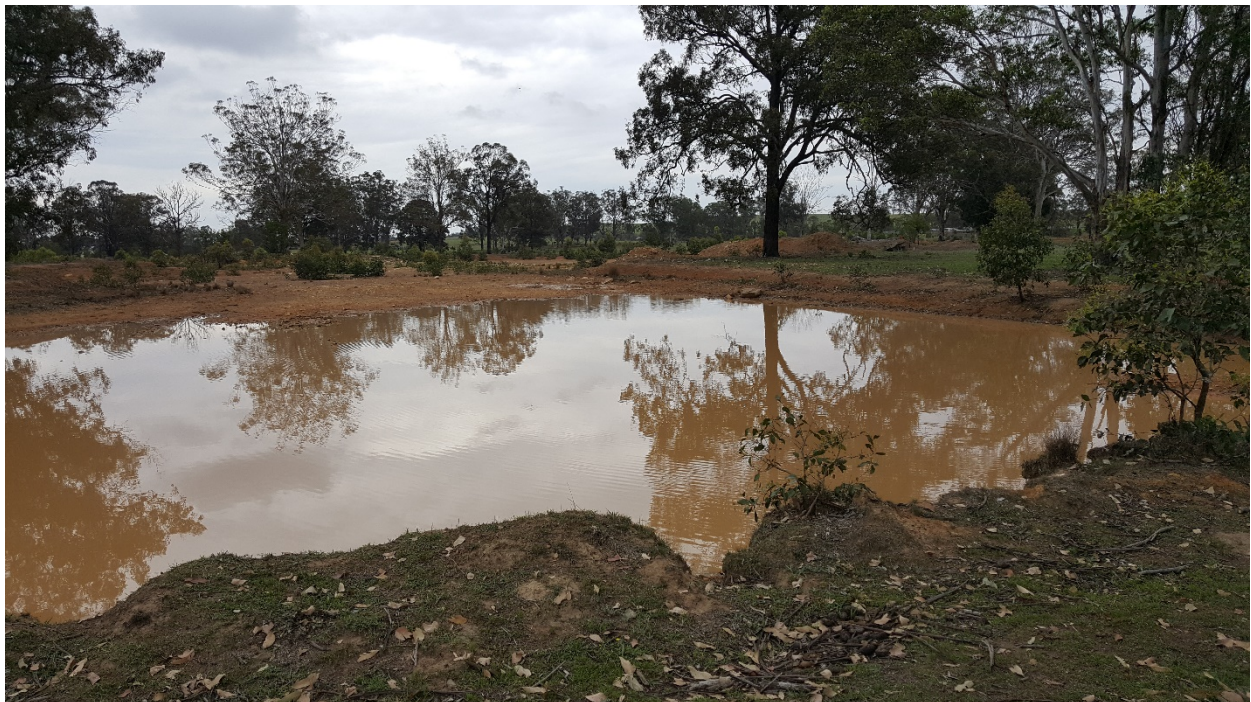
Figure 3 – Part of the unassessed Borrow Area

A borrow area of approximately 4Ha was located around 286900E, 6211400N. This area was holding water and was only minimally assessed as the original soil cover had been removed and with it, any evidence relevant to this FVS.

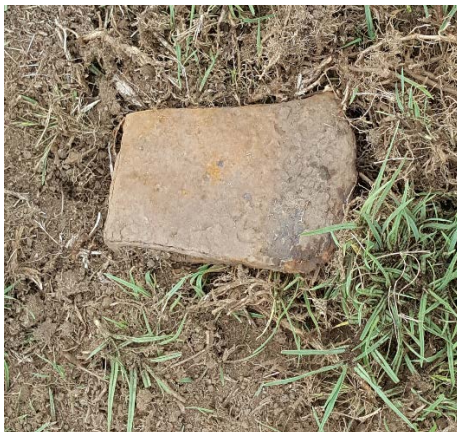
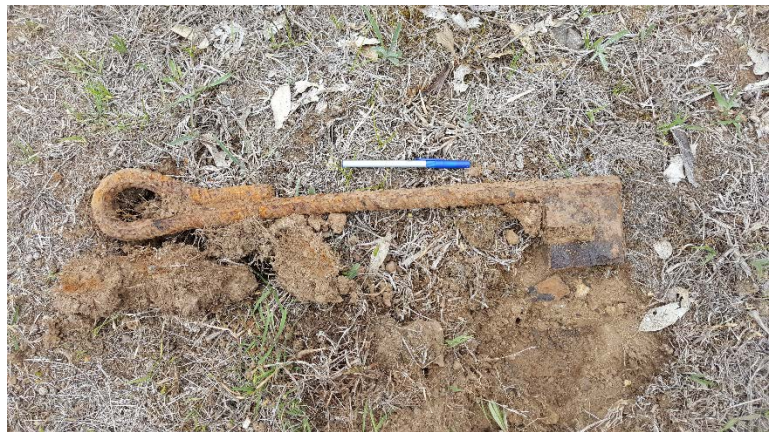
Figure 6 – Indicative "finds"

No items of unexploded ordnance (UXO), explosive ordnance (EO), explosive ordnance waste (EOW) or small arms ammunition waste (SAAW) were identified during this FVS.

Various items indicating agricultural usage were located. No other indications of other waste items were observed.

Based on the works conducted, it is considered that there is little to no risk of UXO, EO, EOW or SAAW containing high explosive (HE) or other energetic material, such as pyrotechnics or propellant, to be remnant within the requested Bingara Gorge FVS area as a result of any activities within the former Douglas Park Bombing Range.

It is recommended that any planned development works within those parts of Lot 31 DP270536, Lot 26 DP270536 and Lot 1 DP270536 within the Bingara Gorge development area south of the Hume Highway/Motorway be allowed to proceed without further unexploded ordnance assessment, remediation or other works being required to be conducted.
