Report on  
Targeted Site Investigation for Contamination

Part of Fairways North, Bingara Gorge Estate  
Fairway Drive, Wilton

Project 43677.47  
December 2017

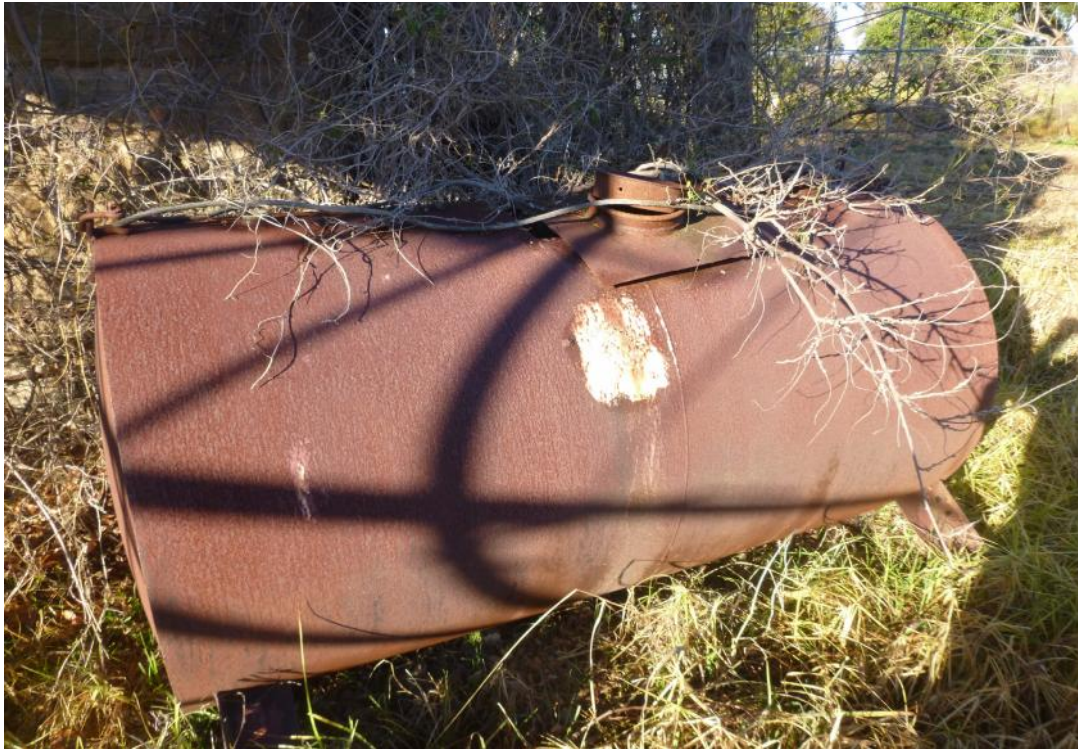
the cottage and were probably used to store farming equipment. Fuel (diesel) was likely stored somewhere close to the sheds, as old, disused tanks were observed near the uninhabited cottage. The exact location of where fuel was kept whilst the cottage was occupied is unknown. A number of (farm) dams had been constructed.

Photograph 1 - Derelict tank

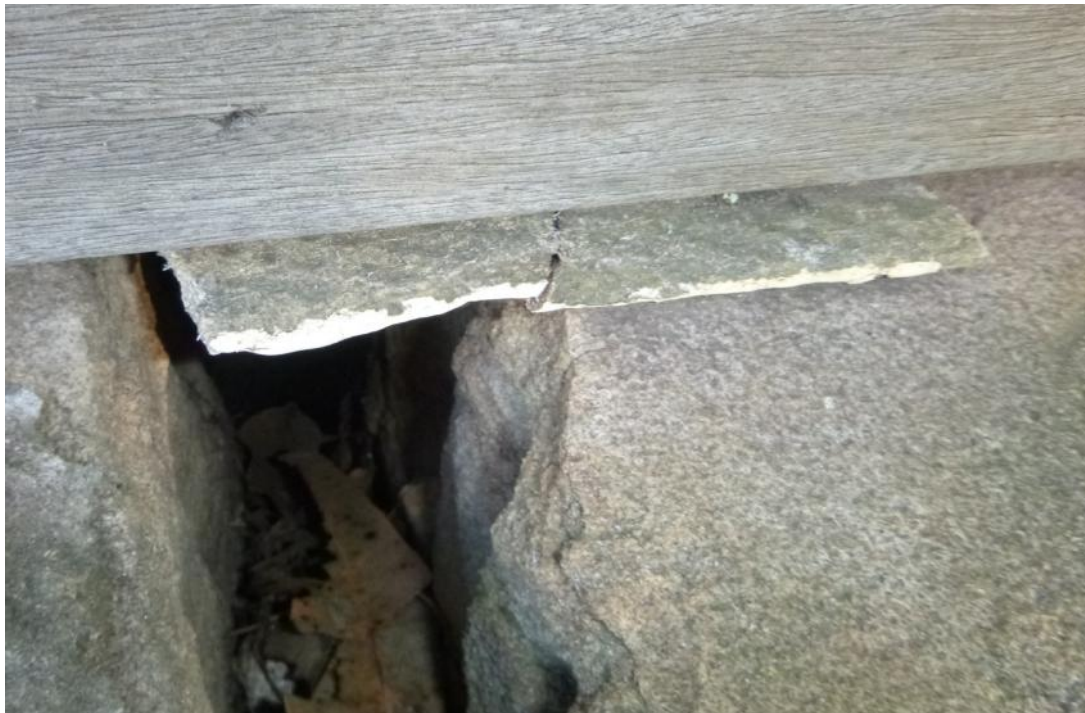
Photograph 2 - Presumed asbestos containing fibre-cement

Given the presence of observed fibre-cement pieces used as support for the timber decking, and the elevated lead concentrations in soil in close proximity to the cottage, it is recommended that a hazardous building materials survey be conducted for the demolition or refurbishment of the cottage.

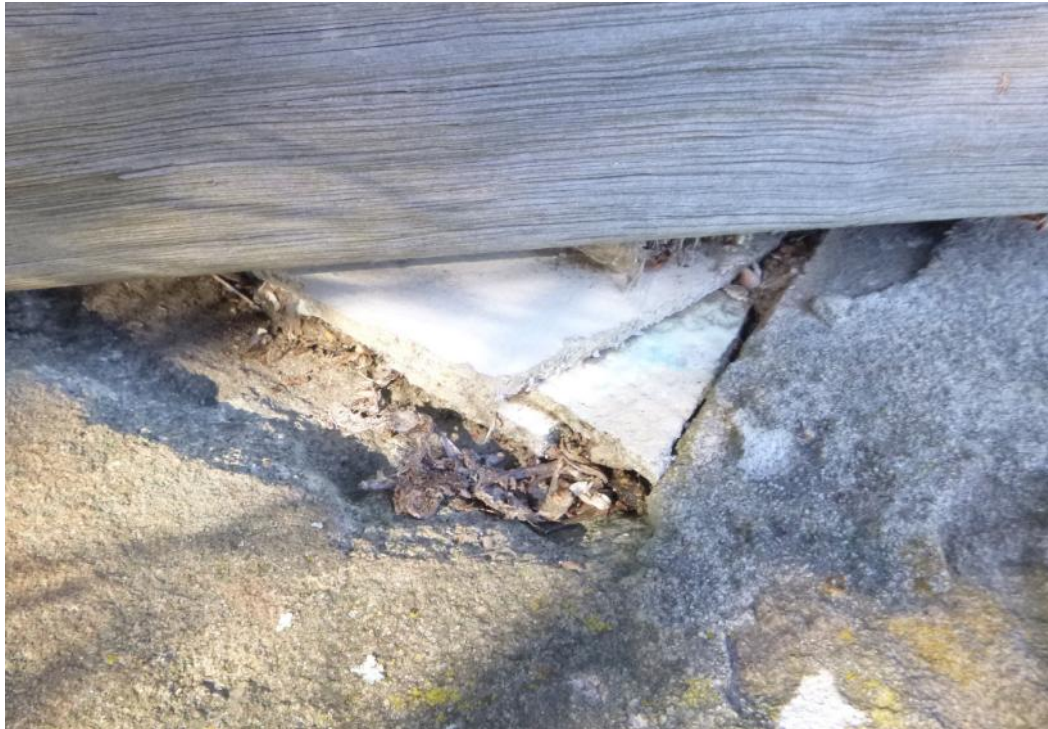
Photograph 3 - Presumed asbestos containing fibre-cement
