TECHNICAL REPORT

GEOTECHNICAL FEASIBILITY STUDY

REMEMBRANCE DRIVE and ARGYLE STREET, PICTON, NSW

Project No.: 2022-095

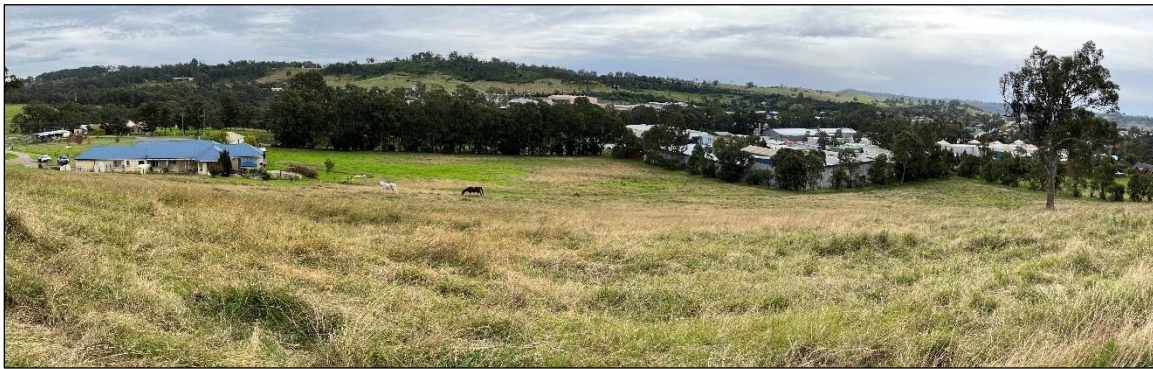
Photograph 3: View looking west to north from near the south boundary of Lot 2 DP583247

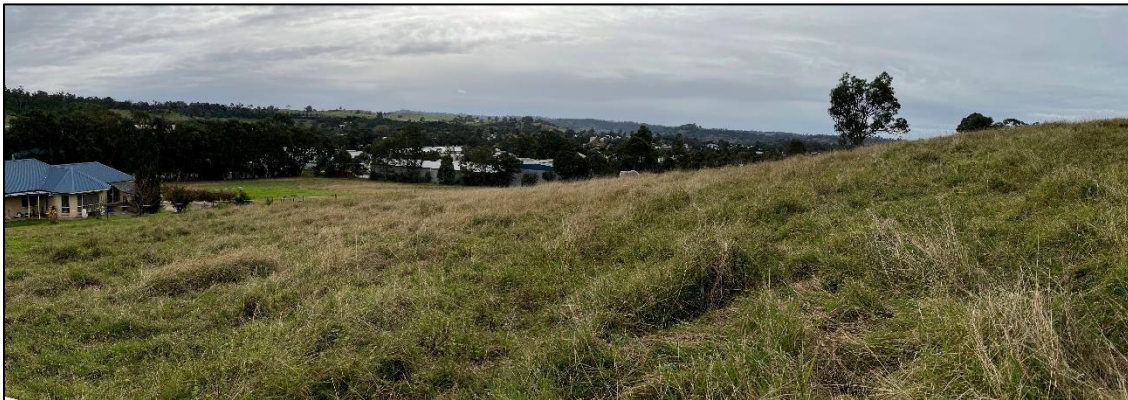
Photograph 4: View looking north to east from near the south boundary of Lot 2 DP583247

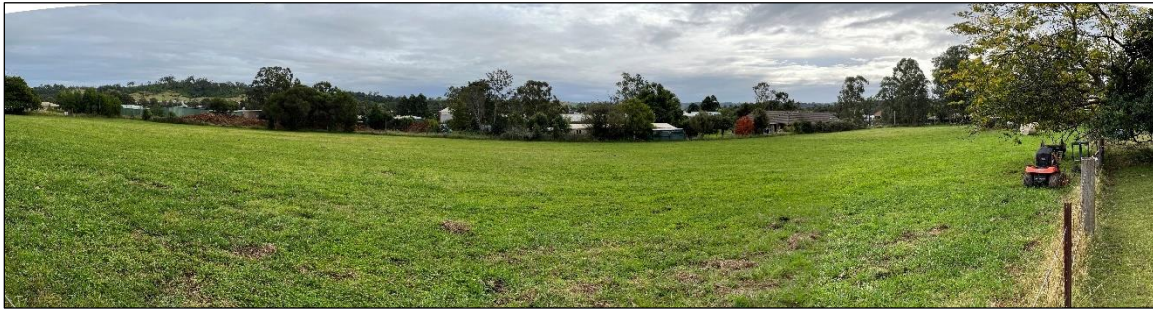
Photograph 7: View looking north from near the south boundary of Lot 141 DP997490

Signs of surface erosion or potential landslip movements were not observed. No areas of discoloured grass or vegetation were observed to indicate the presence of potential contaminants or elevated salinity.

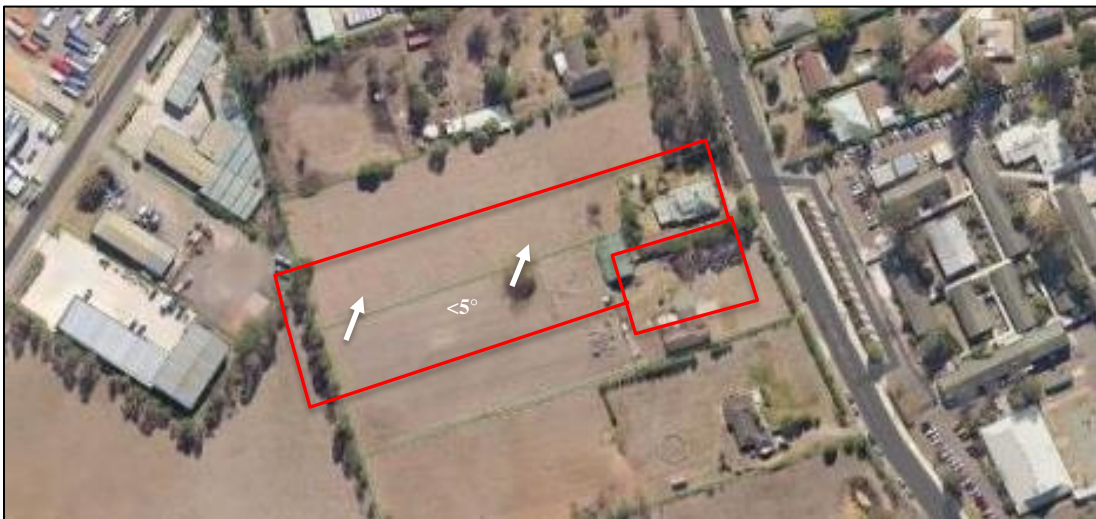
Inspection of the existing structures within the lot did not indicate any significant cracks to indicate excessive shrink swell movements of the founding soils. Signs of surface erosion or potential landslip movements were not observed. Potential areas of fill were not observed within the lot.

Photograph 8: Aerial view of Lot 141 DP997490 and Lot 1 DP537245

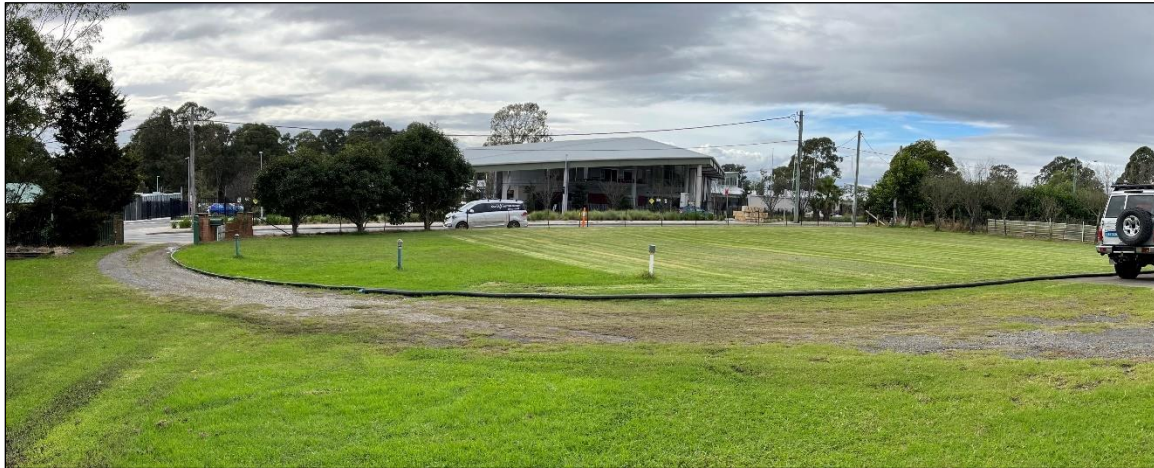
The front of the lot is near level and contains a single storey residential dwelling and lawn which appeared in good condition with no signs of cracking or distress observed to indicate potential excessive shrink swell movements.

Photograph 9: View looking west from near the east boundary of Lot 15 DP1105675

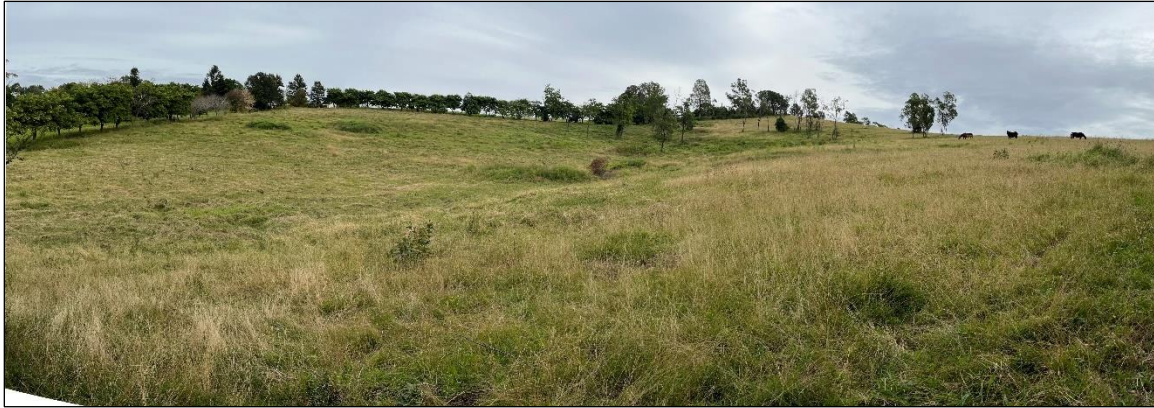
Signs of significant slope stability were not observed. Some localised exposed earth/scarring was observed within the north of the lot however no indications of widespread dispersive/erosion prone soils were observed.

Photograph 14: View looking west from near the east boundary of Lot 1 DP207443

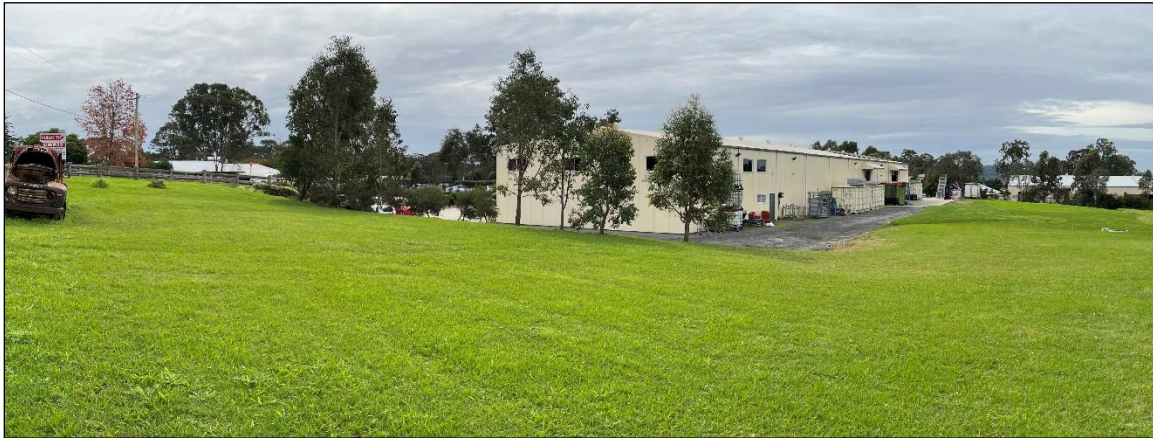
The north portion of Lot 911 DP1121899 is occupied by a warehouse type structure (Derks Pet and Rural Supplies) which is surrounded by a concrete slab used for parking and delivery vehicle access. A masonry retaining wall is present within the northwest corner of the lot and is up to approximately 1.5m in height. It appears the existing warehouse type structure is constructed on a cut/fill pad with maximum estimated fill depth of around 1.5m depth, estimated from the retaining wall height.

Photograph 18: View looking east from near the west boundary of Lot 11 DP1121899

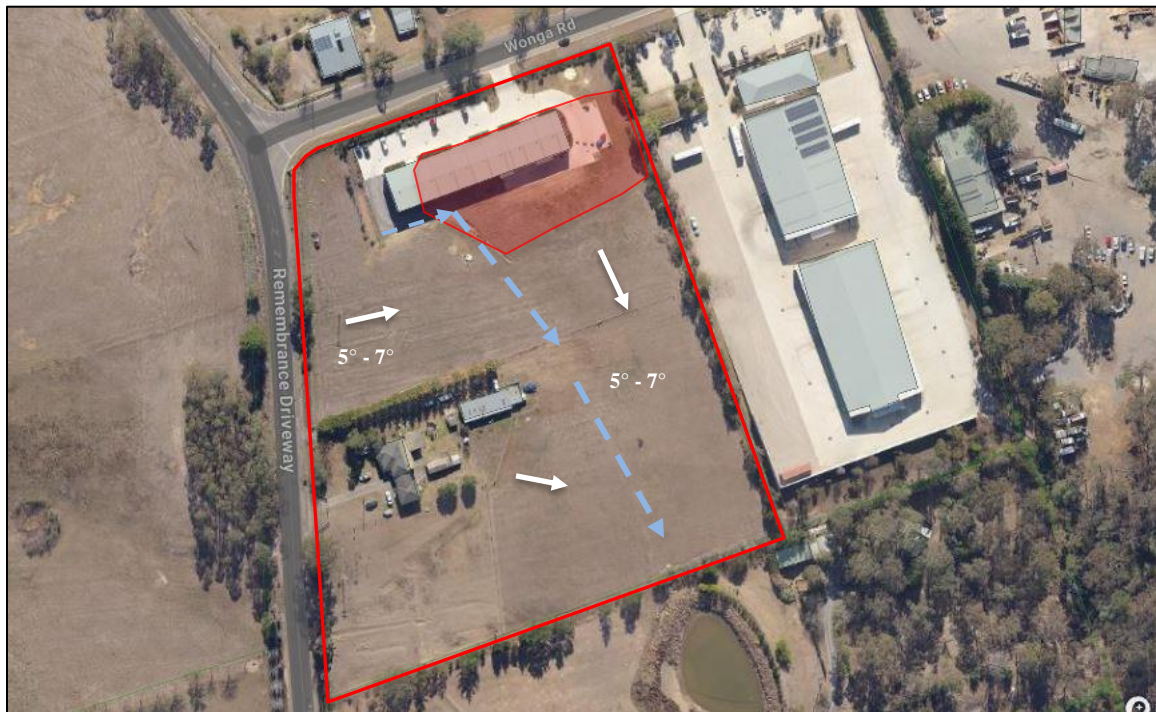
Signs of surface erosion or potential landslip movements were not observed. No areas of discoloured grass or vegetation were observed to indicate the presence of potential contaminants or elevated salinity. The area directly to the south of the area of suspected fill appeared wet underfoot in comparison with the rest of the lot.

Significant cracking of the pavement or signs of movement were not observed within the warehouse type structure within the lot.

Photograph 21: Aerial view of Lot 11 DP1121899

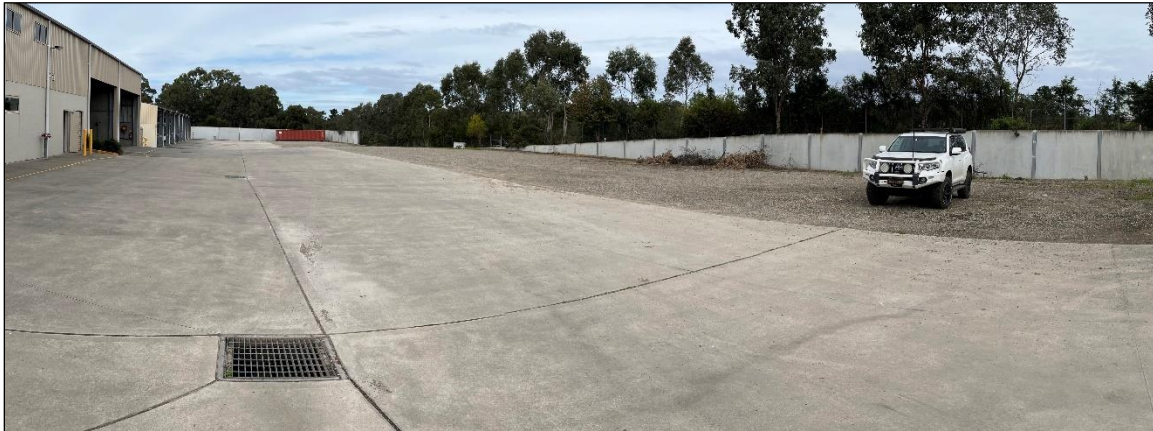
This lot is occupied by a bus depot comprising a large warehouse/garage type structure to accommodate/service buses which is surrounded by a concrete parking area which occupies the majority of the site area of approximately 20,108m². The existing warehouse and concrete parking area appear to have been formed using cut/fill with retaining walls up to around 2m in height present within the northwest and southwest corners of the site.

Photograph 22: View looking south from within the east of Lot 910 DP1121899

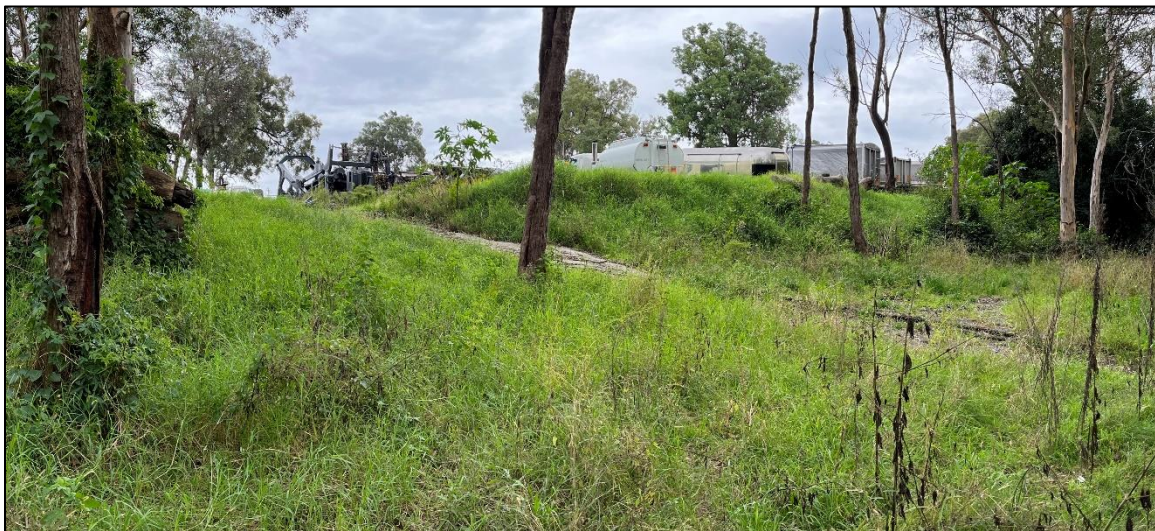
Photograph 27: View of the south end of Lot 2 DP570466 looking east

In general, the ground surface dips from north to south at $<5^\circ$ and it appears (although unconfirmed) that the useable space may have been extended in a series of cut/fill modifications which, in one area was supported by a concrete/blockwork retaining wall up to around 2.5m in height.

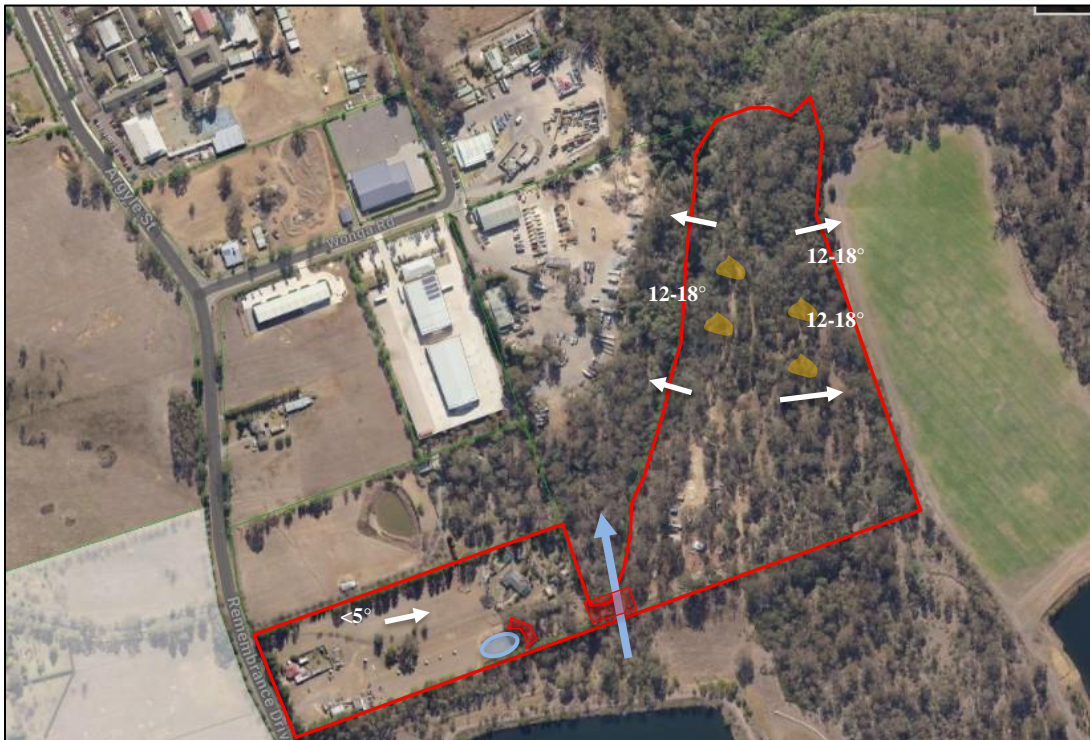
Access to the east portion of the site is provided by an earth fill bridge which traverses a small creek which runs broadly north south through the center of the lot (separating the east and west portions) draining from a large dam in an adjacent property to the south and outside the study area. Some minor slumping of the earth bridge was observed near the crest of the fill.

Photograph 37: Aerial view of Lot 1 DP570466

Inspection of the existing structures did not indicate any significant cracks to indicate excessive shrink swell movements of the founding soils. No signs of excessive surface erosion or potential landslip movements were observed with the exception of the minor slippage associated with the earth bridge. The surface of the lot appeared generally well drained with no uncontrolled water/erosion observed. No areas of discoloured grass or vegetation were observed to indicate the presence of potential contaminants or elevated salinity.
