# Geotechnical Site Classification

## 4 Close Street Thirlmere NSW 2572

**Client:** Devine Drafting & Design Pty Ltd

**Project:** 6966-18

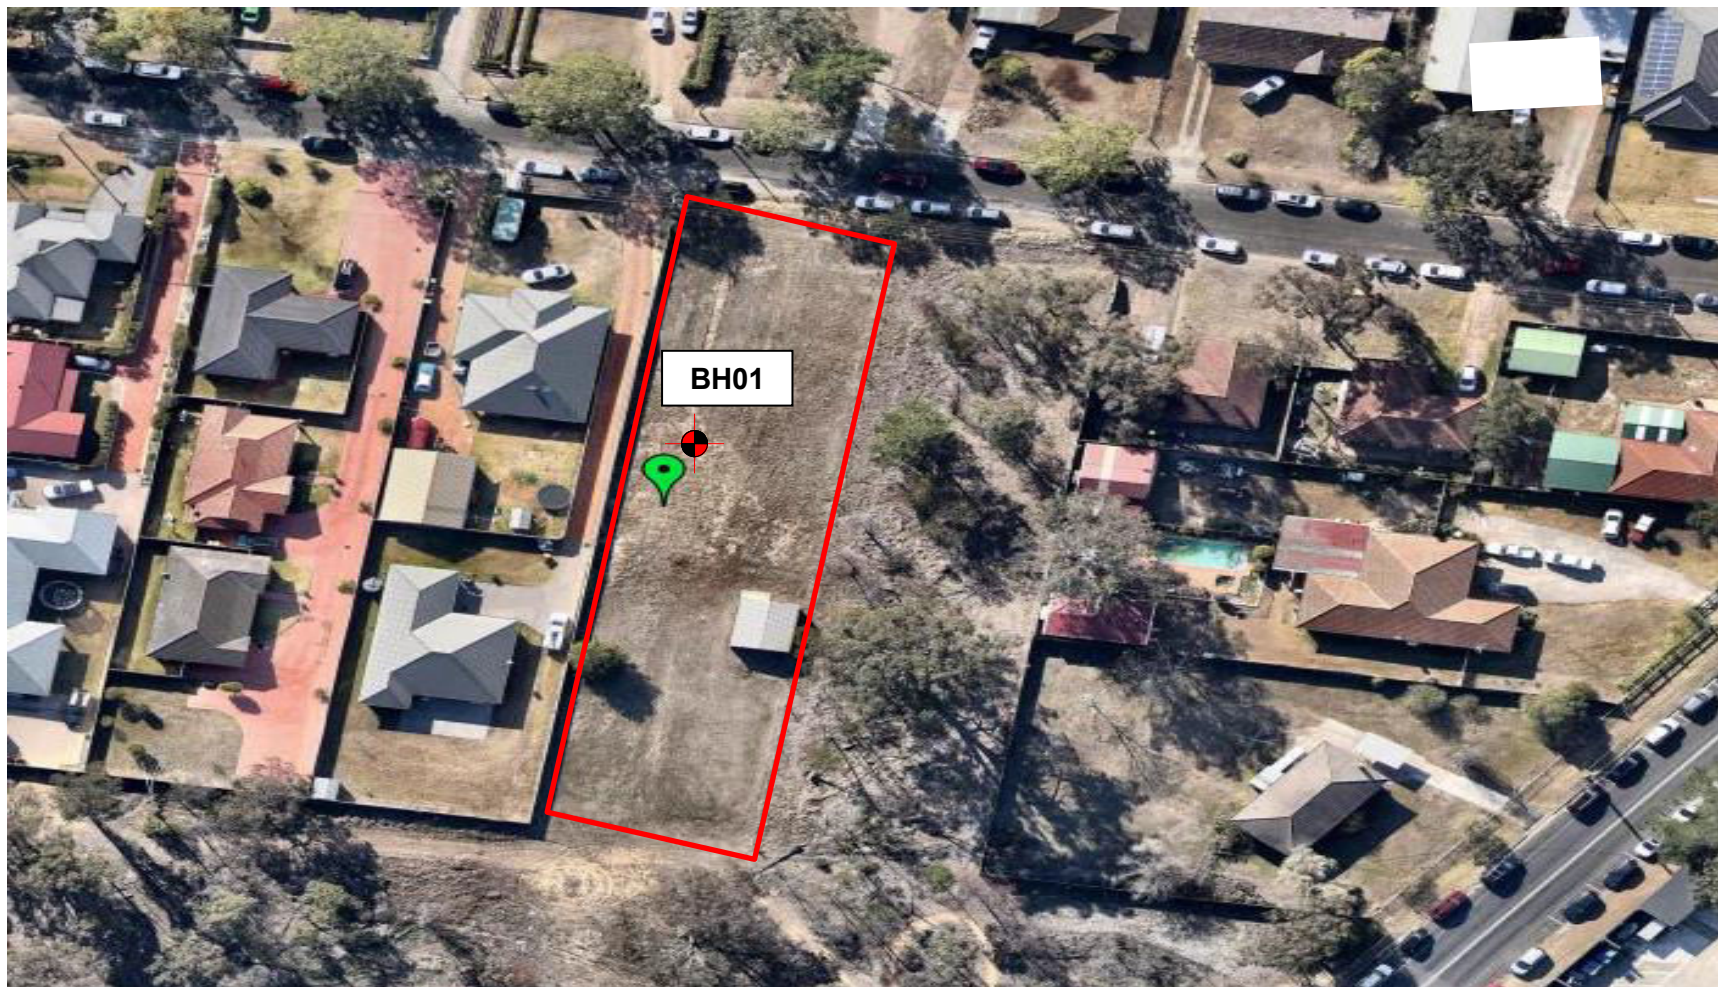
## Borehole and DCP Test locations

Note: Boreholes not to scale. Borehole/test location approximate.  
DCP undertaken in all borehole locations.
