Road Safety Audit Report

Picton Town Centre – Pre-Construction Detailed Design Stage Road Safety Audit

Prepared for Wollondilly Shire Council

28 April 2022

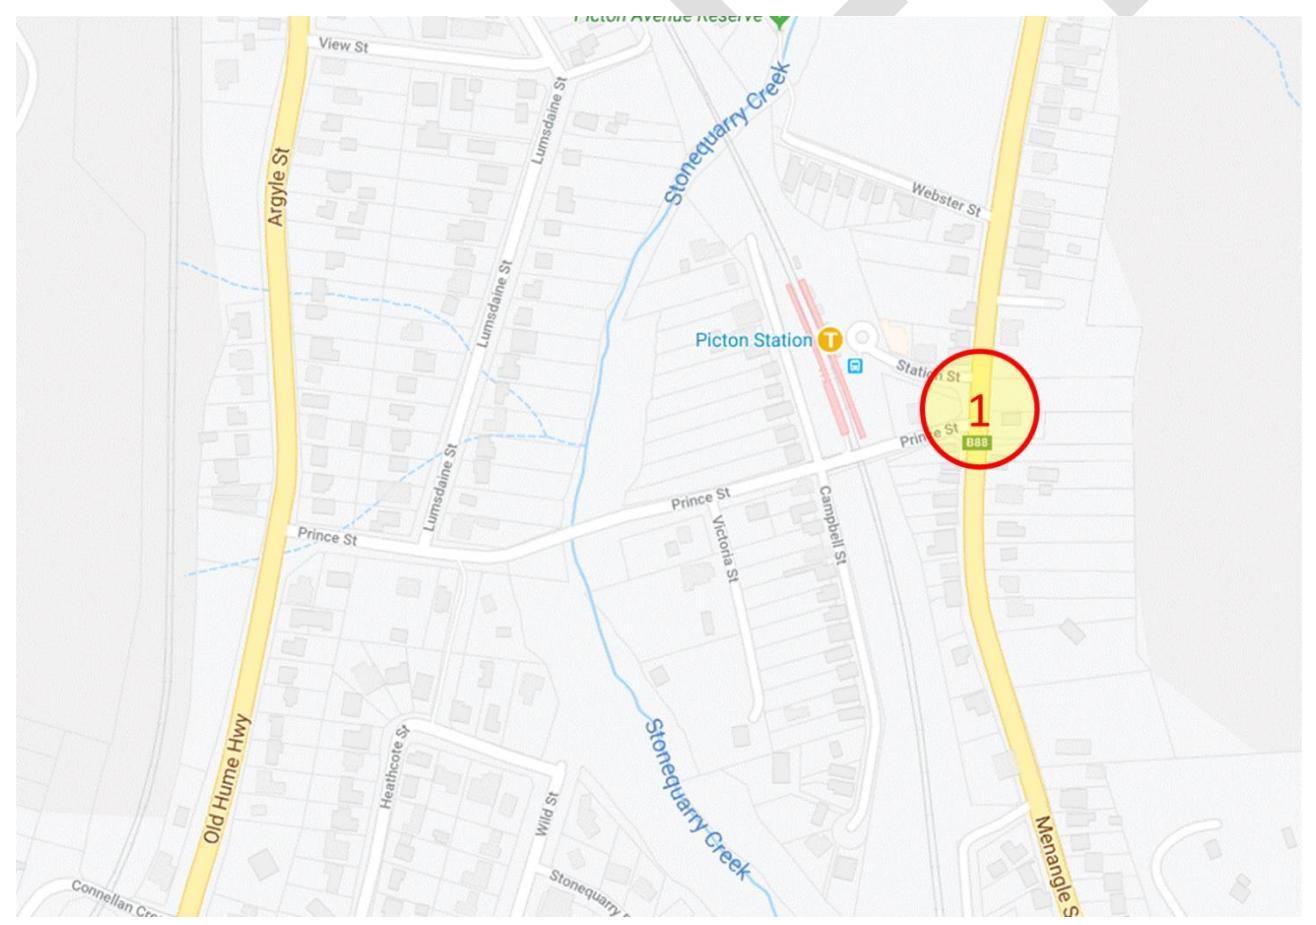
Figure 4-1 Areas of Audit

The focus of the study is limited to the Prince Street / Menangle Street intersection as shown in Figure 4-1.

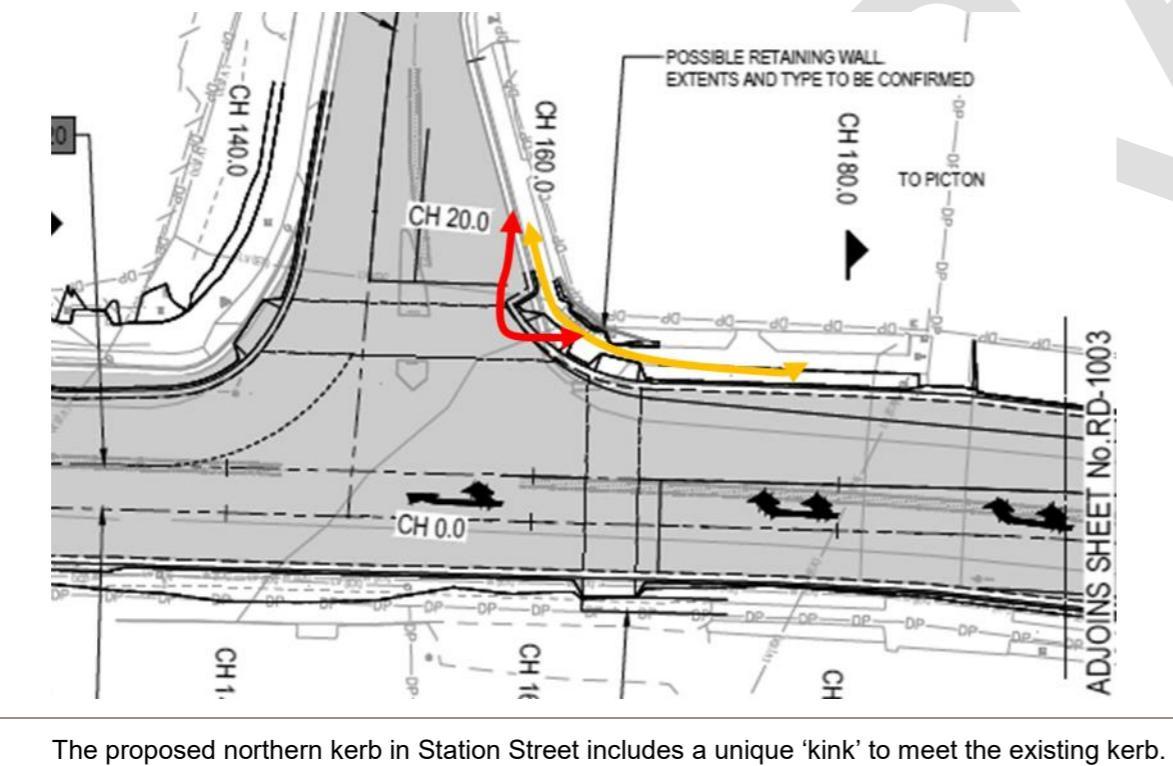
1.04

The proposed northern kerb in Station Street includes a unique 'kink' to meet the existing kerb.	Frequency	Occasional	Li
There is a risk that a vehicle may mount the kerb in this location resulting in pedestrian collisions.	<u>Severity</u>	Minor	
Additionally, there is a risk that parking may occur in this location resulting in reduced travel lane width and side swipe collisions with parked or adjacent turning vehicles.	Level of Risk	Medium

Alignment

RD-1002

Station Street Kerb

Project Manager Response
Stormwater design has been finalised as part of the 20% detailed design. To be Addressed in the 80% design.
This area is proposed to be vegetated and is not intended for use by pedestrians.
Minimum footpath width and circulation requirements to be reviewed and incorporated as part of the 80% detailed design.
Linemarking to be provided to delineate shoulder. To be assessed in 80% detailed design.

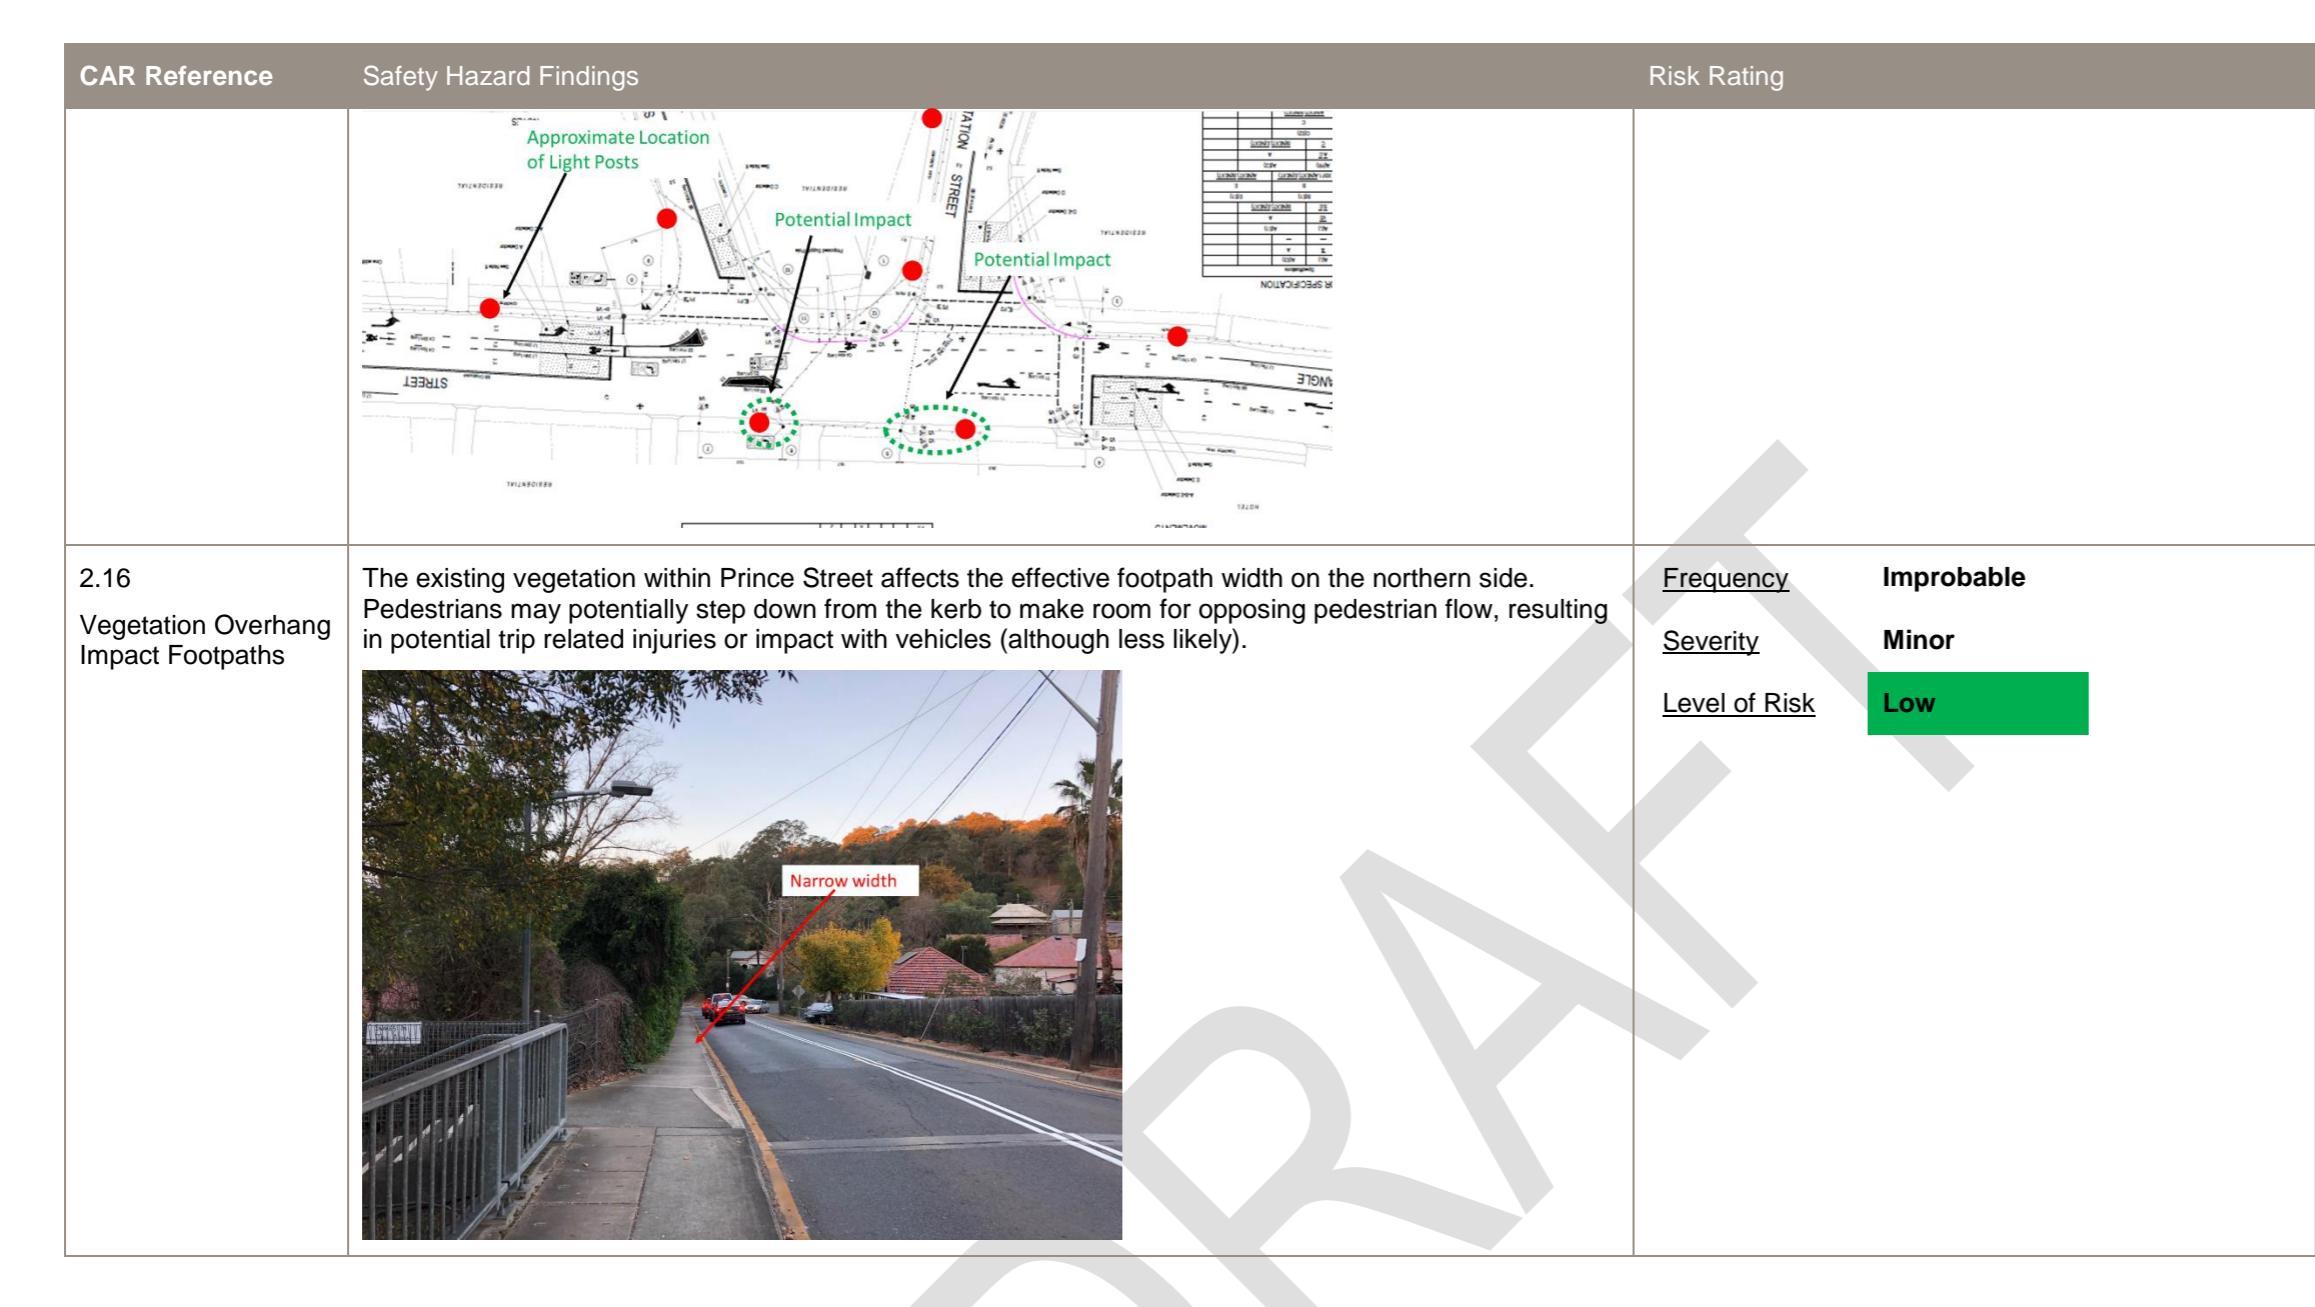
2.14	The footpath appears to narrow adjacent to the pram ramp located on the northern approach of Menangle Street and the steps to the local business	<u>Frequency</u>	Improbable	
GA-1006	Insufficient footpath width may restrict the ability for pedestrians, particularly those with impairments or	<u>Severity</u>	Minor	
	resulting in personal injury.	Level of Risk	Low	
	Steps PCW CH 20 0 Narrow width BA-1 C4 PCW CH 20 0 CH 20 0

2.15	There are a number of locations where proposed light posts may restrict sight lines to signal lanterns.	Frequency	Improbable	
Sight Lines to Signal Lanterns	There is a risk that insufficient sight distance to lanterns may result in insufficient reaction time for motorists, potentially resulting in increases in rear-end crashes or running red lights.	Severity	Serious	
LT-1121 & TCS Plan		Level of Risk	Medium

Project Manager Response
Noted as per audit finding 1.03. To be assessed in 80% detailed design.
, i i i i i i i i i i i i i i i i i i i
Light pole locations to be reviewed to provide
clear line of sight for signals in 80% Detailed
Design.

Project Manager	Response
Vegetation to be	maintained and cutback.
